# Cuttagee Lake Rapid Catchment Assessment

## Catchment Management Plan

**Bega Valley Shire Council**

*15 July 2016*

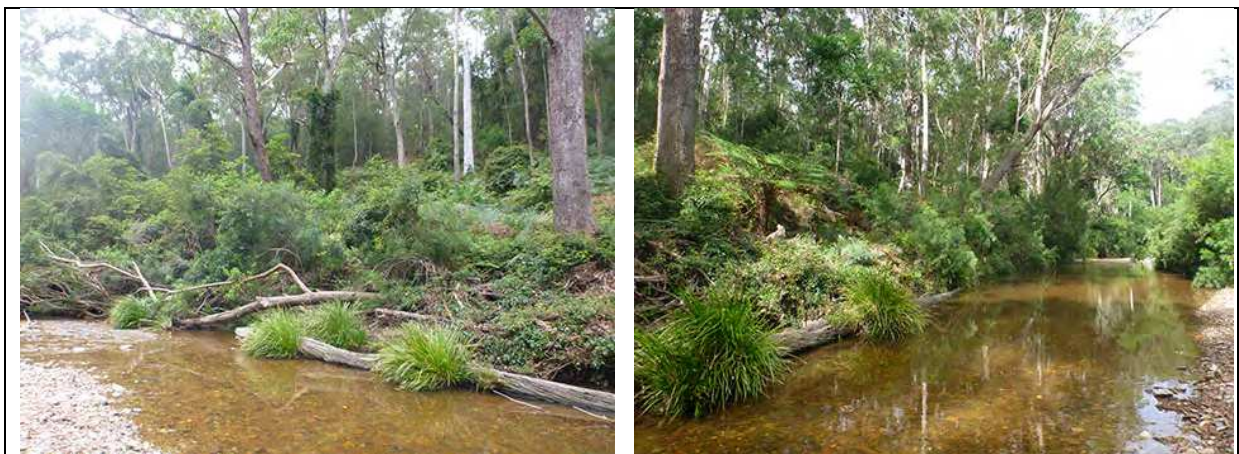
**Figure 14.** Examples of typical stream banks of upper catchment locations. Banks were in very good condition characterised by healthy riparian vegetation comprising canopy and understory strata with large woody debris providing protection to the bank toe.

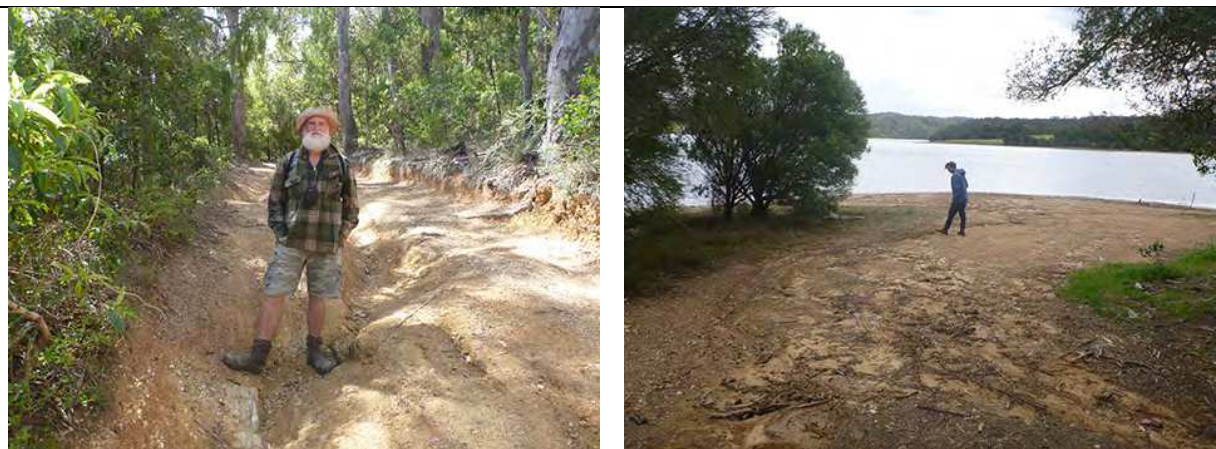
**Figure B2** Crown access road with example of section with deep rutting due to inadequate stormwater runoff controls (*left image*). Ongoing road erosion is contributing sediment fines to the estuary foreshore with potential impacts to adjacent nearby seagrass community (*right image*).

- Implement road repair that may involve regrading, use of aggregate to stabilise the road surface and improve stormwater drainage/runoff controls. Stormwater and engineering designs are required. Soft engineering approaches will not succeed in treating this serious erosion issue.

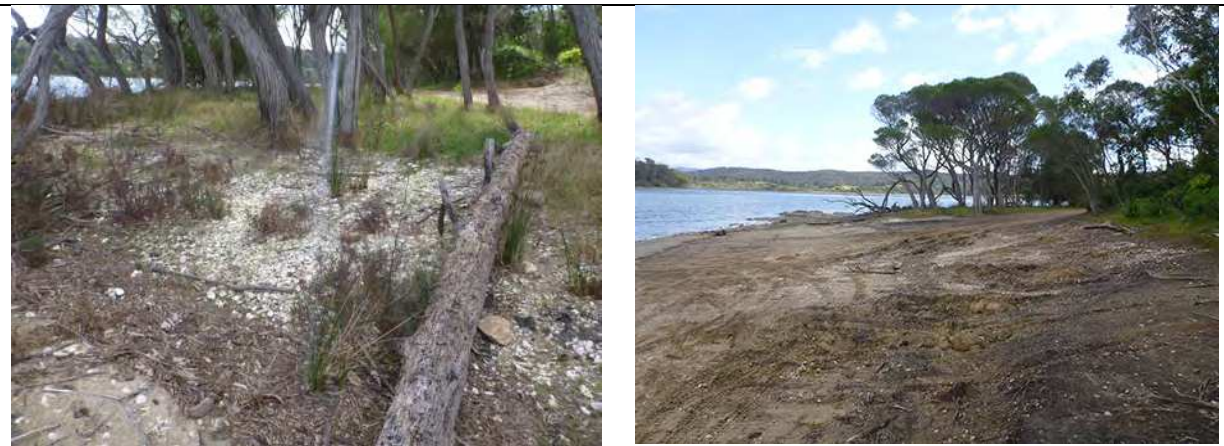
**Figure B3** Foreshore access areas were coincidentally often important estuary access sites for aboriginal community. Shell midden suggests the site may have local cultural heritage values (*left image*). Vehicle impacts to foreshore (*right image*).

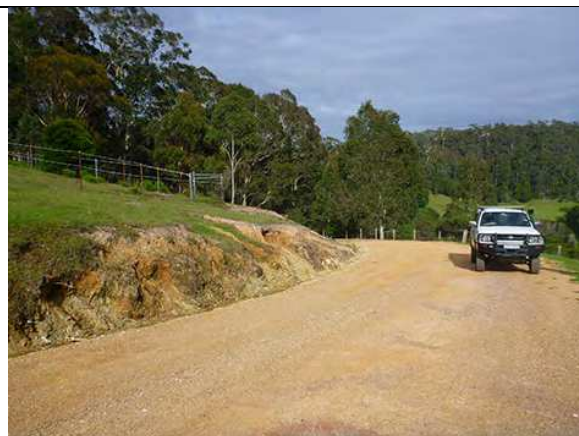
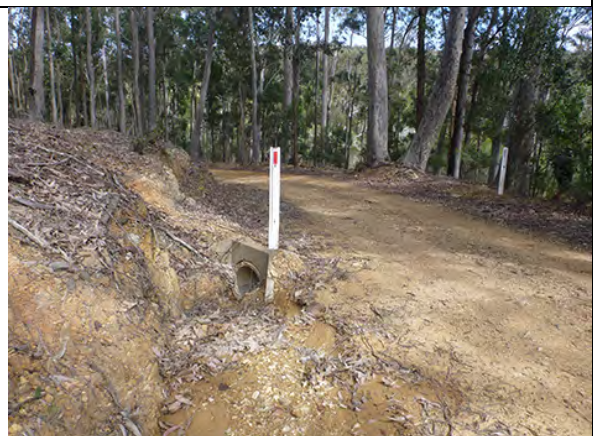
**Figure B5** Erosion of roadside embankment on Head of Cuttagee Road adjacent to Lot 183

DP752130 (*left image*), stormwater pipe on Head of Cuttagee Road (*right image*).

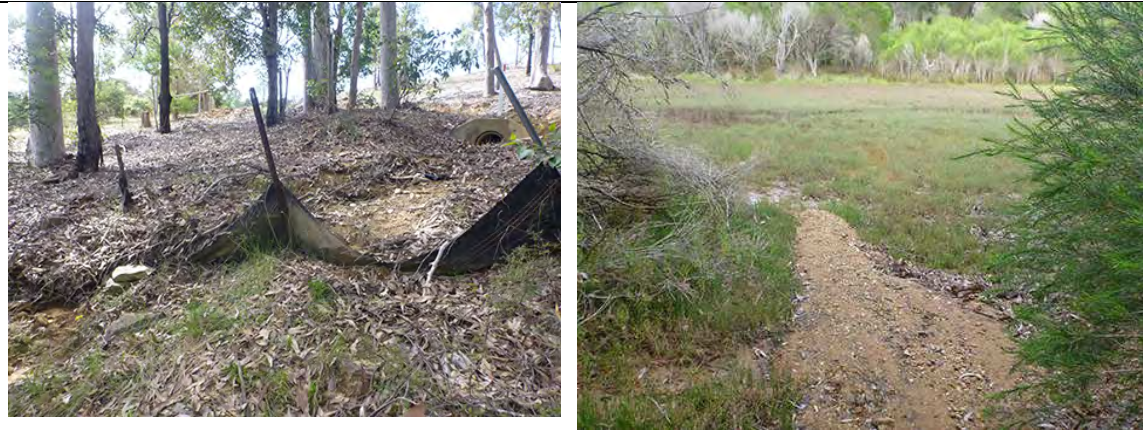
**Figure B6** Failing siltation curtain at the stormwater pipe outlet (*left image*), new slug of roadside sediments that has intruded into the coastal saltmarsh community at bottom of hillslope following heavy rainfall event (*right image*).

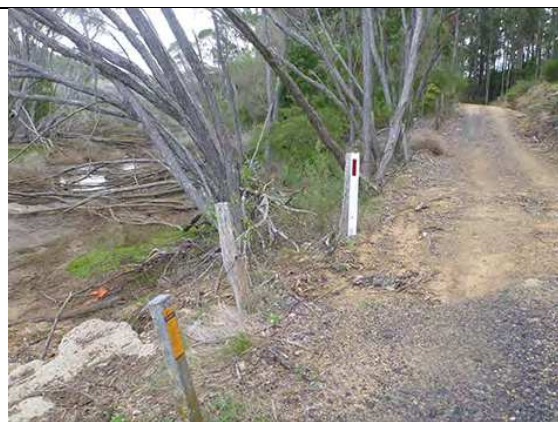
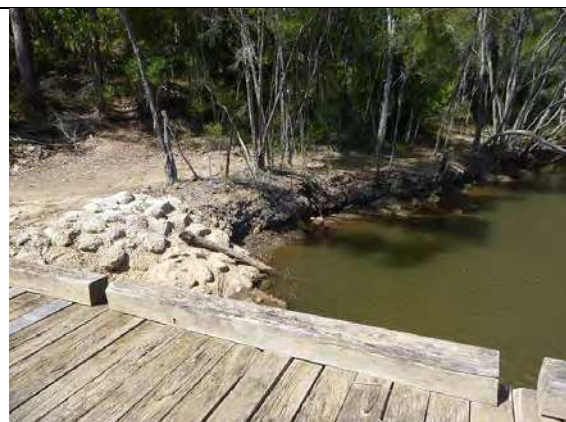
**Figure B8** Inadequate road runoff controls has resulted in moderate erosion to Head of Cuttagee Road with some sediment depositing to estuary on western side (*left image*), and sediment also depositing to estuary on eastern side (*right image*).

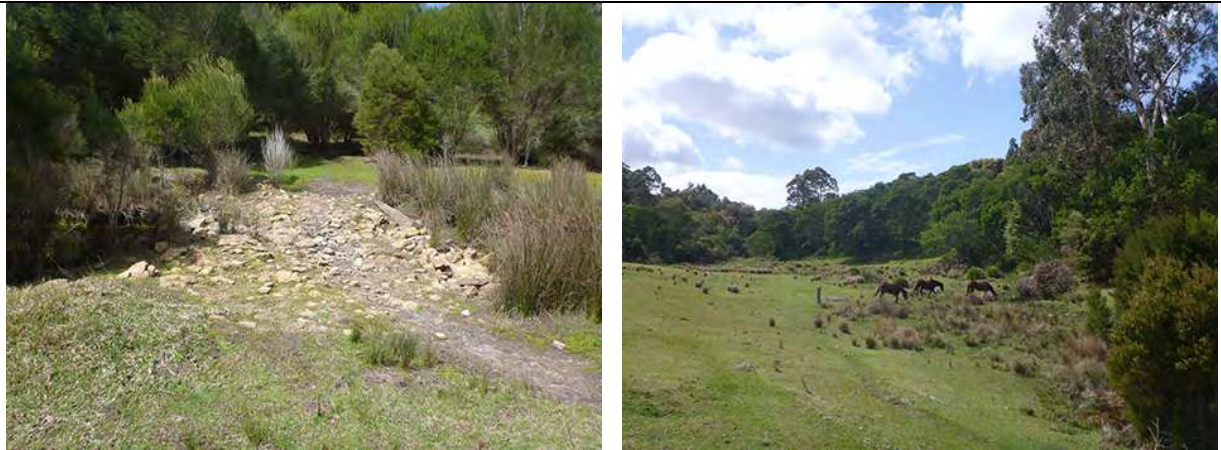
**Figure B9** Small ford constructed across watercourse that permits stock access to coastal saltmarsh (*left image*), and horse paddock above the coastal saltmarsh (*right image*).

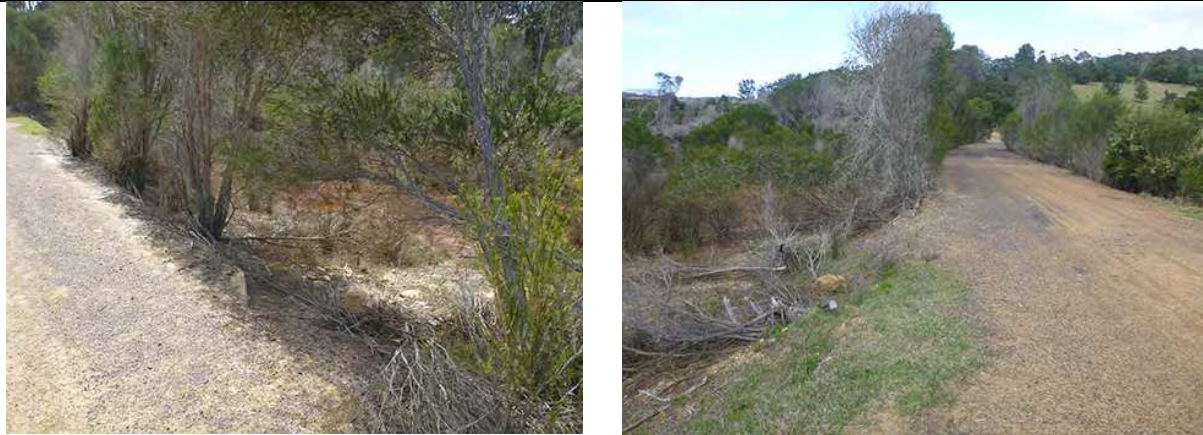
**Figure B10** Examples of localised minor erosion points on the eastern side of roadside embankment.

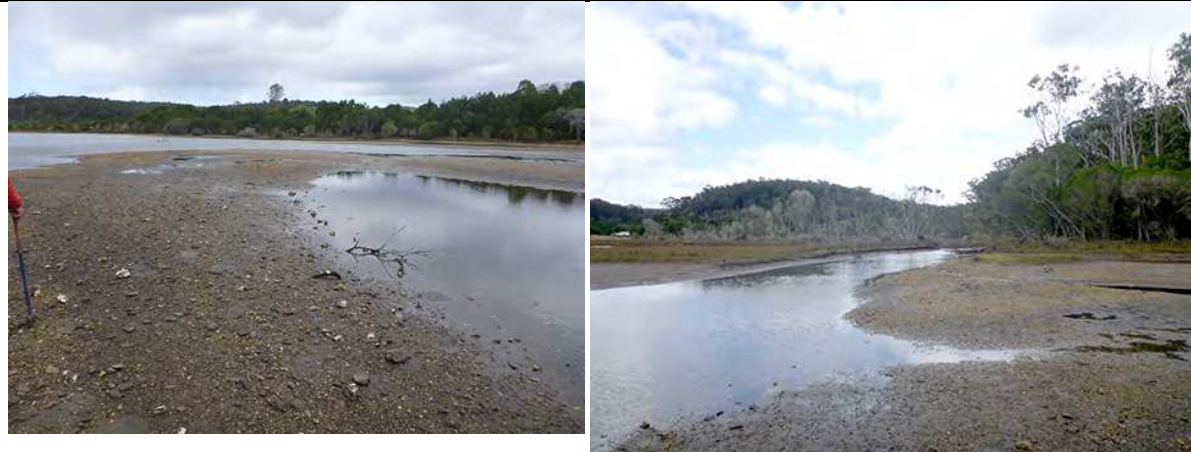
**Figure B12a** Fluvial supply of gravels and cobble-sized rocks present across the propagating delta with channel structure impacted by excessive deposition over short time-scale (*left image*). View of the propagating fluvial delta looking upstream towards the causeway where the channel structure is in good condition (*right image*).

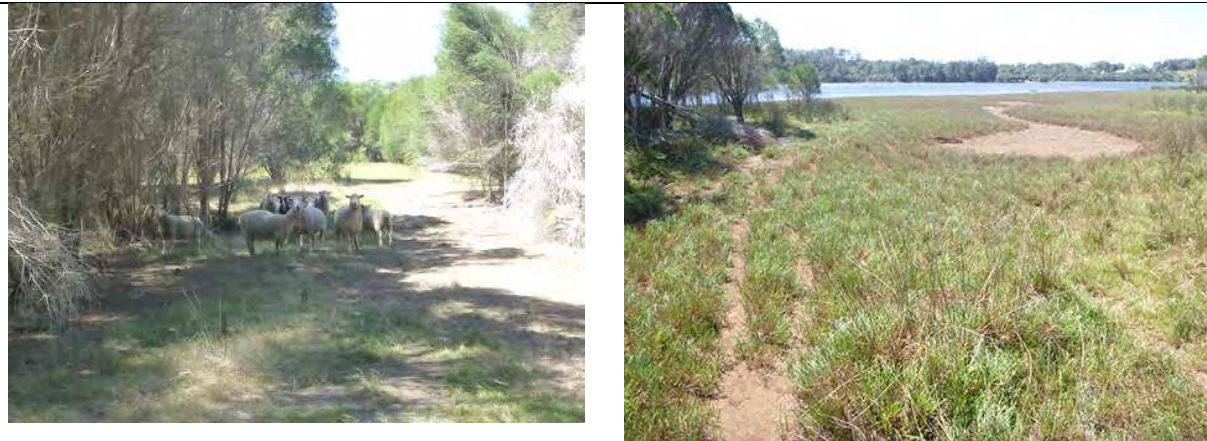
**Figure B14** Sheep can currently access coastal saltmarsh community located on northern side of Cuttagee Creek with evidence of low-level impacts such as track formation.

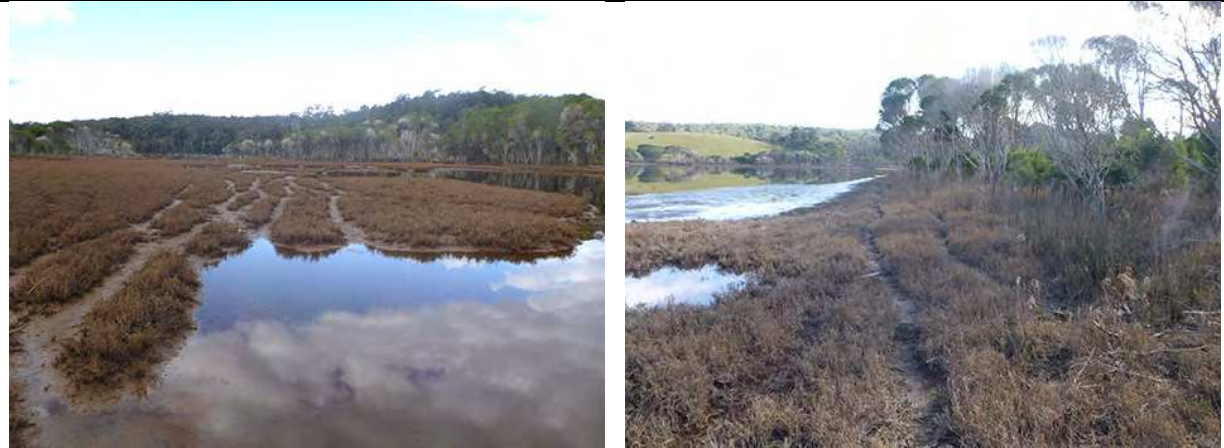
**Figure B15** Coastal saltmarsh community located on southern side of Cuttagee Creek with evidence of stock impacts such as track formation (*left image*), tracks around margin of saltmarsh community with occurrence of EEC *Swamp sclerophyll* forest in background.

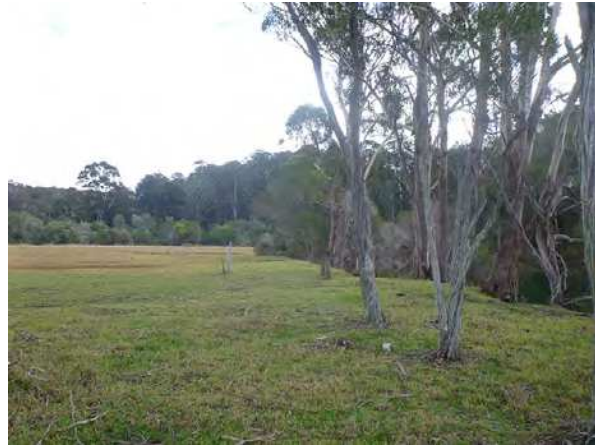
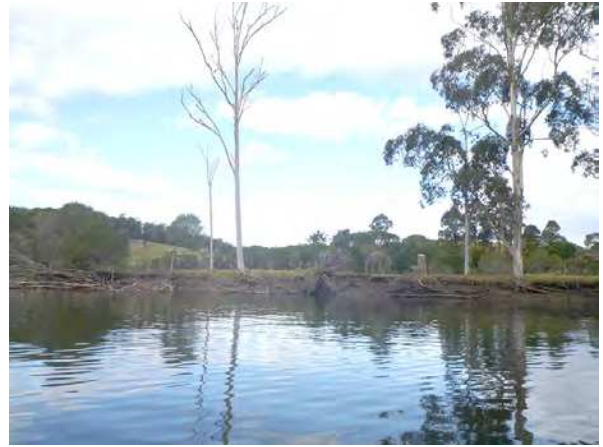
**Figure B16** Large areas of the riparian zone on the floodplain of Cuttagee Creek are characterised by an absence of understorey strata (*left image*) and a general lack of riparian vegetation (*right image*).

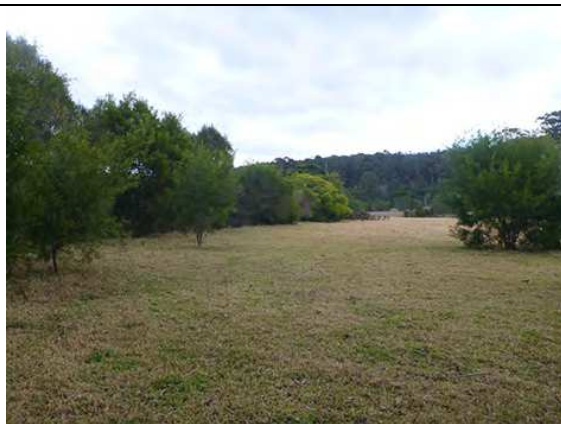
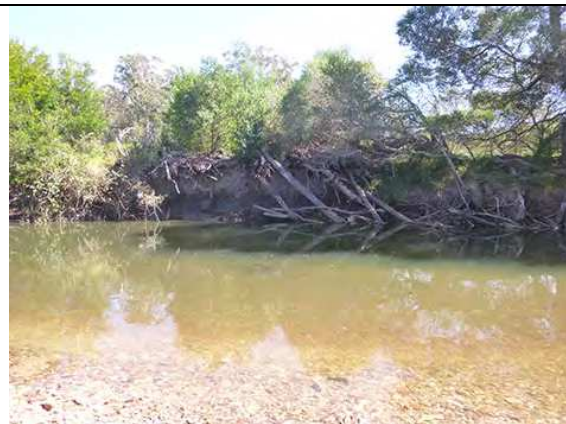
**Figure B17** Riparian vegetation on the alluvial flats of the western bank of Cuttagee Ck (*left image*), example of localised bank erosion on the western bank with woody debris providing some bank protection (*right image*).

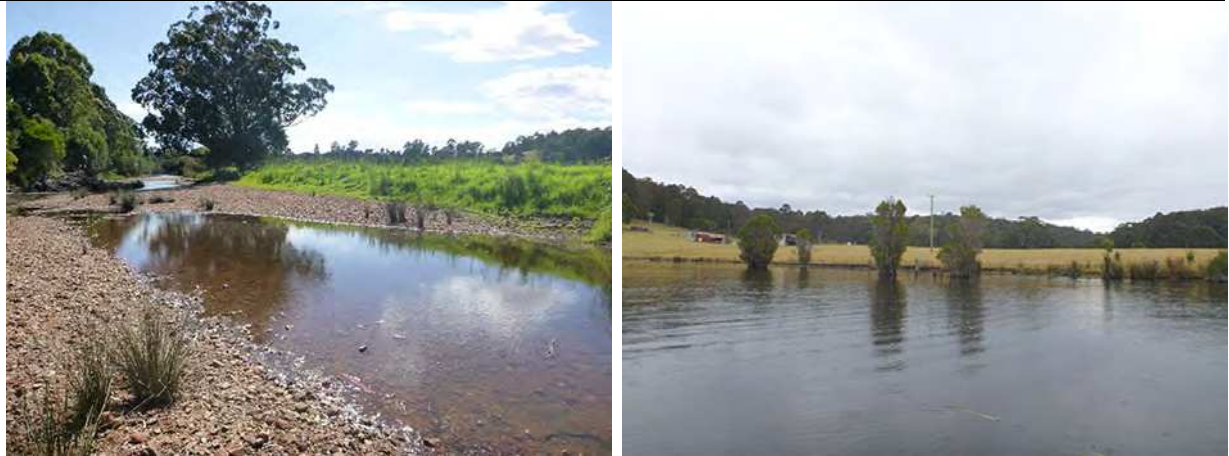
**Figure B20** Example of a reach of Cuttagee creek lacking riparian vegetation (*left image*). Example of the largely bare banks surrounding the freshwater wetland (*right image*).

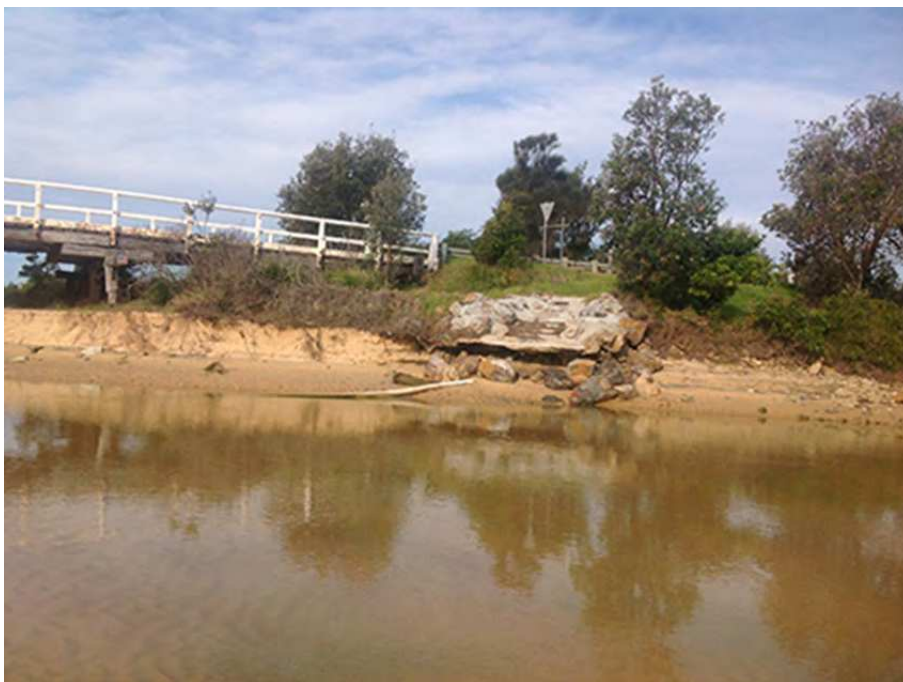
**Figure B24** Community access to estuary foreshore degraded following recent erosion.

Issue 6.1 Community foreshore access point degraded.  
Undertake minor landscaping works to formalise access to the estuary foreshore from western side of Tathra-Bermagui Road.

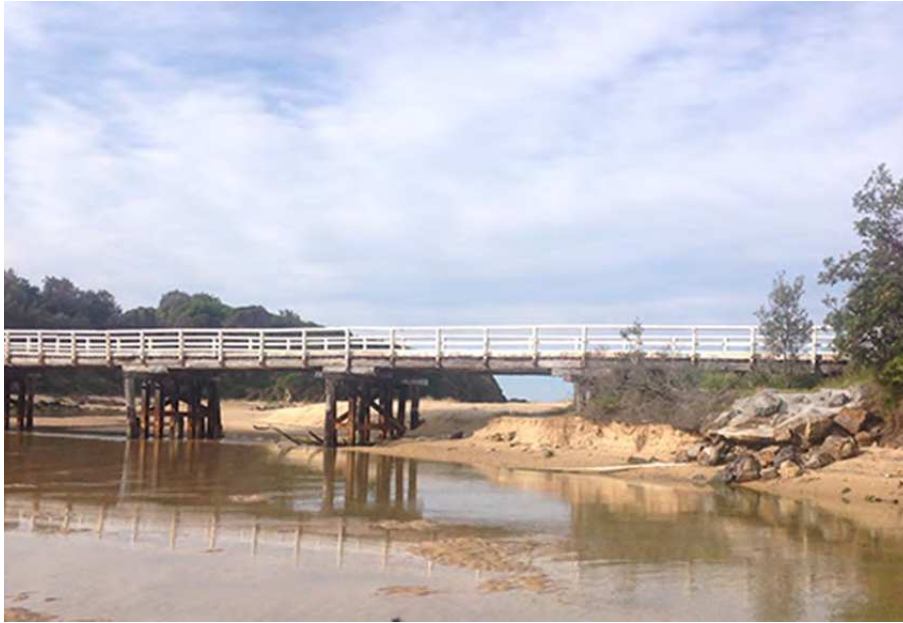
**Figure B25** Recent bed erosion around the foundations and support poles of the Tathra-Bermagui Road bridge with potential to threaten the structural integrity of bridge.

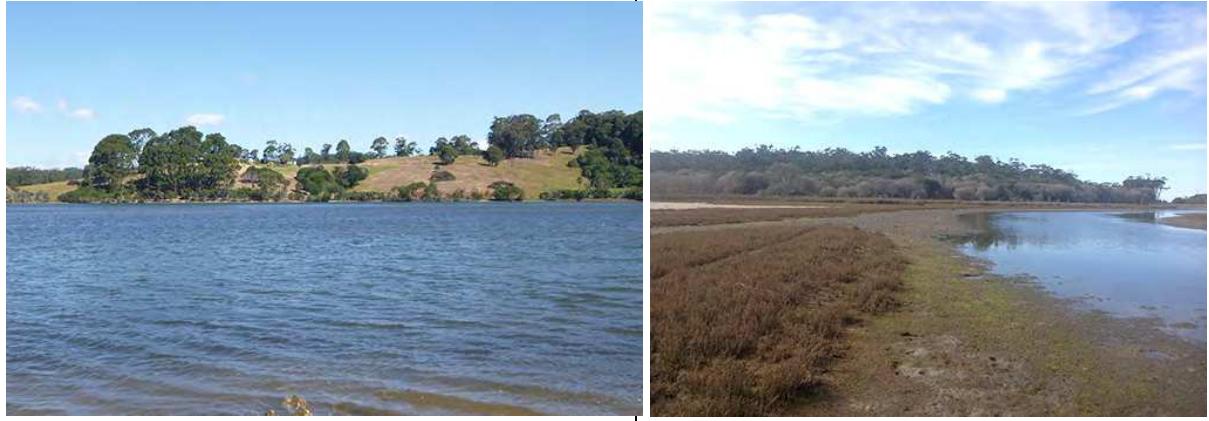
**Figure B28** View of priority management area 7 from the northern side of the estuary showing relatively sparse riparian vegetation on southern foreshore and opportunities to improve the vegetation cover on some of the bare slopes (*left image*). Significant saltmarsh community comprising threatened species *Wilsonia backhousei* exists around Little Cuttagee Lake (*right image*).
