Structure 228 - Structural Assessment Report

MR272 & MR320 Structures
Assessment

Prepared for
Bega Valley Shire Council

6 December 2021

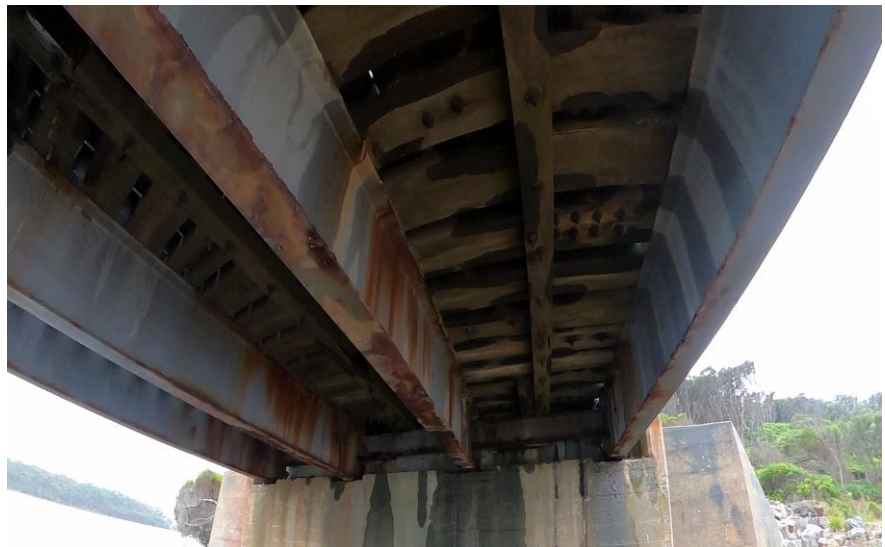
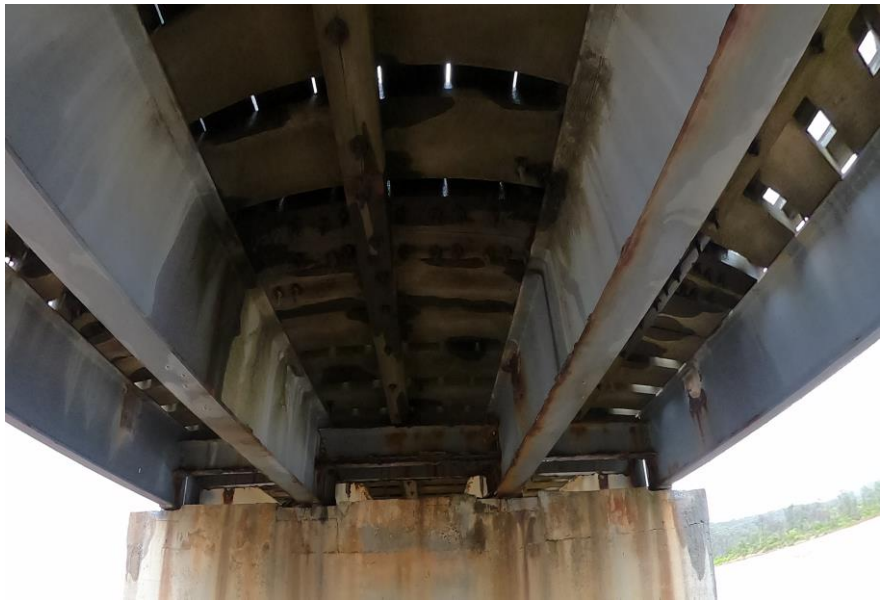
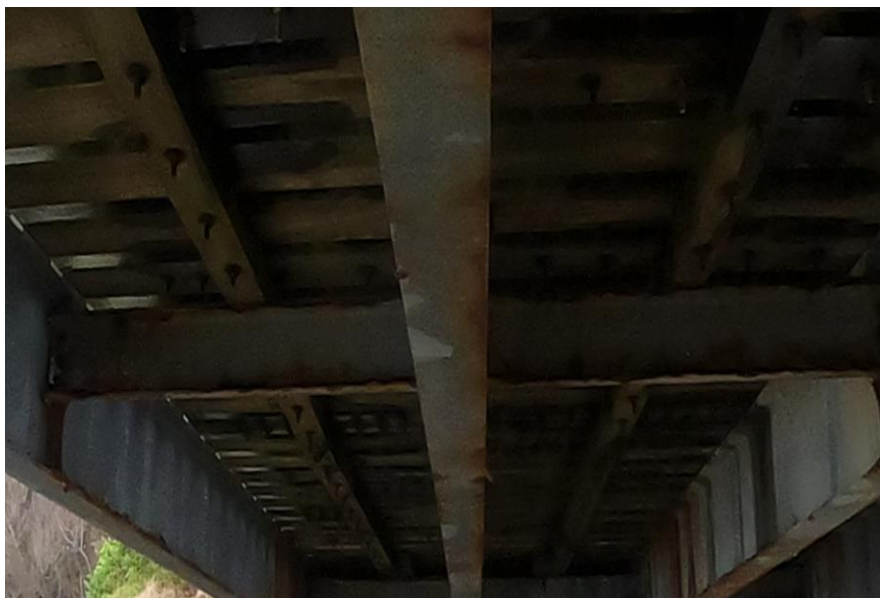
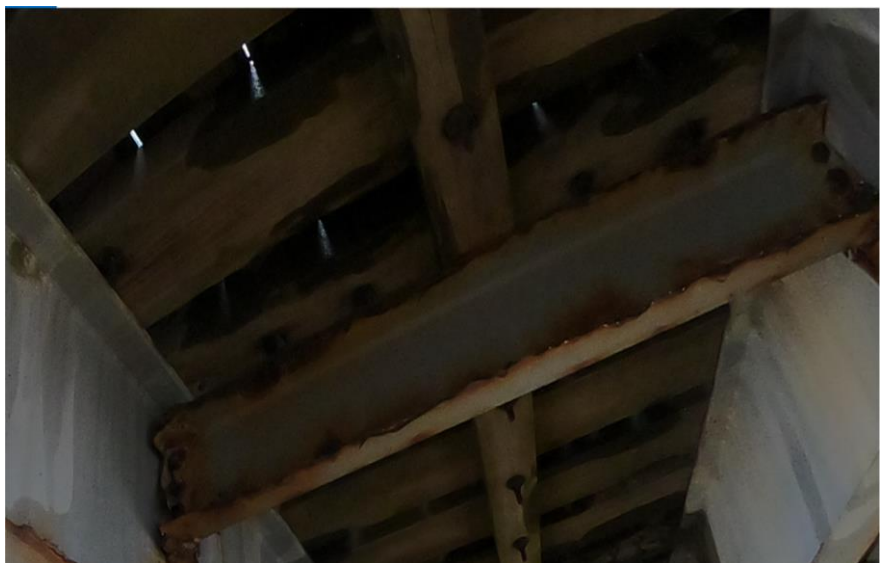
Steel Girder Defects

3. The steel girders were found to be severely affected by the harsh marine environment. They were generally rusted and severe local corrosion. Loss of section for both transverse beams and longitudinal girders was observed. Loss of connection between the transverse beams and longitudinal girders was

also observed with the capacity of connections being reduced by 30 to 60 percent. Girders of Span 1 were found to in slightly better condition than the other spans. All girders, however, were placed in condition 3 and 4 and the loss of girder section is estimated to be of the order of 20%. Refer steel girder defects photographs.

Span 10 defects showing the corroded girder sections with steel showing disintegration in the form of lamination. The third and fourth photograph show the transverse members badly corroded with loss of connection. Instead of 3 bolts, 2 can be observed. Photo 5 shows loss of connection. Loss of capacity anticipated to be 20%.

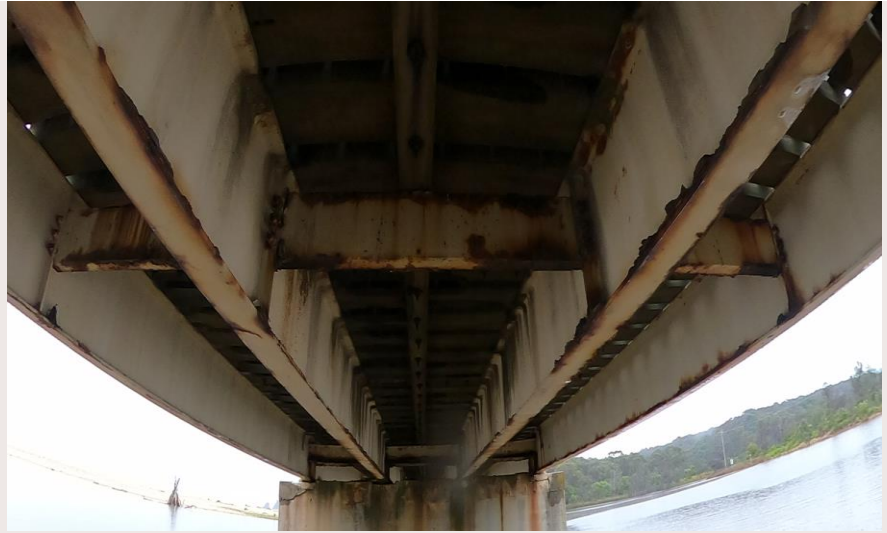
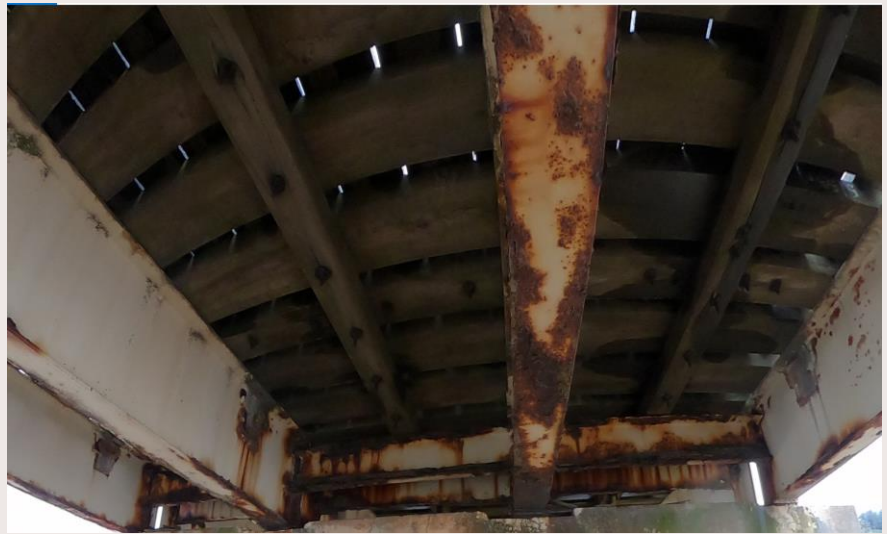
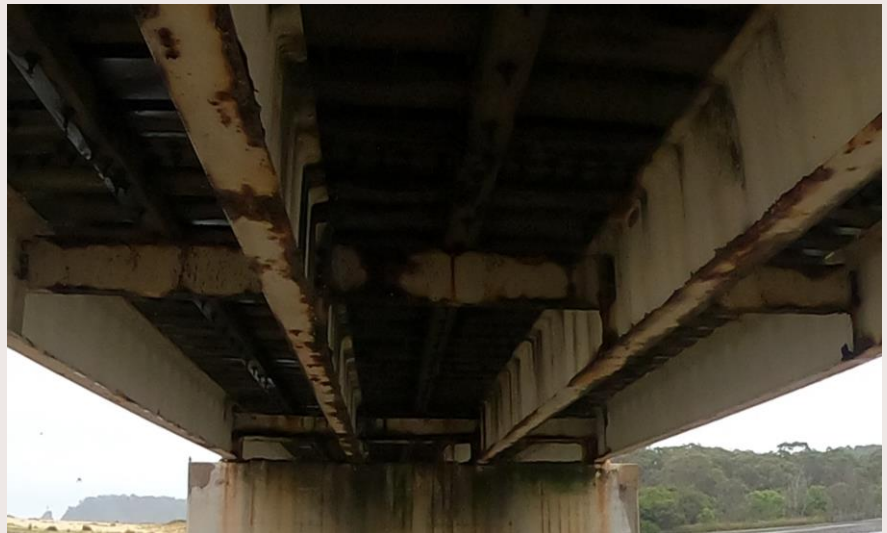
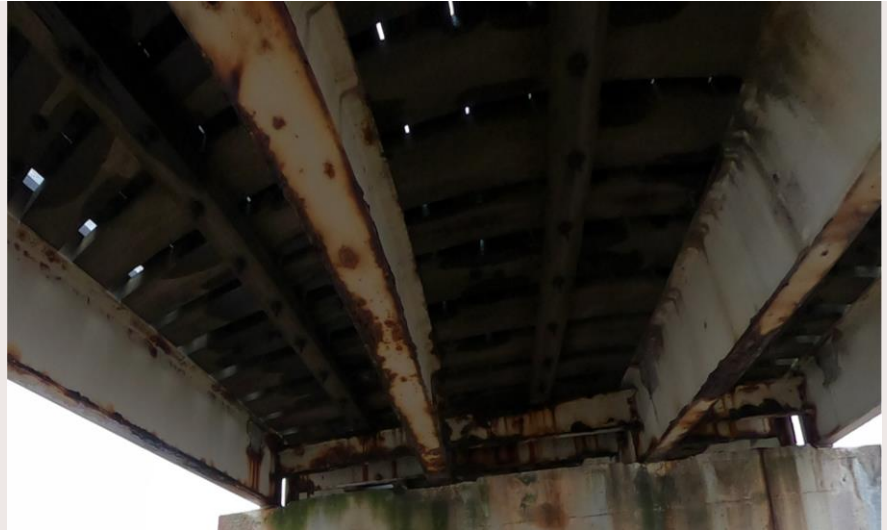
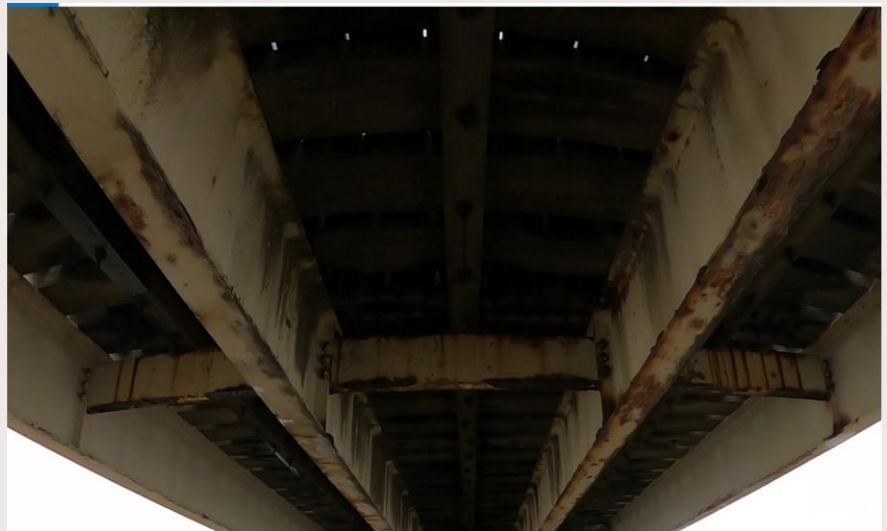
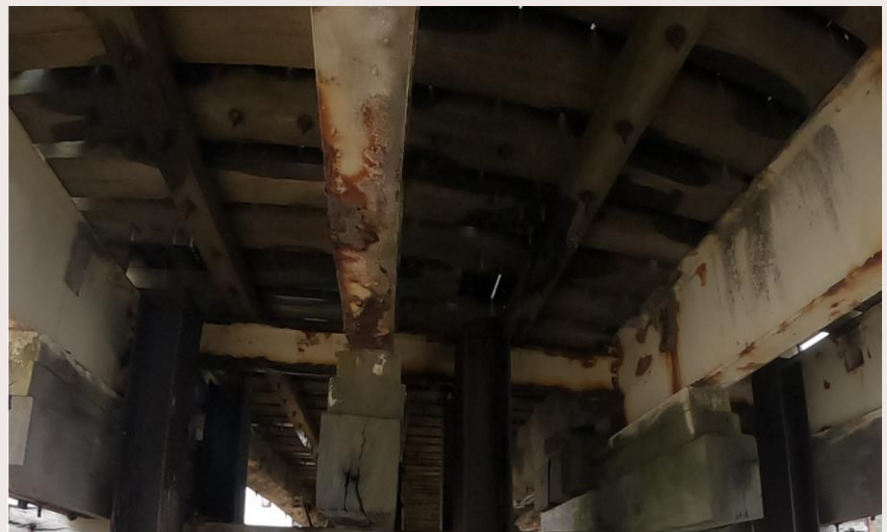
Span 7 to 9. Issues similar to Span 1 but more severe. Loss of section capacity anticipated to be min 25%.

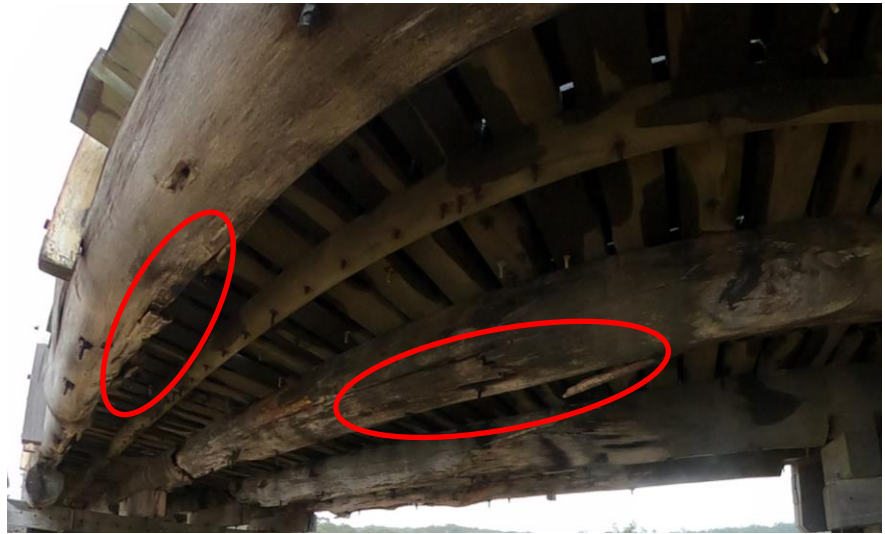
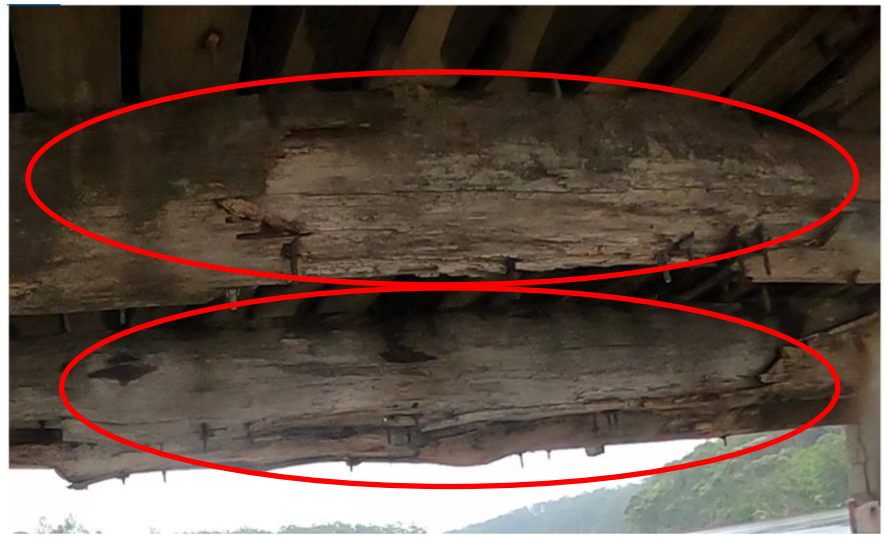
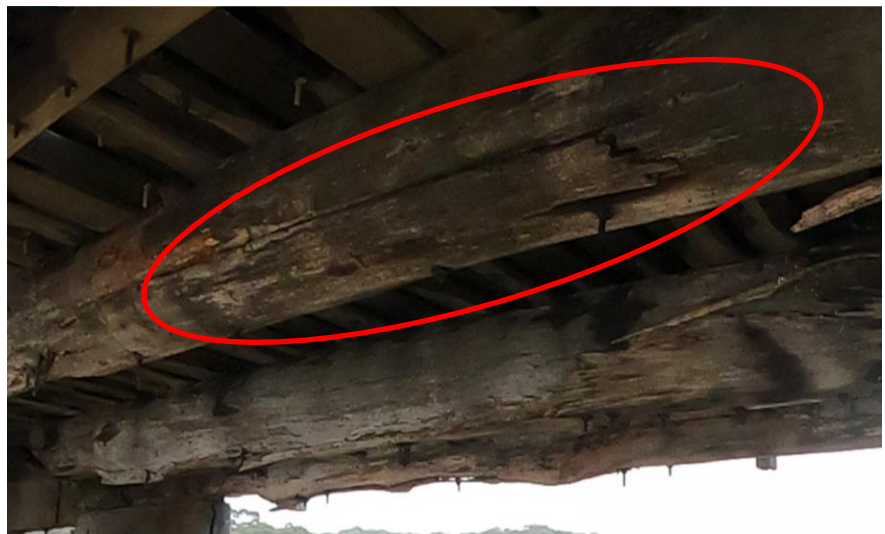
Span 6. Splitting / Cracking in the second girder from the Eastern side, deterioration of section and loss of section observed for the girders in the span. The cracked girder needs immediate attention for repair to avoid catastrophe. Anticipated loss of section capacity is 30%.

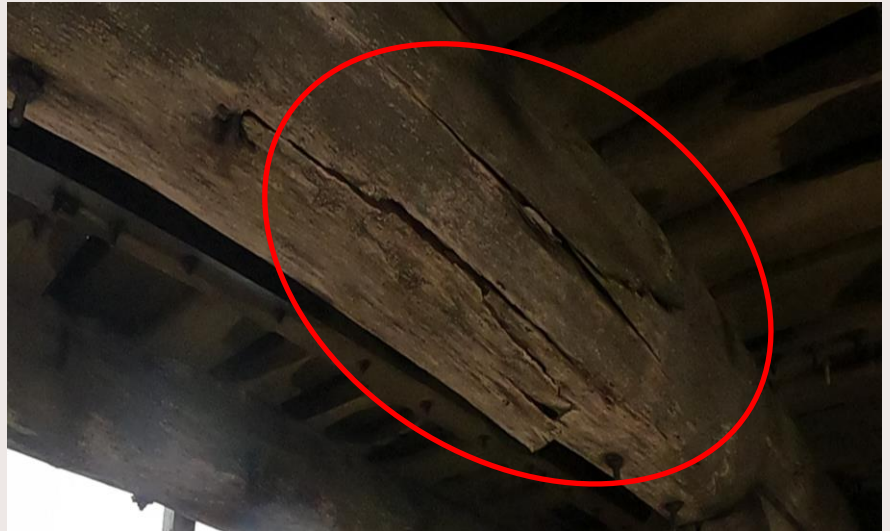
Span 2. Splitting of section / Crack developing in the girder 3 from the Eastern side. Anticipated loss of section capacity is 30%.

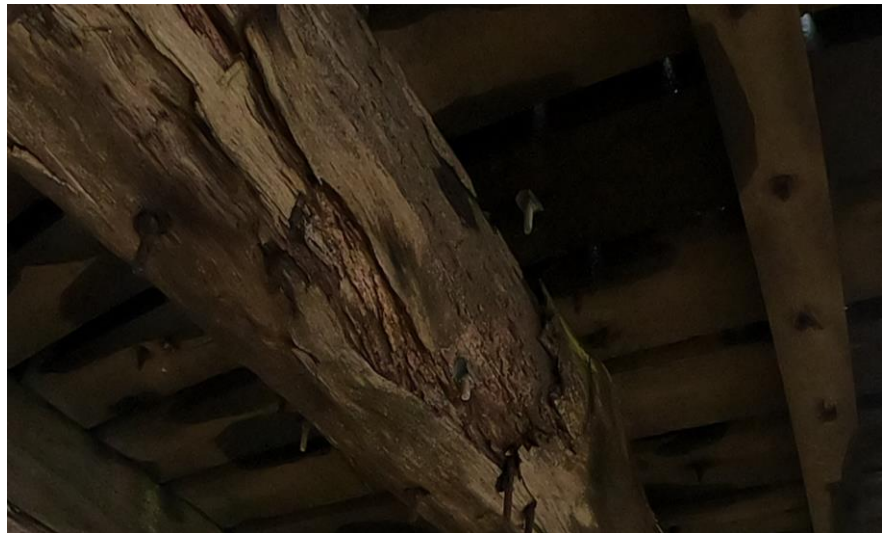
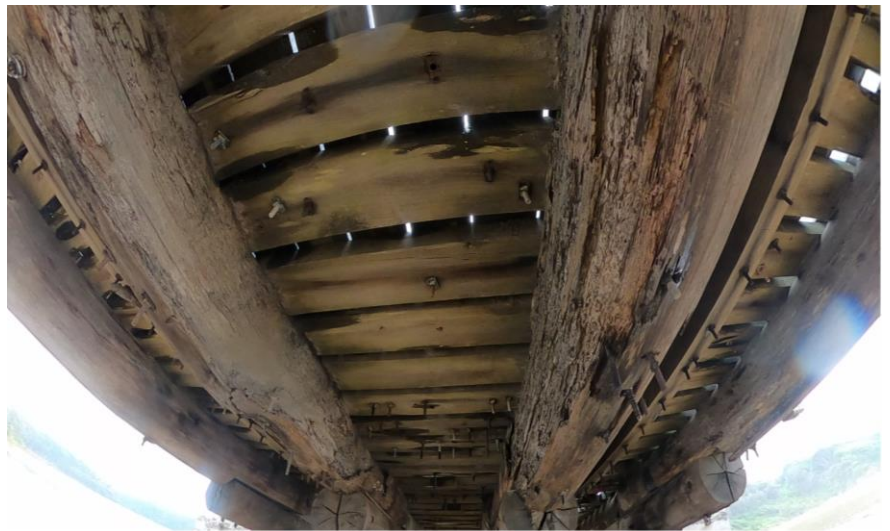
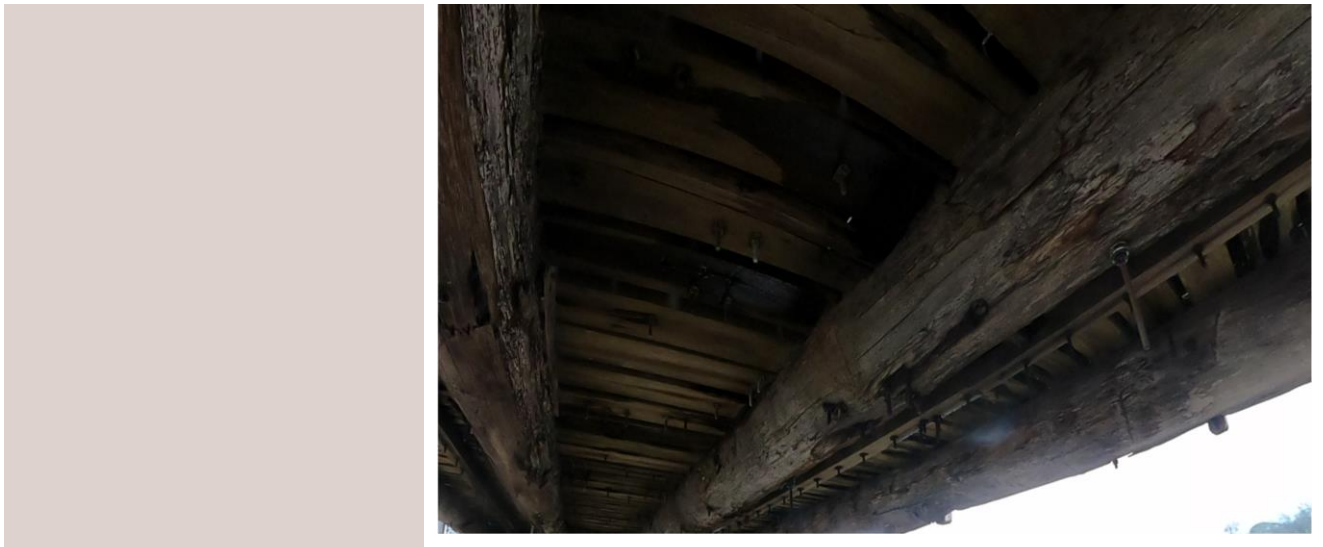
Typical defects in Timber girders of all spans. Loss of section due to deterioration of members. Anticipated loss of section capacity is 30%.

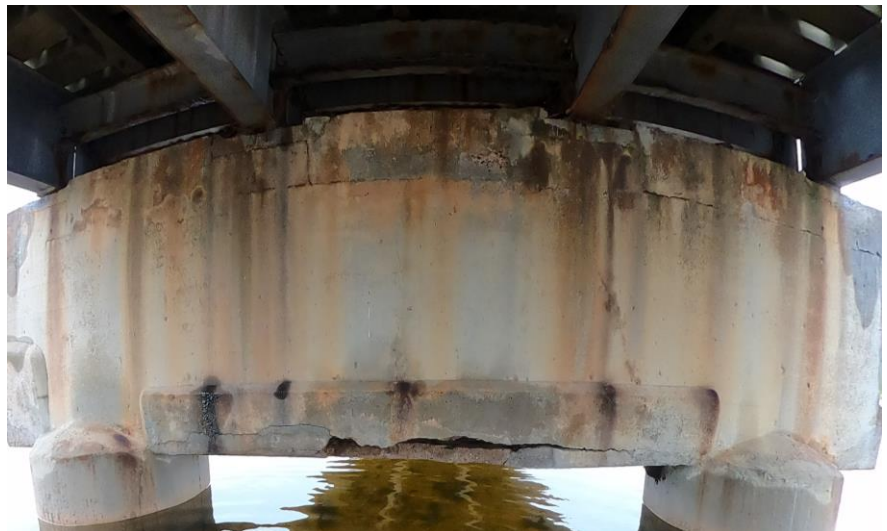
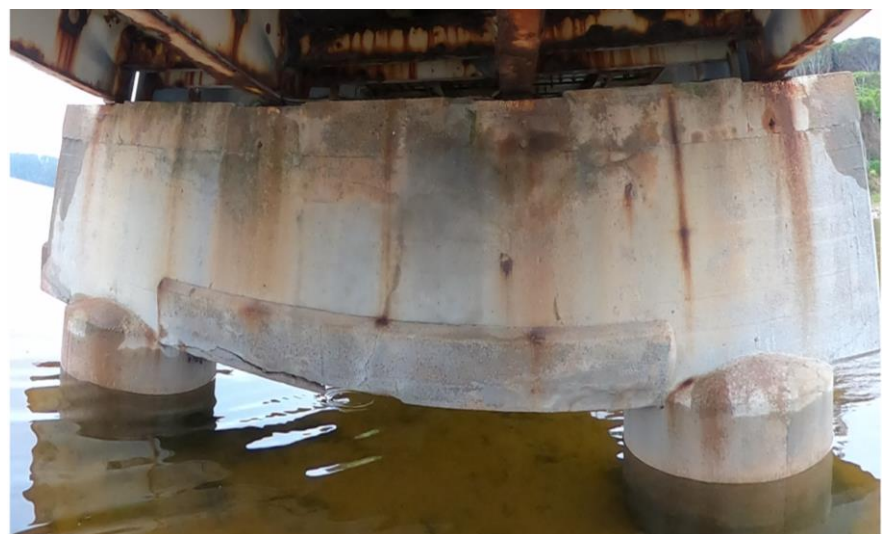
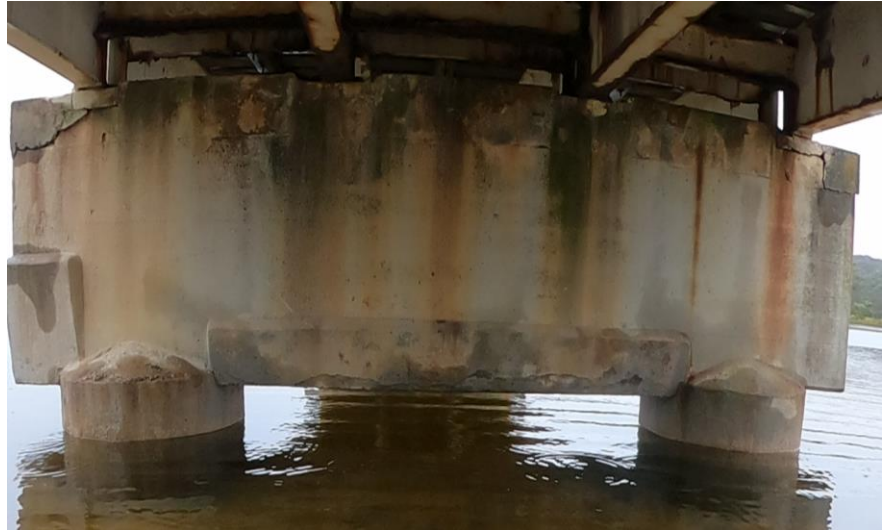
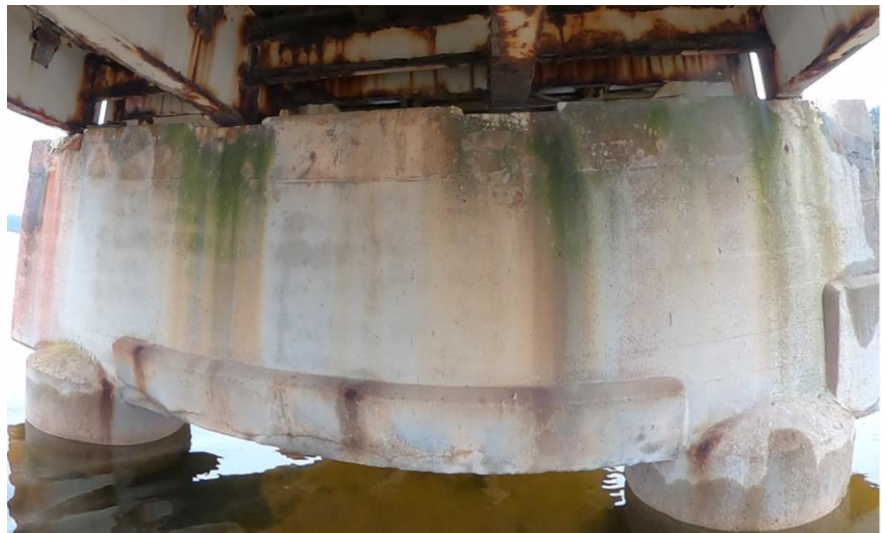
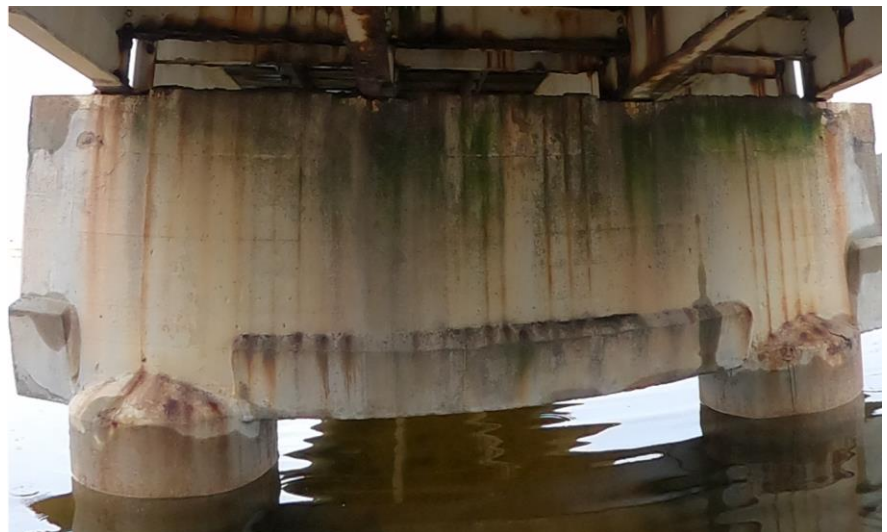
Pier Defects

5. The concrete substructure, piers 7 to 9, were found to have severe defects. Cracking of structure exposing reinforcement, signs of reinforcement corrosion, water marks and discoloration of structure were observed. These structures were placed in condition 3 and 4. Refer Concrete Pier defects photographs.

Piers 7 to 9. Cracking of structure exposing reinforcement, spalling, signs of reinforcement corrosion, water marks and discoloration of structure. Severe cracking and reinforcement exposure observed in Pier 1 (first and second photo)

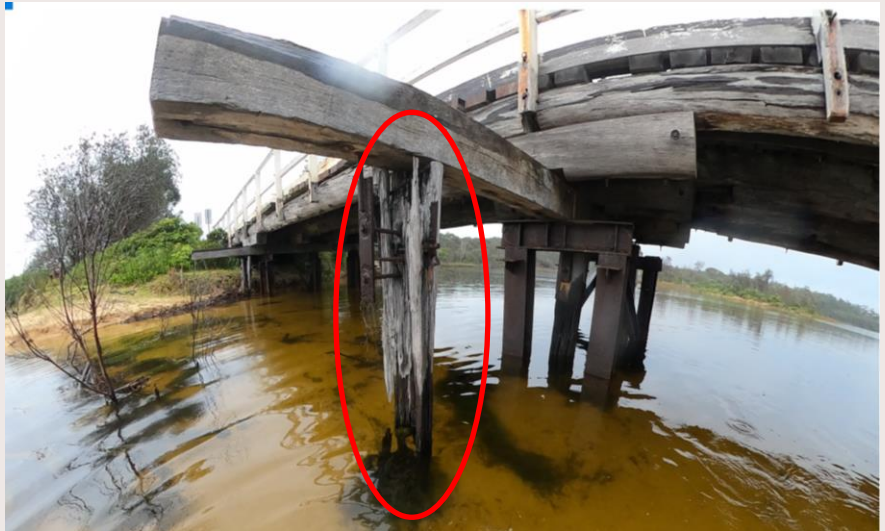
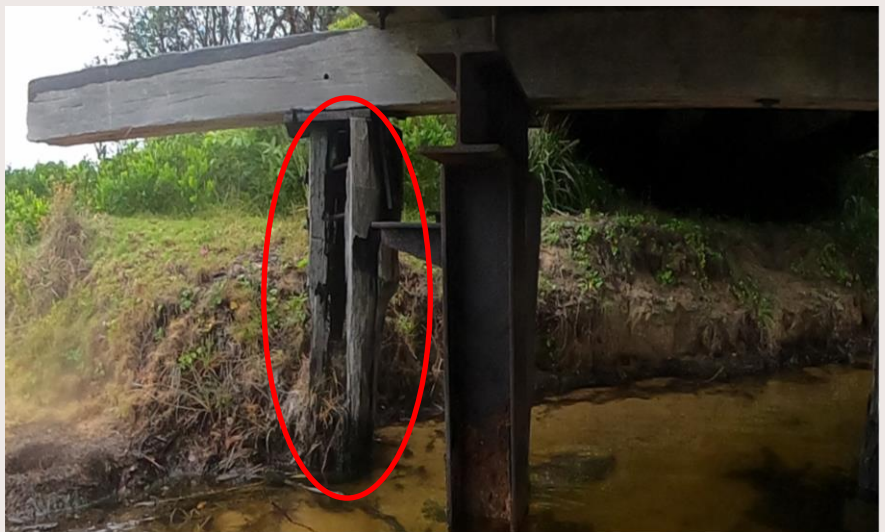
6. The wooden substructure / supports, piers 1 to 6, were found to be severely damaged and all have undergone strengthening works. The wooden piles at pier support 2 and pier support 1, on the Eastern side, were found to be severely damaged and need immediate attention. Their collapse may damage the wooden transom beam supporting the outermost girder resulting in the loss of the girder. The steel strengthening frames were observed to be significantly corroded as well. These structures were placed in condition 3 and 4. Refer Wooden Pier defects photographs.

Pier 2 and Pier 1. Severe damage to the timber pile supporting the outer girder. Needs immediate attention to avoid localised failure of structure and possibility of loss of structure. The first photo is of Pier 2 and the second of Pier 1

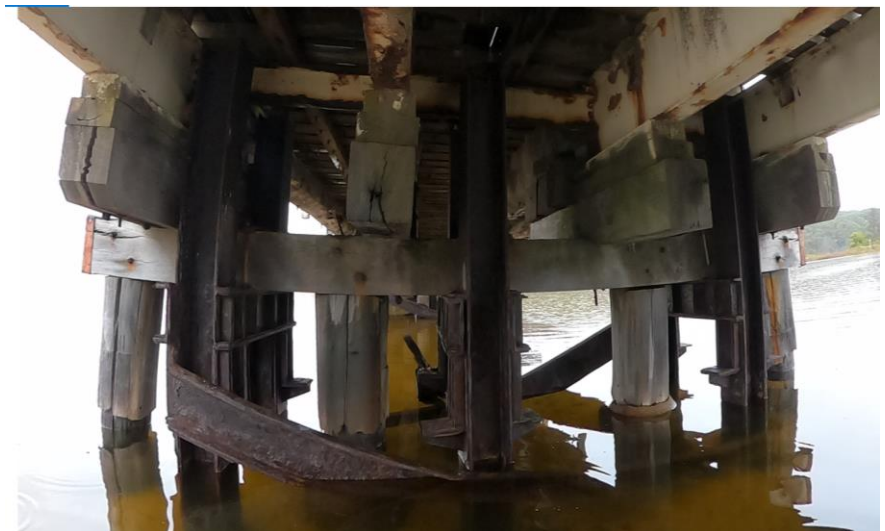
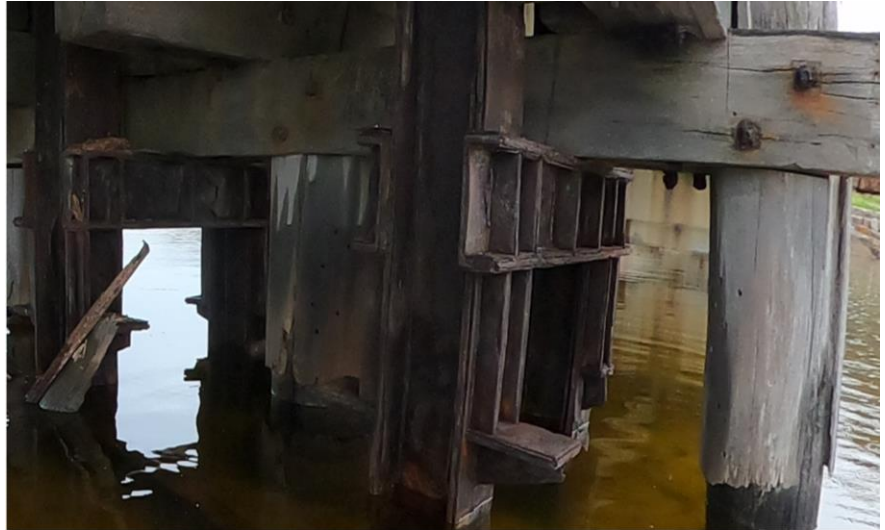
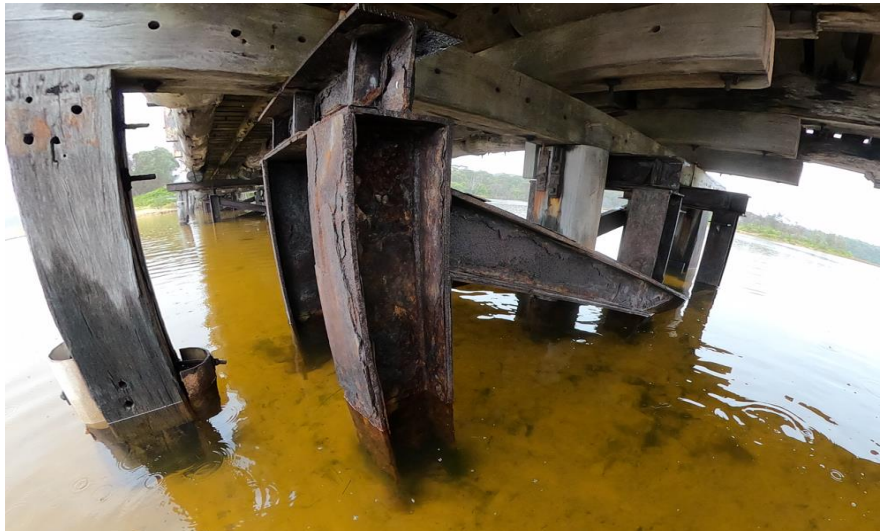
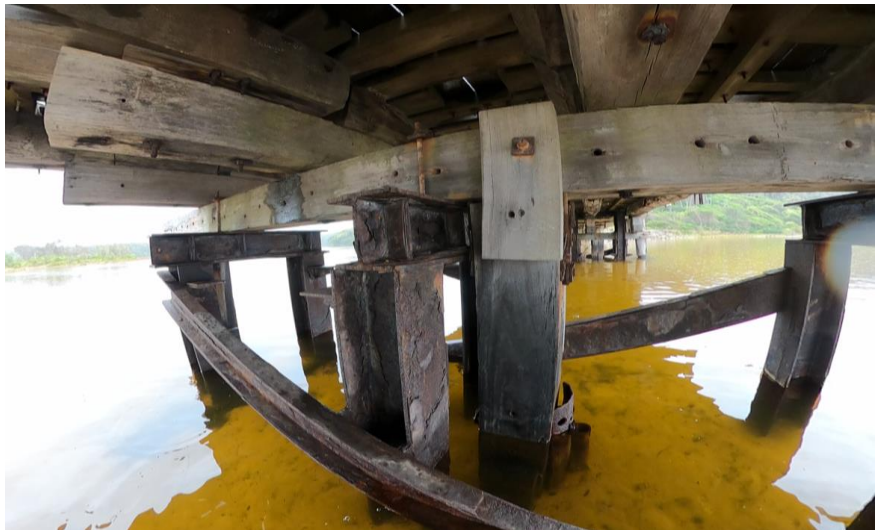
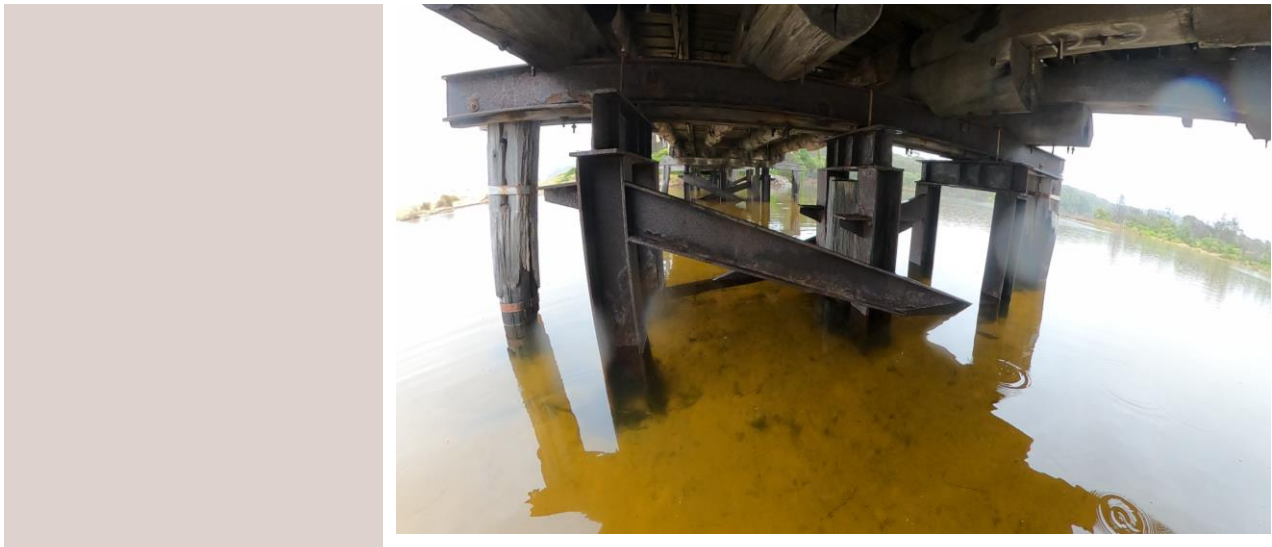
Piers 1 to 6. Typical condition. The wooden structure severely damaged and strengthened using steel frames. The unprotected steel frames also found to be corroded due to humid environment and contact with saltwater.
