Our reference: PA1042-100-100_gwb300315-maintenance works.docx
Date: 8 April 2015

**Subject: CATTLE BAY MARINA – RESPONSE TO SUBMISSIONS ON EIS
REFURBISHMENT AND MAINTENANCE WORKS FOR THE EXISTING
JETTY**

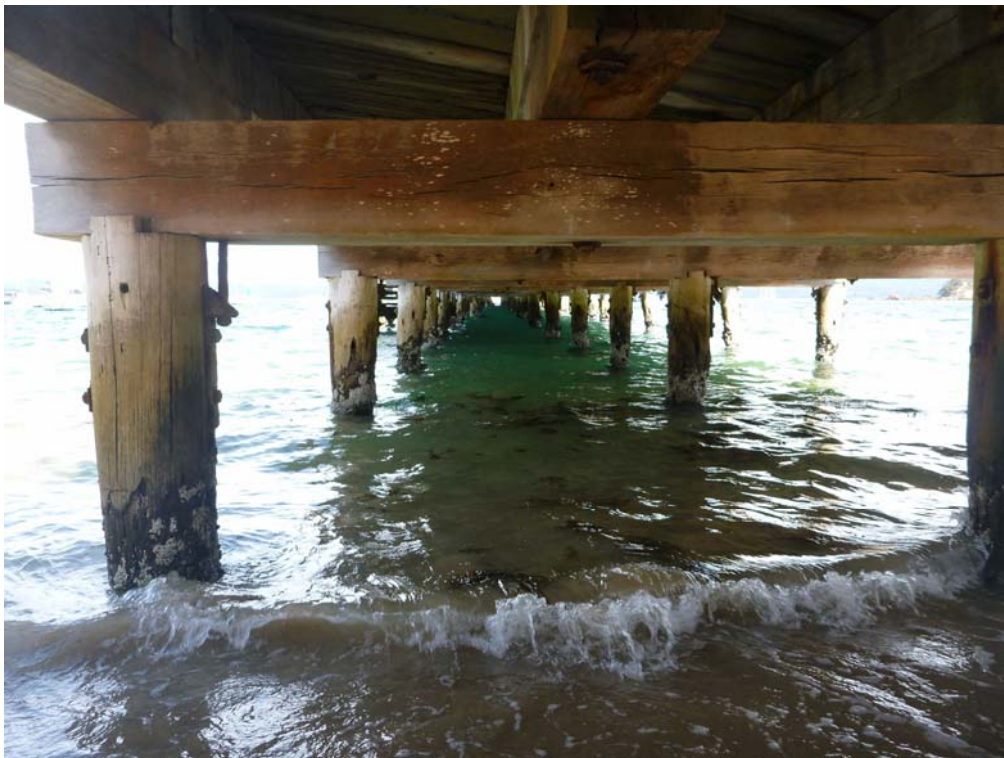
Photo 1 View looking seaward under the jetty showing pairs of piles, headstocks, girders and decking

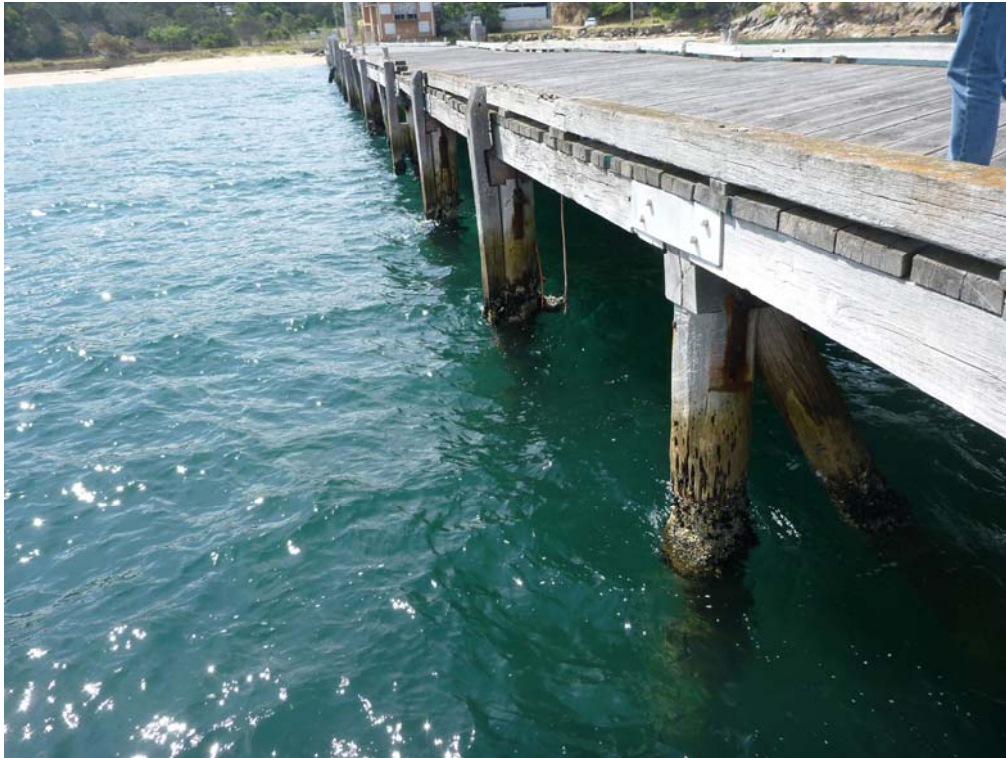
Photo 2 View looking towards shore along the western side of the jetty showing vertical piles, a raker pile, external girder, decking and kerb

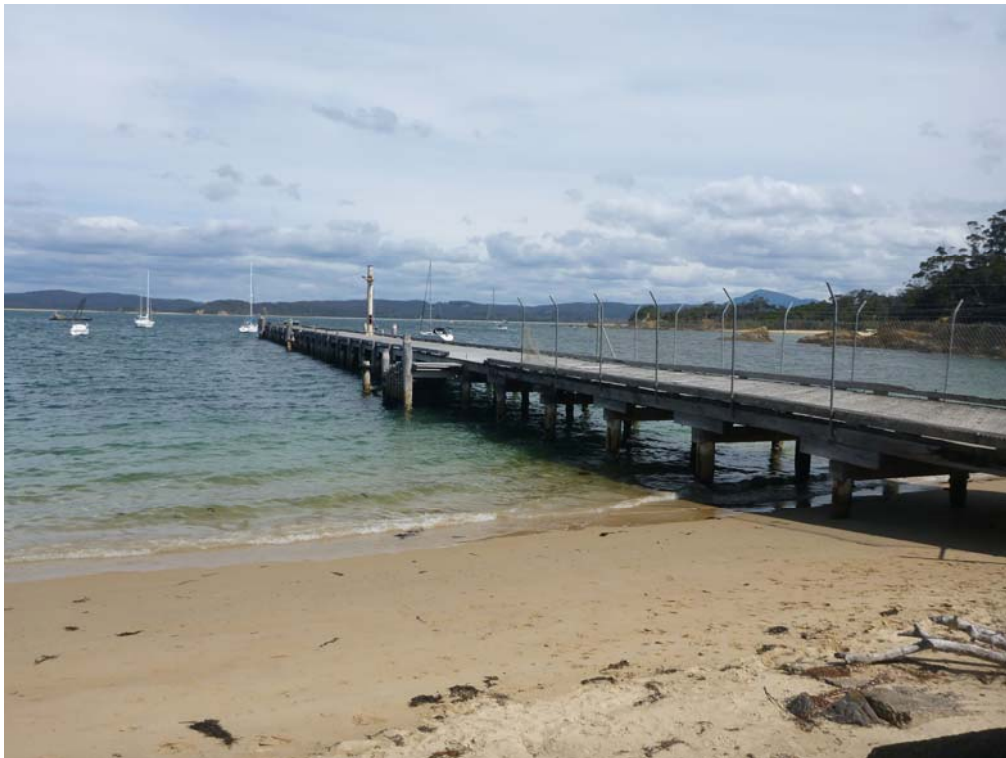
A set of low level landing steps is situated along the eastern side of the jetty close to shore (refer **Photo 3**). These steps would be no longer required for vessel access due to the inclusion of the hinged access gangway and pontoon system, and accordingly would be demolished.

Photo 3 View of the jetty from the beach east of the structure showing the low level landing

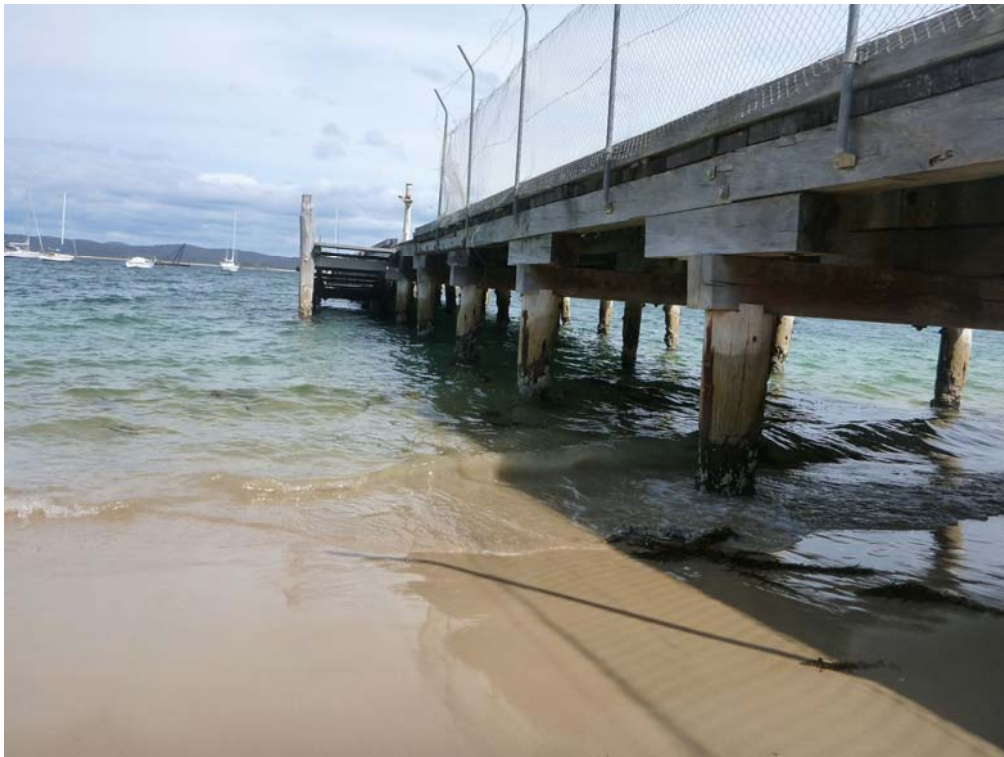
The piles are in variable condition. Many of the piles appear to be in reasonable condition, but a number exhibit evidence of marine borer attack in the intertidal zone characterised by loss of cross-section or 'hour glassing'. Refer **Photo 4** and **Photo 5**.

Photo 4 Piles in reasonable condition near the landward end of the jetty

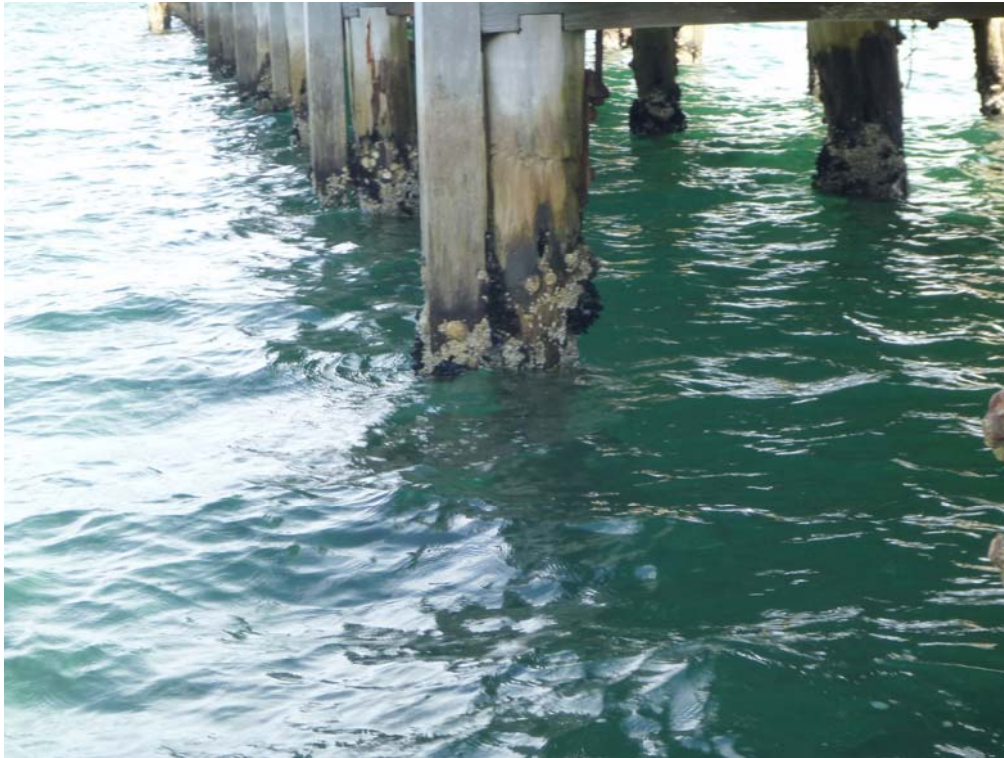
Photo 5 Pile showing signs of marine borer attack in the intertidal zone, viewed from the low level landing

A common method for repair of timber piles is use of the PileJax system. In this method a sleeve is fitted around the pile in the zone to be repaired, typically the intertidal zone for timber piles. The sleeve is manufactured from a light weight high quality filament wound fibre composite material. The sleeve is locked in place and sealed top and bottom, and the annular space between the pile and the sleeve is filled with a cementitious grout or epoxy grout. The method provides a long term protective barrier to the pile against water, oxygen and marine borers.

The application of the sleeve and the filling of the annular space can be undertaken from a barge positioned alongside the jetty. It is not necessary to remove the pile or to drive a new pile.

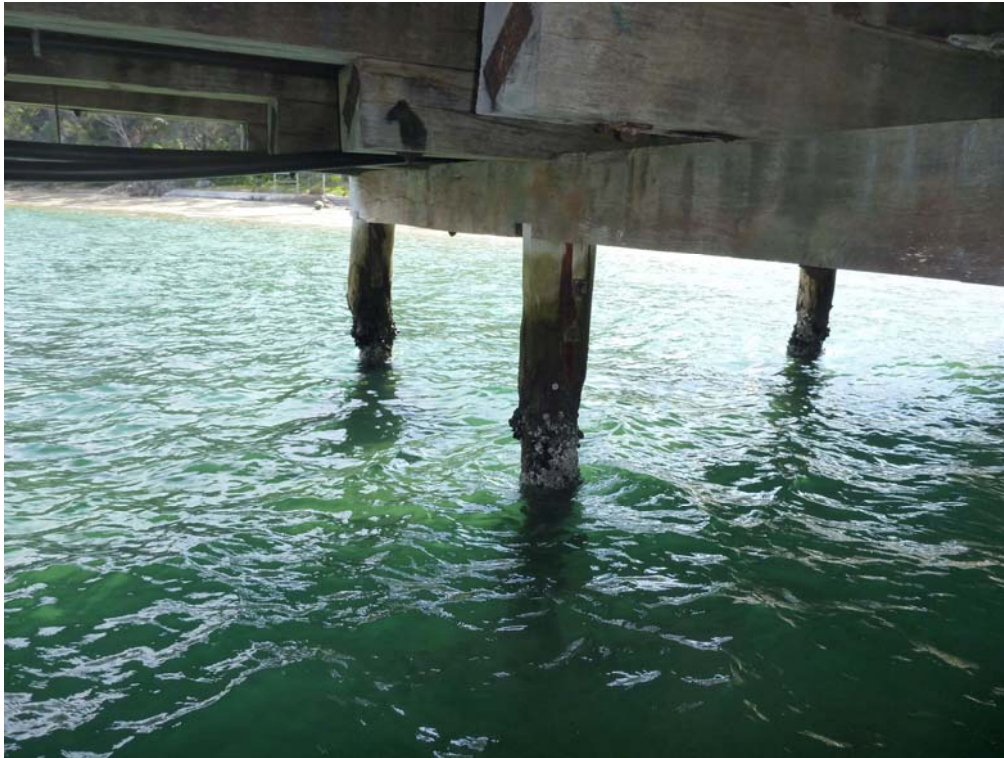
The headstocks and girders appear to be in generally reasonable condition (refer **Photo 1** and **Photo 6**). A section of girder on the eastern side of the jetty close to shore has deteriorated due to rot and would need to be replaced (refer **Photo 7**).

Photo 6 View under deck from the low level landing showing headstock and girders

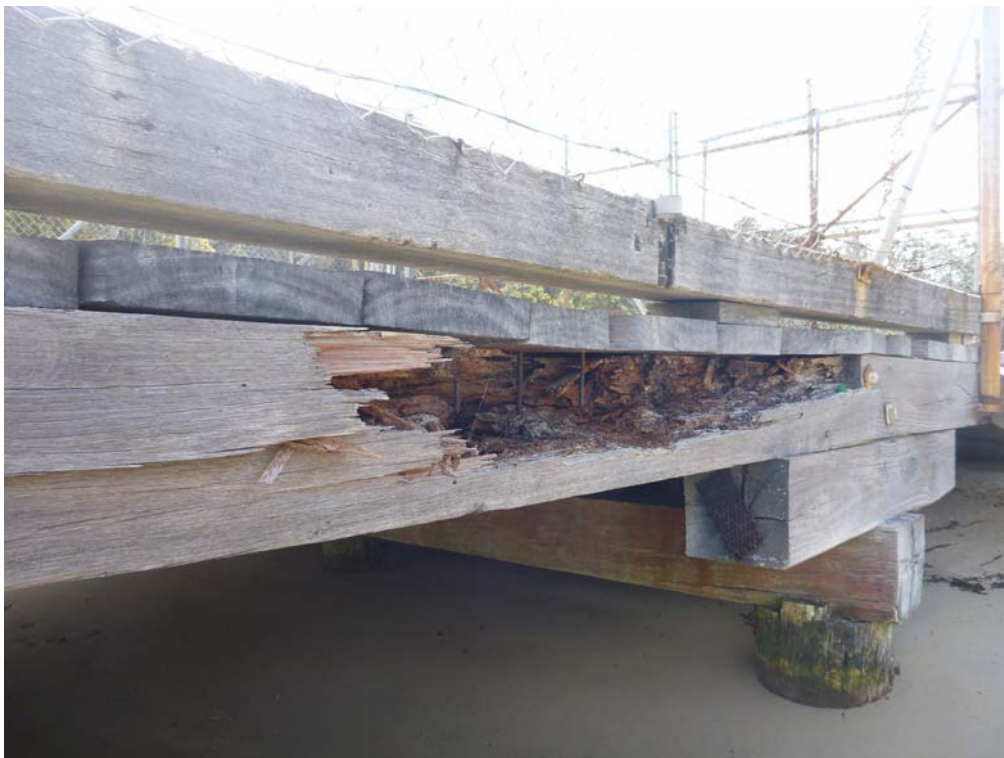
Photo 7 View of rot in girder on the east side of the jetty close to shore

Where detailed inspection revealed a headstock or girder had to be replaced this would be typically achieved by locally taking off the deck and installing the new member using a barge mounted crane positioned alongside the jetty. Where barge access was not available due to restrictive water depth, the replacement would be achieved using access from shore.

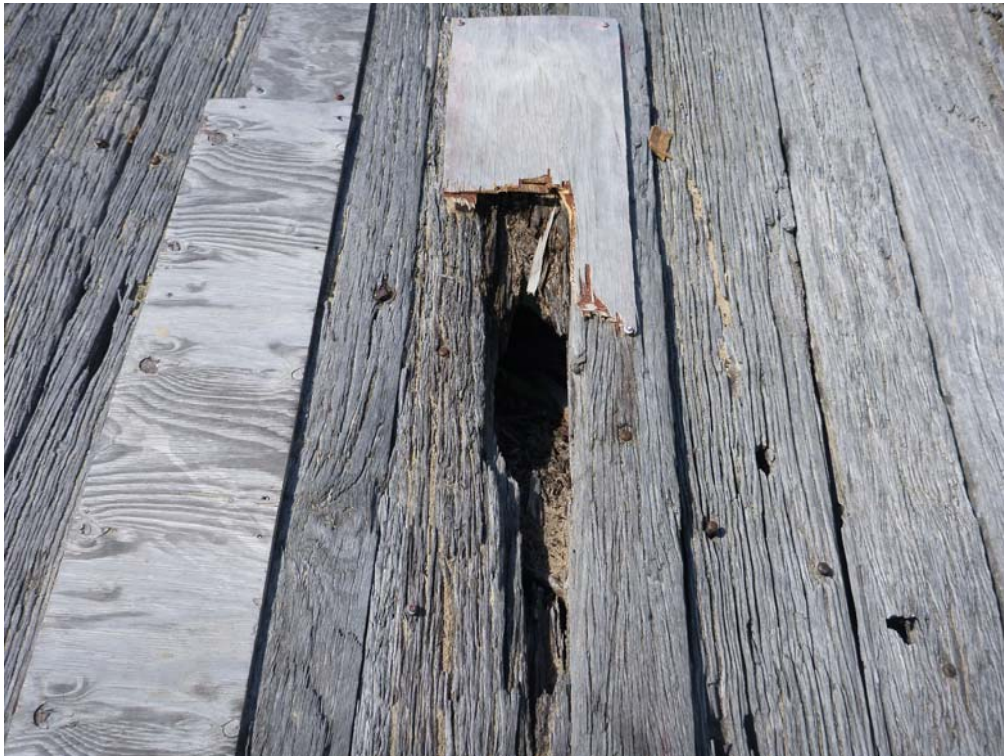
Decking and kerbs are in variable condition. There are some localised areas of deterioration where replacement of decking and kerbs would be necessary, eg. refer **Photo 8** and **Photo 9**. In other areas it should be possible to reuse deck planks and kerbs. Refurbishment of decking and kerbs would be typically undertaken using a barge mounted crane positioned alongside the jetty, except in shallow areas where access would be from shore.

Photo 8 Example of localised deterioration (rot) of decking

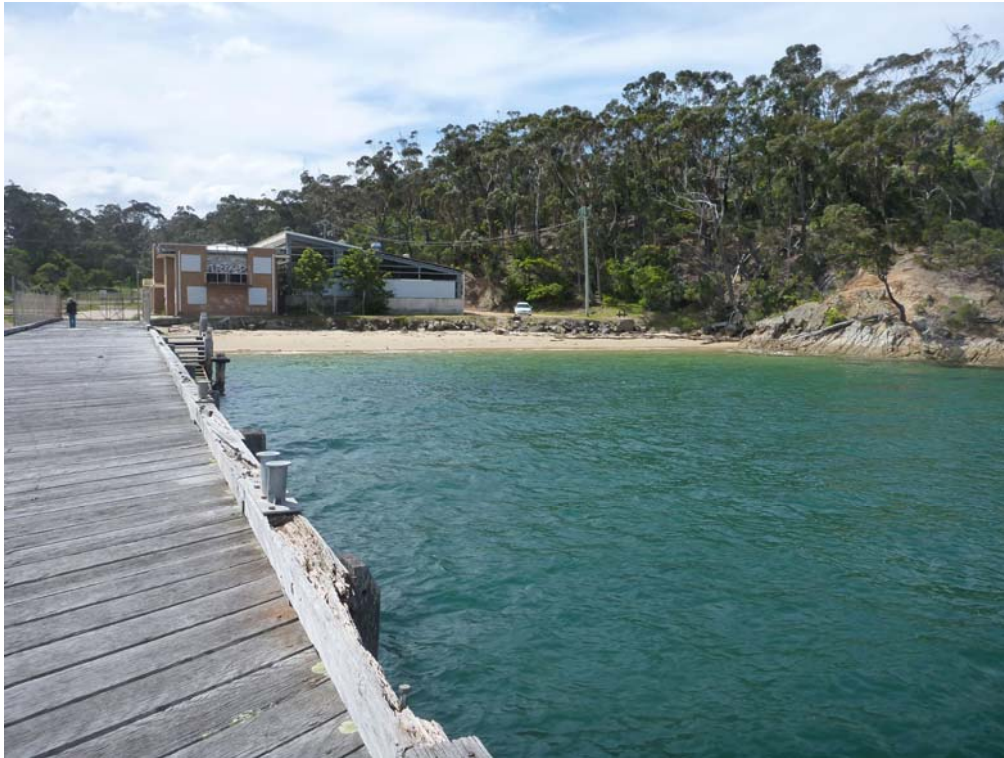
Photo 9 Section of deteriorated kerb along eastern side of the jetty
