Catchment Management Plan

REPORT

Bega Valley Shire Council

PROJECT REFERENCE: JN15115

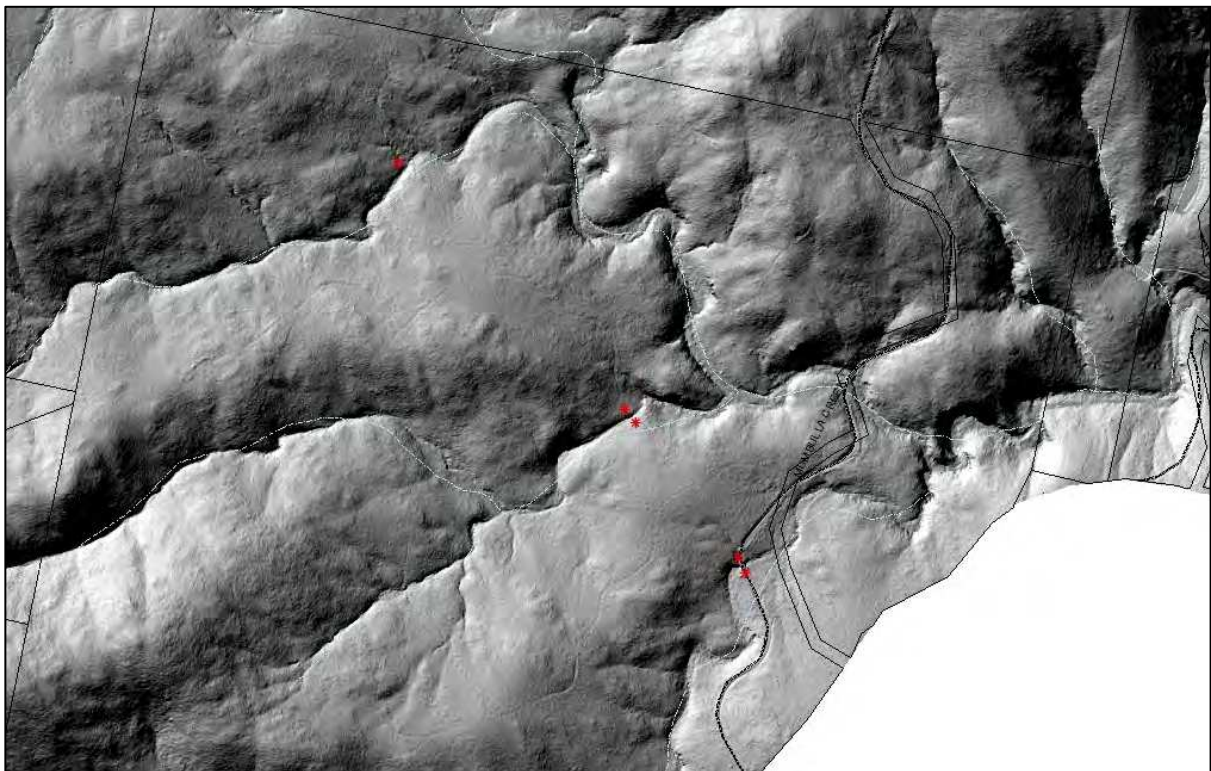
Figure 16. Example of historical forestry logging roads and snig tracks (red asterisks) identified on the enhanced DEM and slope analysis in upper catchment adjacent to Mumbulla Creek Road.

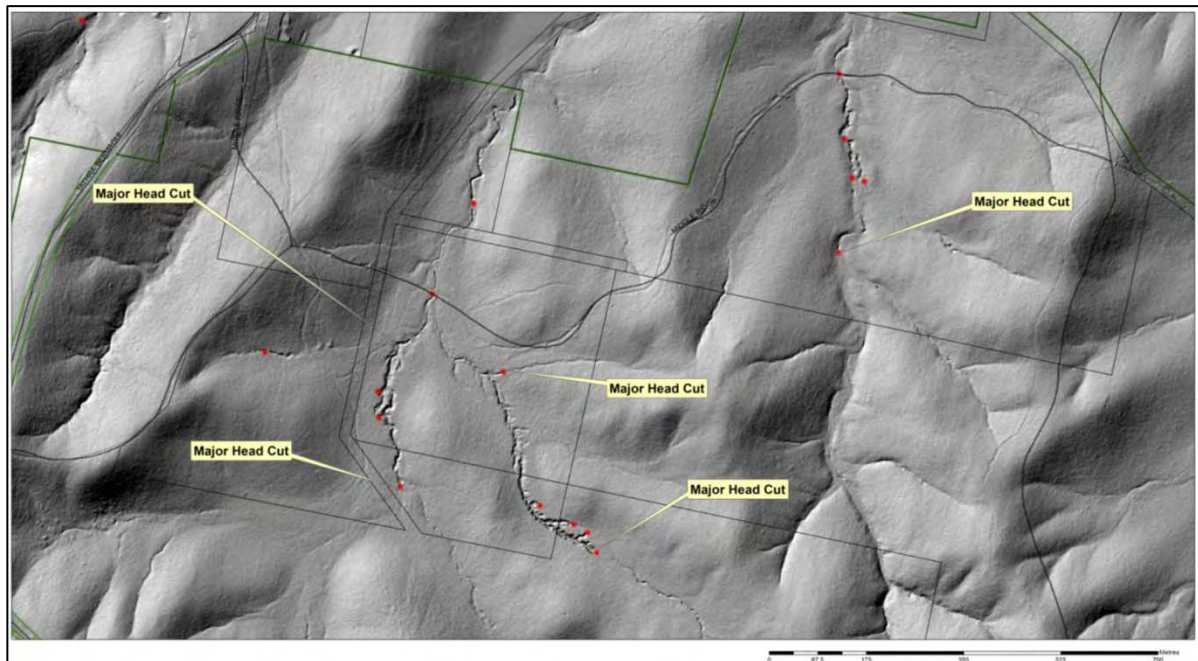
Figure 17. Location of head cuts and serious creek bank erosion identified in the forested area of Sandy Creek sub-catchment using LiDAR.

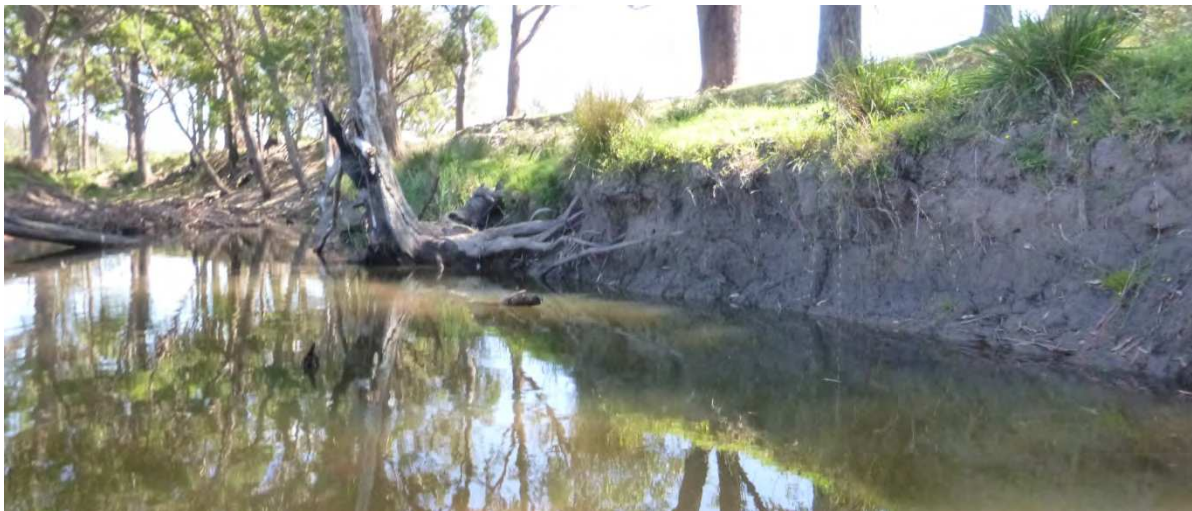
Erosion of bank toes is occurring along the lower reaches of Sandy Creek undermining the stability of large *Eucalyptus* trees (**Figure 19**). Undermined trees are highly susceptible to wind blow, as shear stress created by the wind eventually leads to localised bank collapse as the large tree falls in to the creek (**Figure 20**). These trees supply large woody debris to the creek and estuary, which provide valuable instream refuges and habitat for aquatic flora and fauna. Large woody debris also helps to enhance the geomorphic character and condition of the creek and estuary by exerting strong influence on channel hydraulics and sediment transport and deposition.

Figure 19. Example of bank toe erosion occurring along lower reach of Sandy Creek.

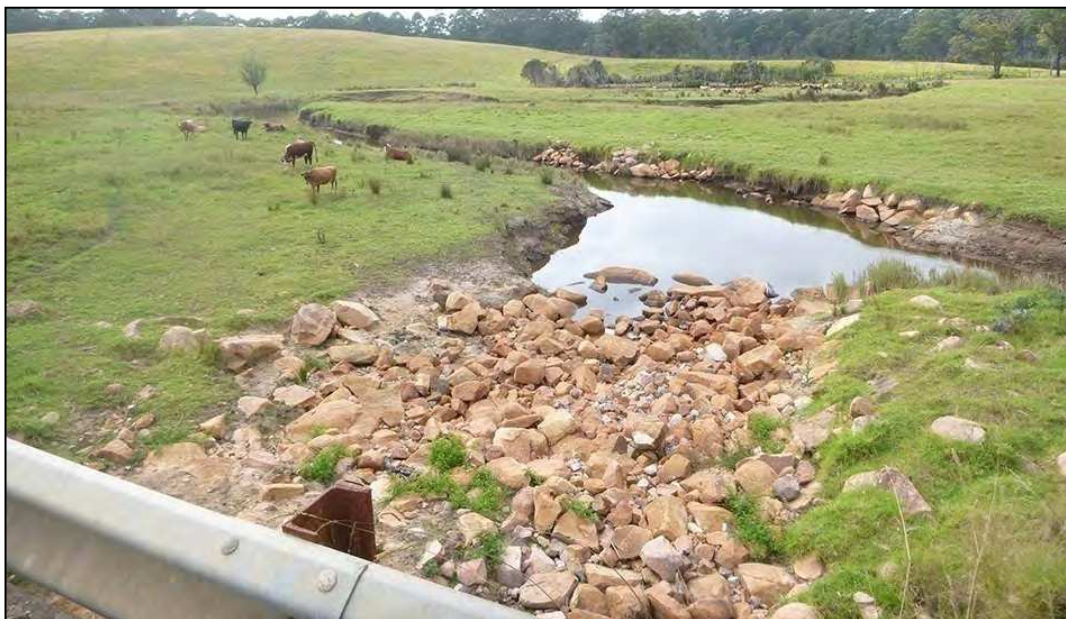
Localised erosion near and adjacent to the box culvert at Booth's Creek is evident (**Figure 21**). This is caused by the hydraulic jump over the box culvert down to the naturally lower elevation of the creek. Local residents report extremely high velocities and erosion during high rainfall events. The existing rock chute and adjacent rock revetment require maintenance to mitigate further bank erosion. This issue is further described in priority management area 4 (**Appendix B**).

Figure 21. Localised bank erosion occurring adjacent to the rock chute at the box culvert outlet on Booth's Creek.

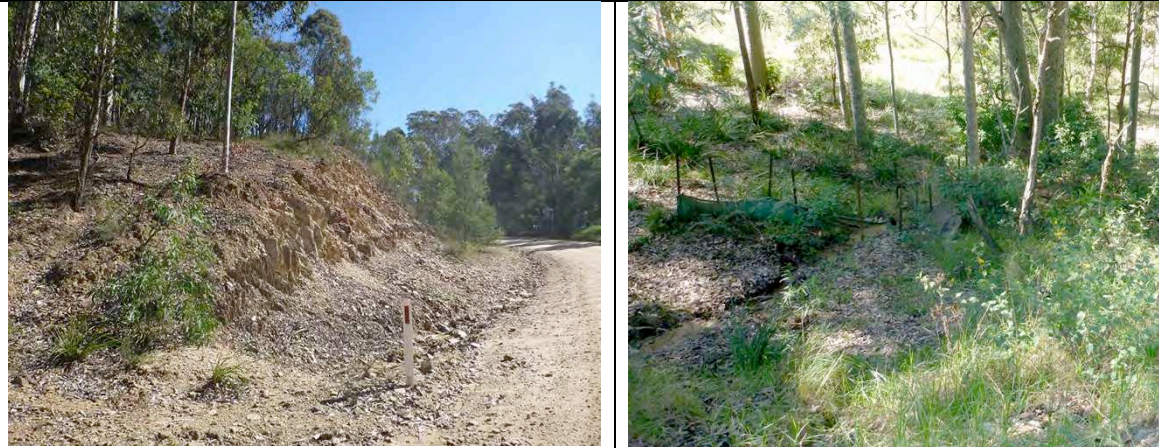
Figure B2 Example of a hillslope and unstable roadside embankment of Dr George Mountain Road that continues to erode and supply dispersible sediment fractions during rainfall events (*left image*). Road surface runoff is directed to the crown road reserve via two stormwater pipes where sediment deposition below pipe outlets is evident. Siltation barrier below one of the pipe outlets is damaged and no longer functional with sediment being delivered further downslope to private land (*right image*).

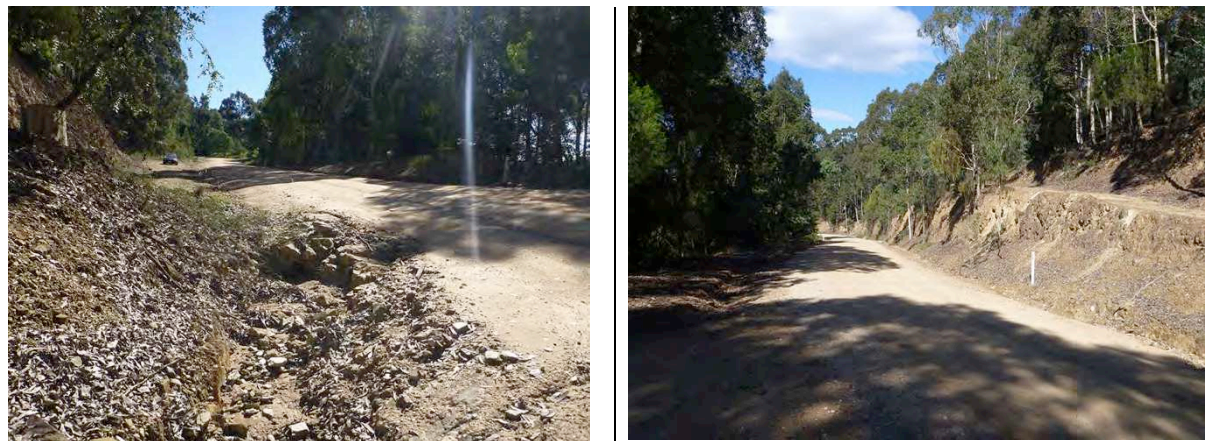
Figure B3 Third storm-water pipe outlet (along the 700m road section) that discharges to roadside drain below embankment (*left image*). From the pipe outlet, road surface runoff flows a further 400m to Tathra-Bermagui Road (*right image*).

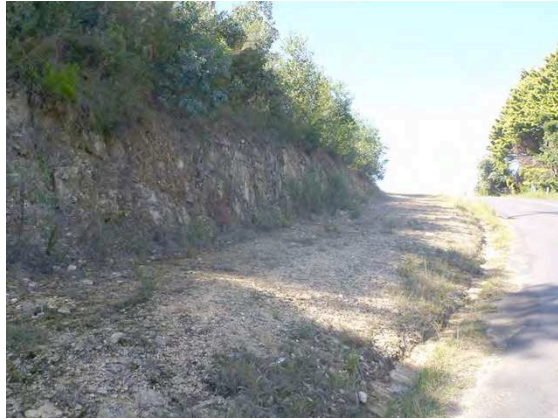
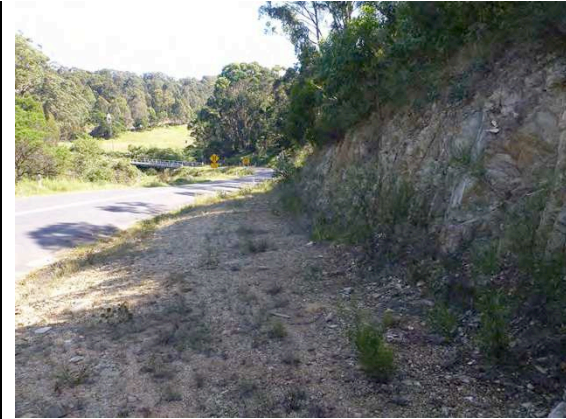
Figure B5 View of roadside embankment and verge towards Worlands Road (*left image*). The view from the roadside embankment and verge towards the Tanja junction bridge (*right image*).

- Recommend stabilising roadside embankment using batter blankets and construction of a small sediment detention basin/trap to prevent excess sediments from entering watercourse (as per Group B control measures in DECC 2008).

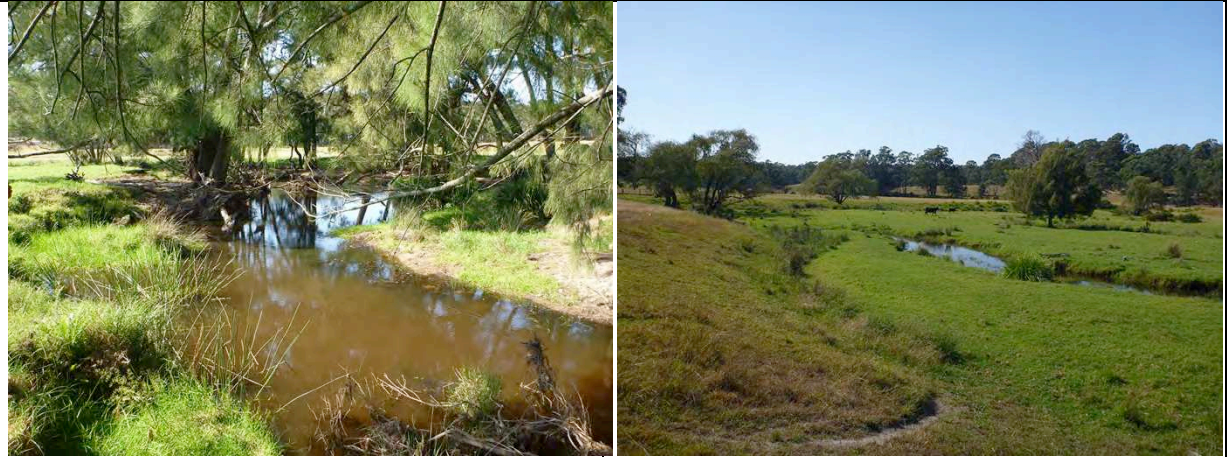
Figure B8 Stock access to the streamside zone and watercourse contributes to diminished water quality of Sandy Creek (*left image*). Example of freshwater reach of Sandy Creek and floodplain with riparian vegetation absent (*right image*).

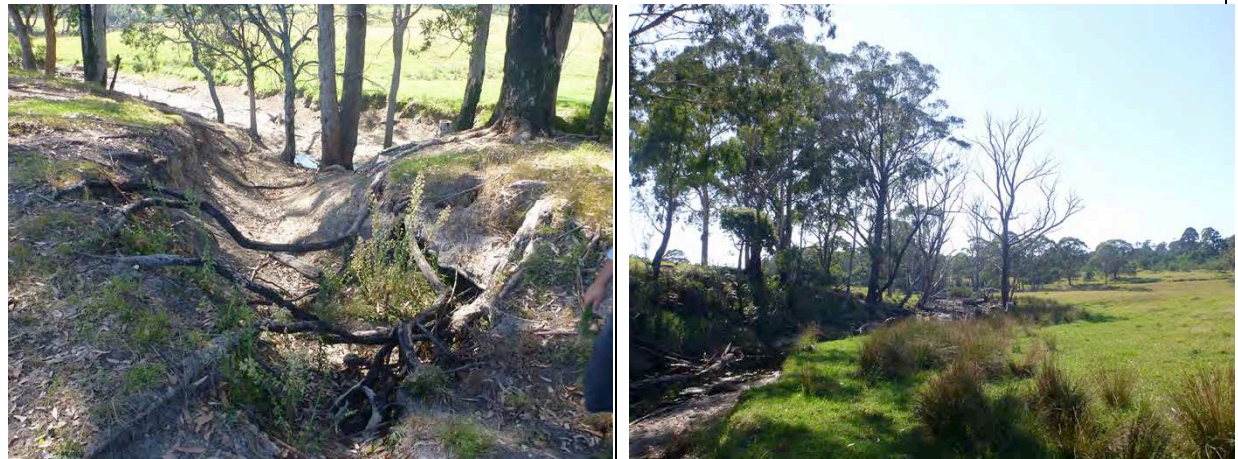
Figure B9 Example of lateral bank erosion that has been caused by water flows from an overland drainage line and a pre-cursor bank disturbance. Improved riparian understorey and groundcover vegetation would help to prevent this type of erosion from occurring (*left image*). Downstream view of lower Sandy Creek with dead *Eucalypts* in the distance due to prolonged inundation. (*right image*).

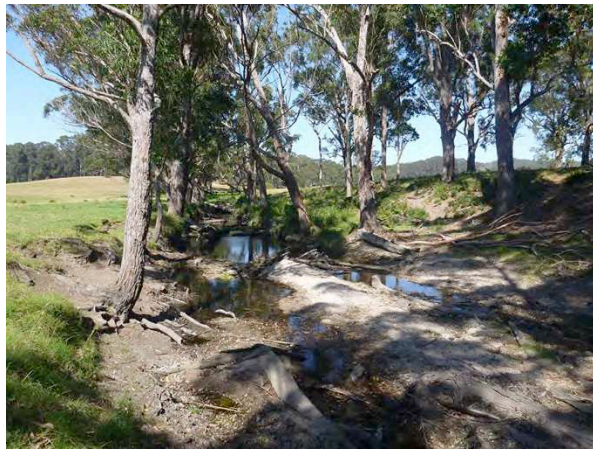
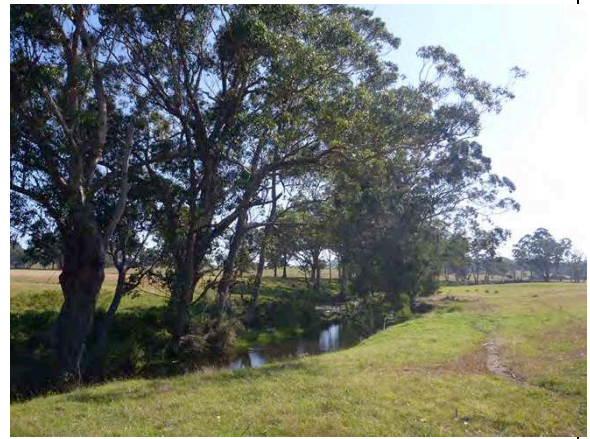
Figure B10 Example of riparian zone where understorey vegetation is absent and bank disturbance due to stock impacts is evident (*left image*). Typical condition of the riparian zone along lower Sandy Creek limited to canopy trees with shrub and understorey vegetation absent (*right image*).

- Work with landholder of Lot 11 DP1092225 to investigate opportunities to re-establish riparian vegetation along bare banks and improve condition of the riparian zone where understorey vegetation is absent. Refer to conceptual drawing for typical river restoration treatment (**Appendix C**) and recommended species list (**Appendix D**).

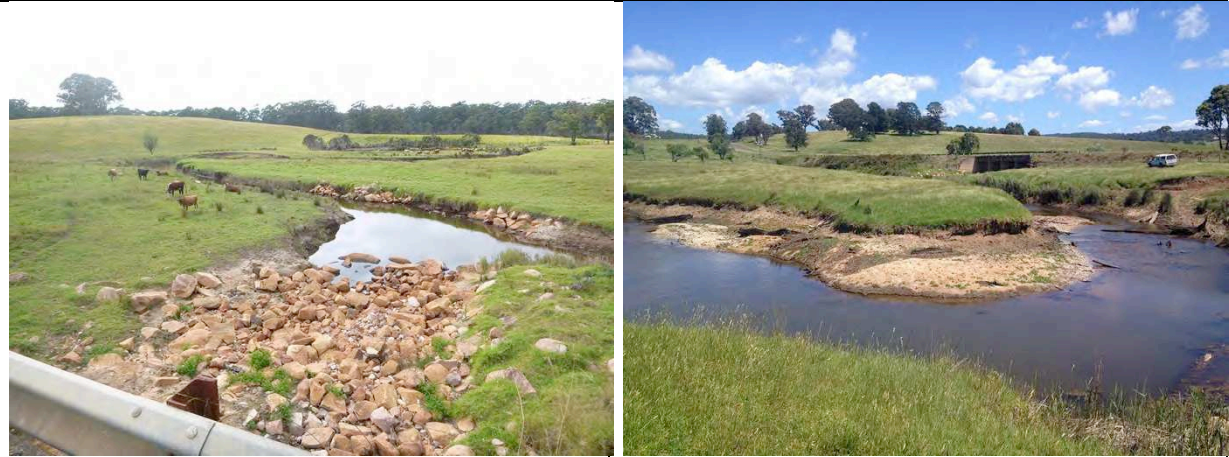
Figure B13 View of lower Booths Creek from Tathra-Bermagui Road showing riparian zone absent of vegetation and stock access to top of bank (*left image*). View over the meander bends showing general absence of natural riparian vegetation (*right image*).

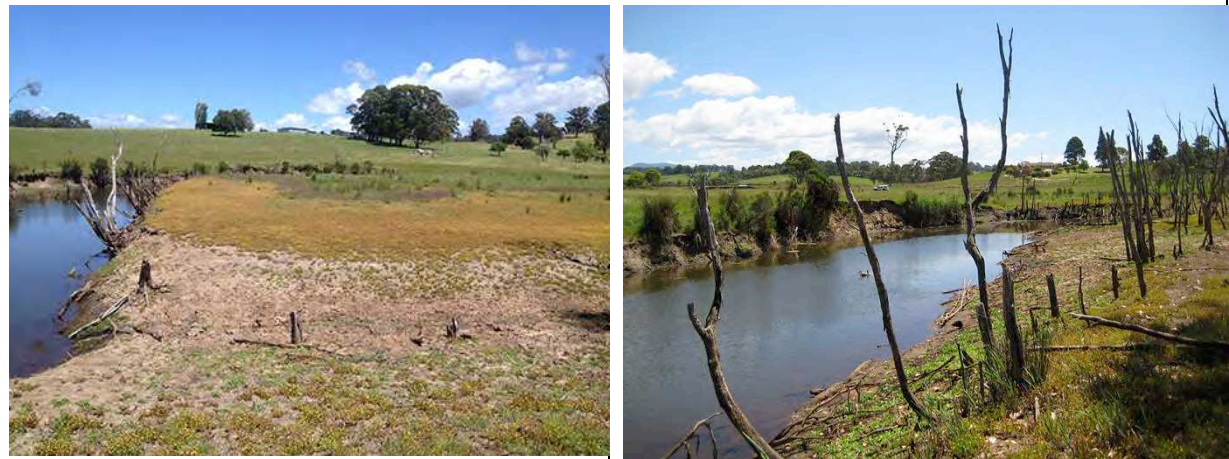
Figure B14 Example of a low-lying area devoid of vegetation with bare earth exposed. This area becomes inundated when the estuary entrance closes (*left image*). Example of current condition of riparian zone of lower Booths Creek where some vegetation exists with isolated stands of *Melaleuca ericifolia* limited to the active channel and remains of dead *Melaleuca* (*right image*).

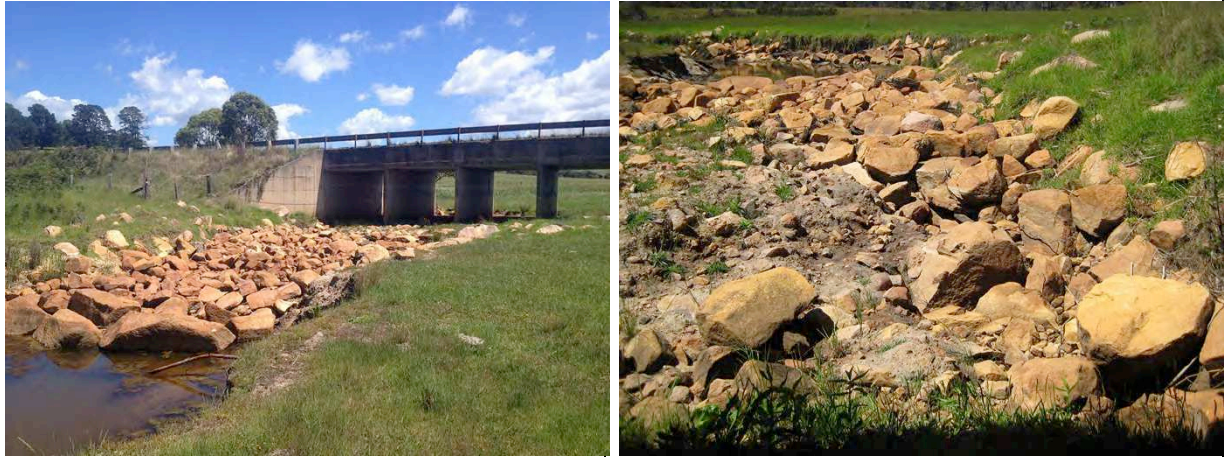
Figure B15 The rock chute outlet below the box-culvert (*left image*). Example of the large boulders comprising the rock chute and disturbance to bed sediments occurring during high flow events (*right image*).

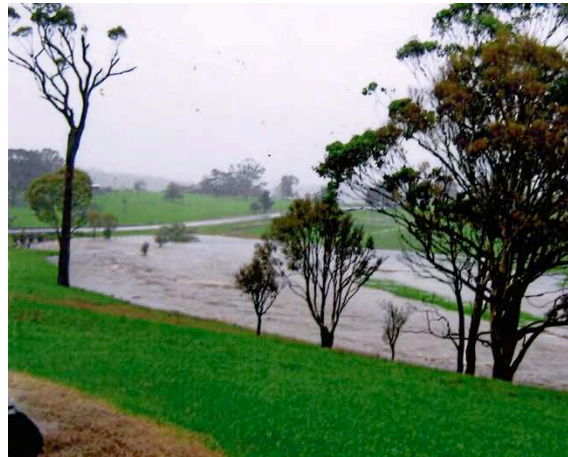
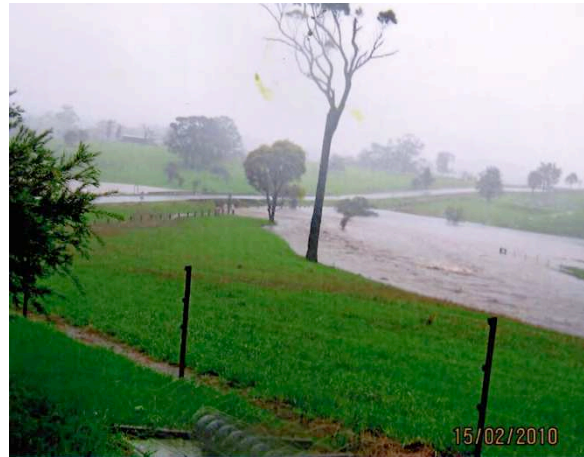
Figure B16 Example of how the road embankment acts like a dam wall causing floodwaters to build-up on the western side of Tathra-Bermagui Road (*photos courtesy of N. Dummett, 15 February 2010*).

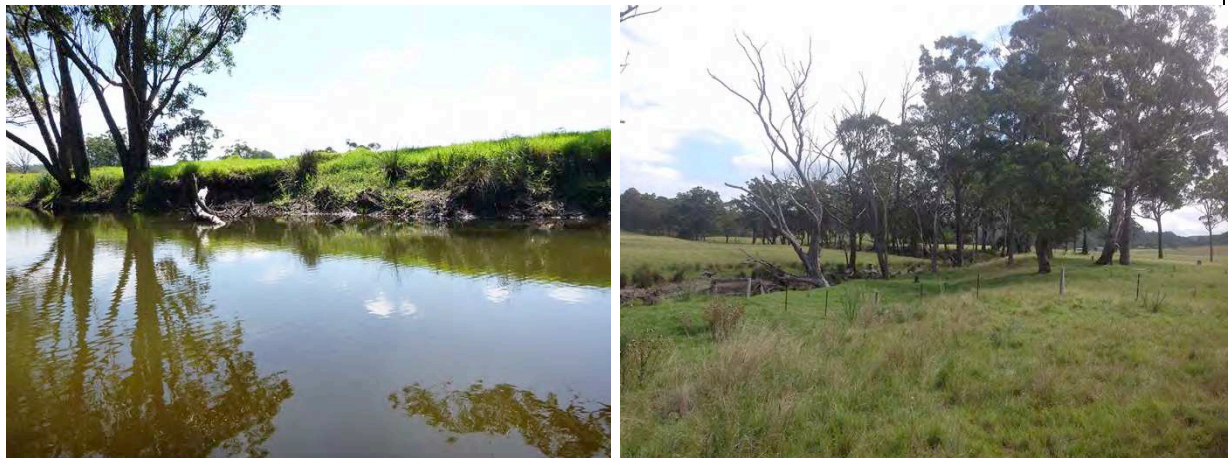
Figure B18 Example of riparian zone of lower Sandy Creek where natural vegetation is largely absent and that could be improved by rehabilitation efforts (*left image*). The riparian zone of Sandy Creek looking upstream to the adjoining property that is characterised by large canopy trees with understorey vegetation absent (*right image*).

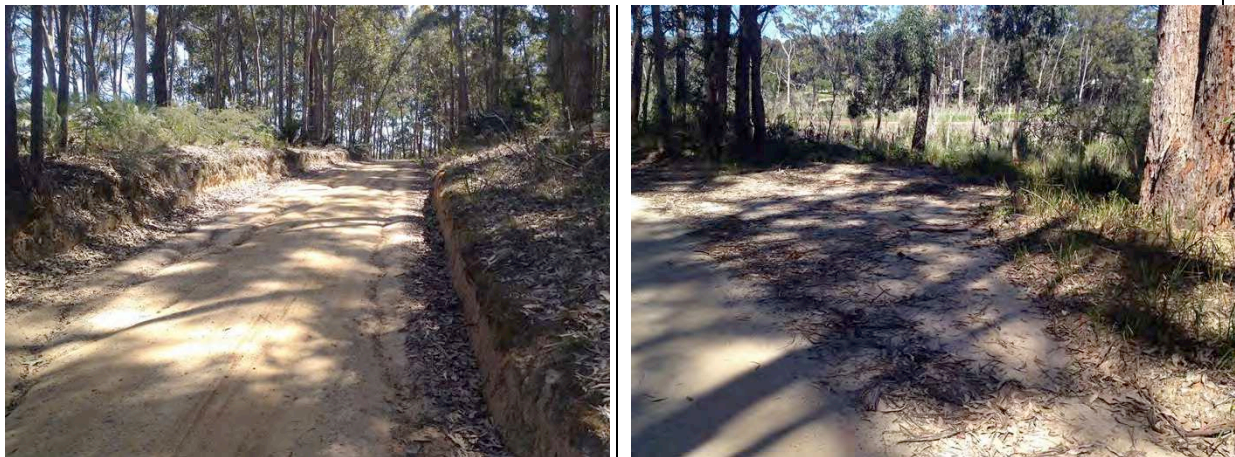
Figure B20 Moderately sloping section of crown road requiring improved surface runoff controls and improved maintenance schedule undertaken in liaison with landholders (*left image*). The mitre drain at the base of the road slope increasing in size with dispersible soil fractions entering the saltmarsh in high rainfall events (*right image*).

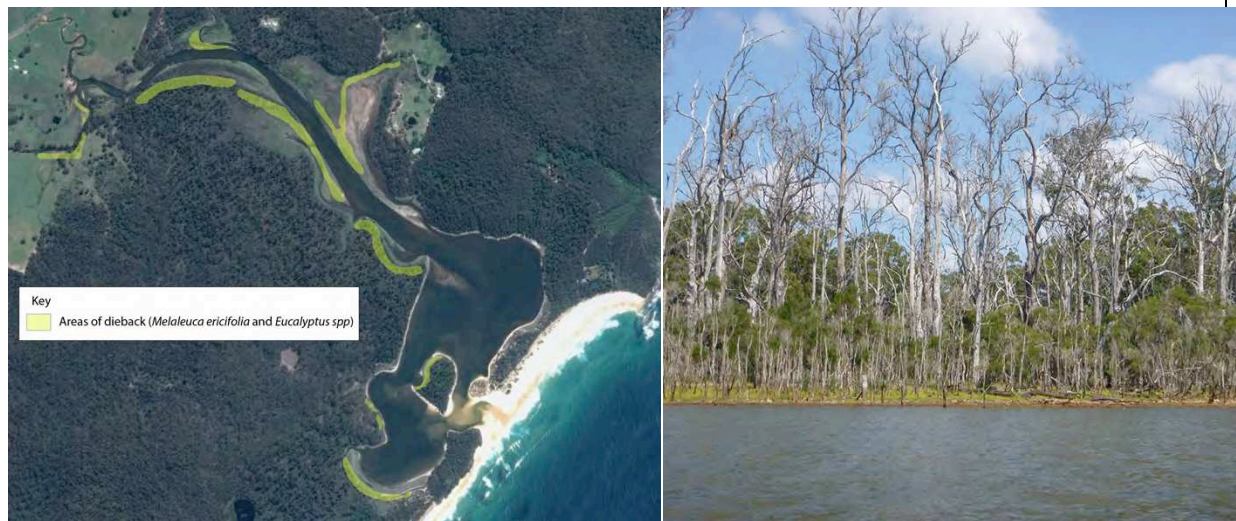
Figure B22 Approximate foreshore areas where tree dieback (*Eucalyptus* and *Melaleuca*) has occurred (*left image*). Example of dead *Eucalyptus* trees on lagoon foreshore (*right image*).

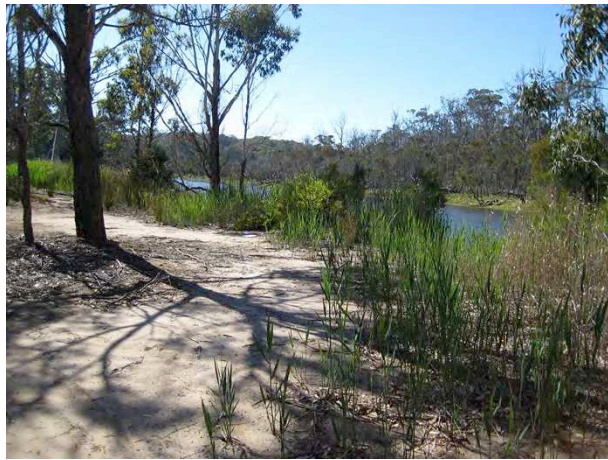
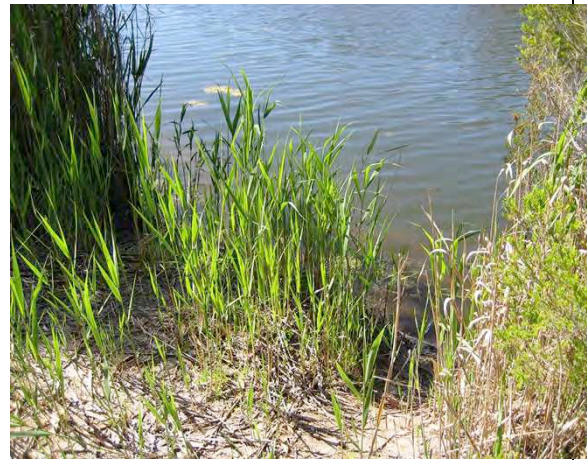
Figure B23 NPWS management track terminating at the lagoon foreshore (*left image*). Wheel ruts forming on the bank where boat launching has been occurring (*right image*).

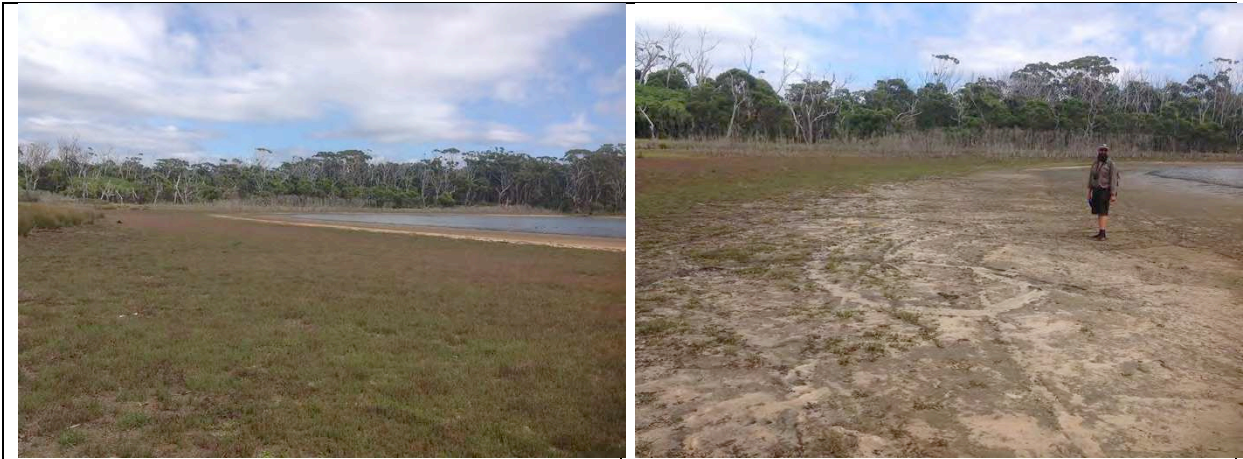
Figure B28 The southern end of Middle Lagoon is characterised by a large extent of coastal saltmarsh community (*left image*). Evidence of recent impacts to saltmarsh community likely due to motorbikes (*right image*).

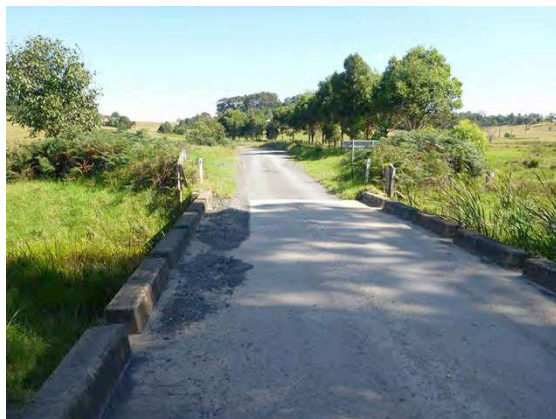
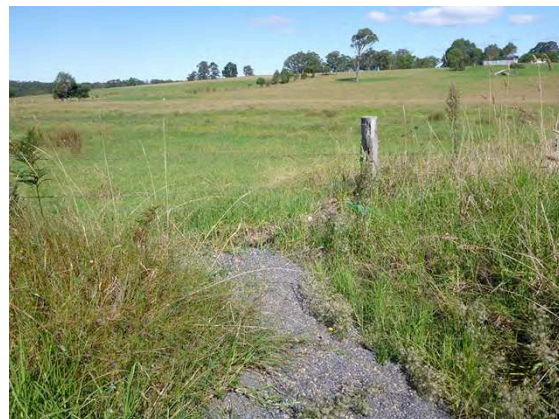
Figure B31 Gravel deposits transported to Kellys Bridge from Barrabooka road surface runoff after recent heavy rainfall event (*left image*). Gravel deposits accumulating in roadside drain adjacent to

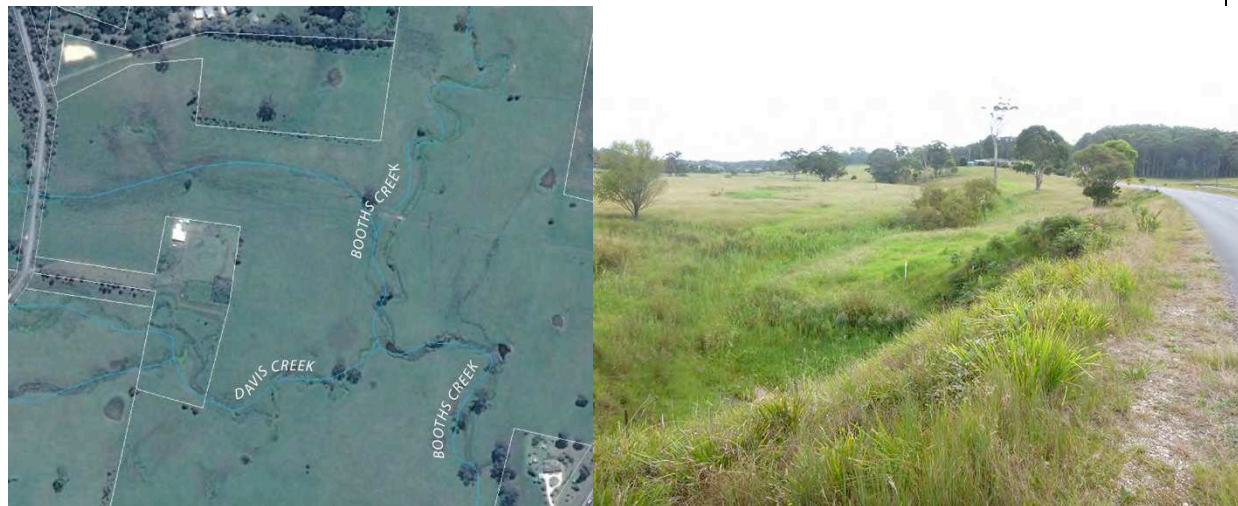
Figure B33 Overview of lower freshwater section of Booths Creek showing general absence of tree cover and riparian vegetation along the creek (*left image*). The view of Booths Creek upstream from Tathra-Bermagui Road showing a riparian zone largely devoid of trees (*right image*).

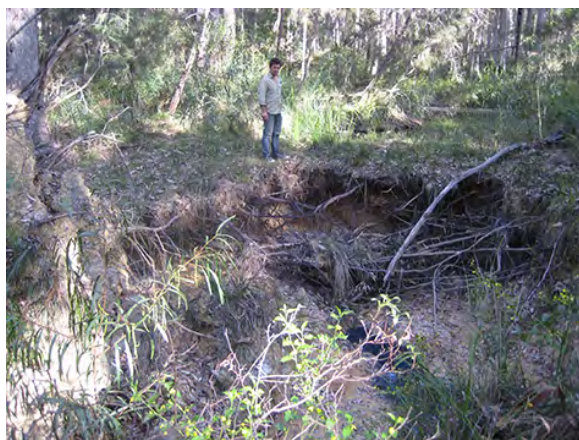
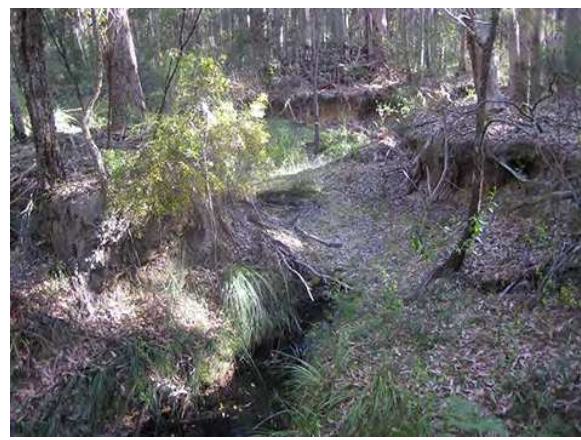
Figure B35 Active head-cut on second order stream in forested setting (*left image*). Gully formation due to migration of the head-cut up the drainage line. A natural process in areas with highly erodible soils such as Sandy Creek sub-catchment (*right image*).

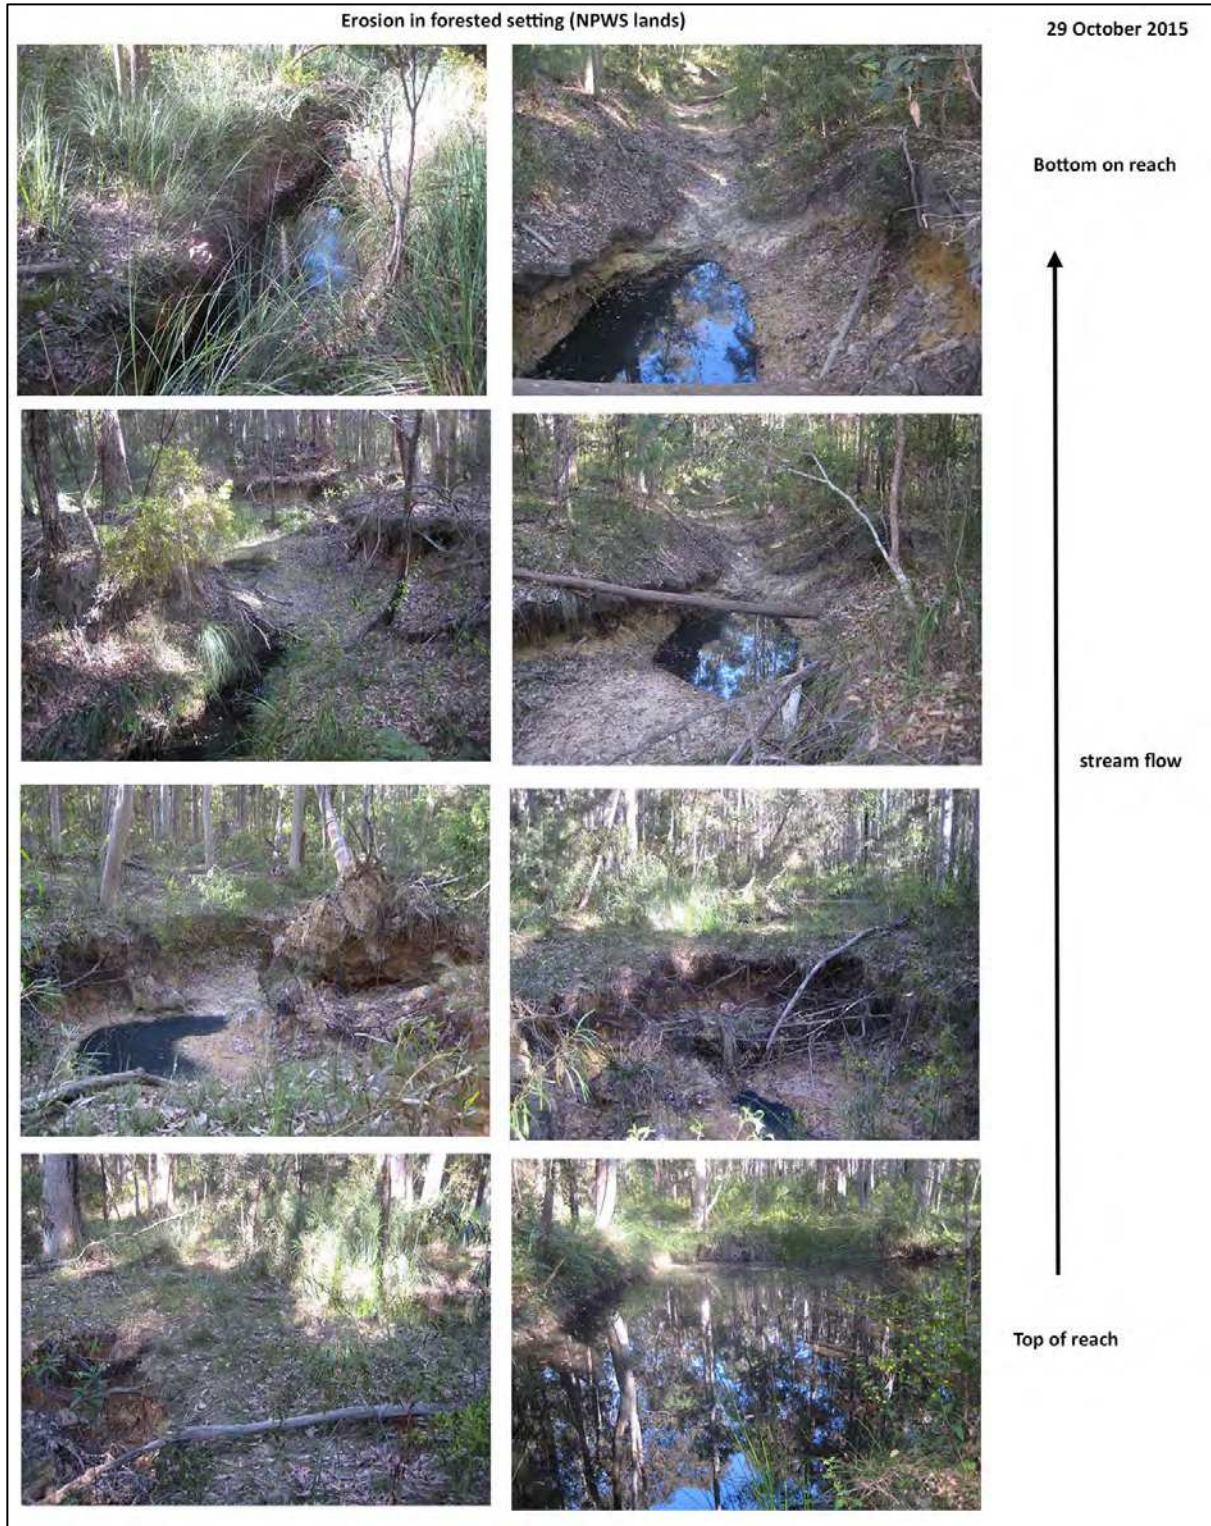
Figure B36 Sequential images of erosion impacts occurring along a 400m reach of a second order stream in forested setting (as described above).
