Review of Environmental Factors

BLACKFELLOWS LAKE BOAT RAMP UPGRADE

JUNE 2019

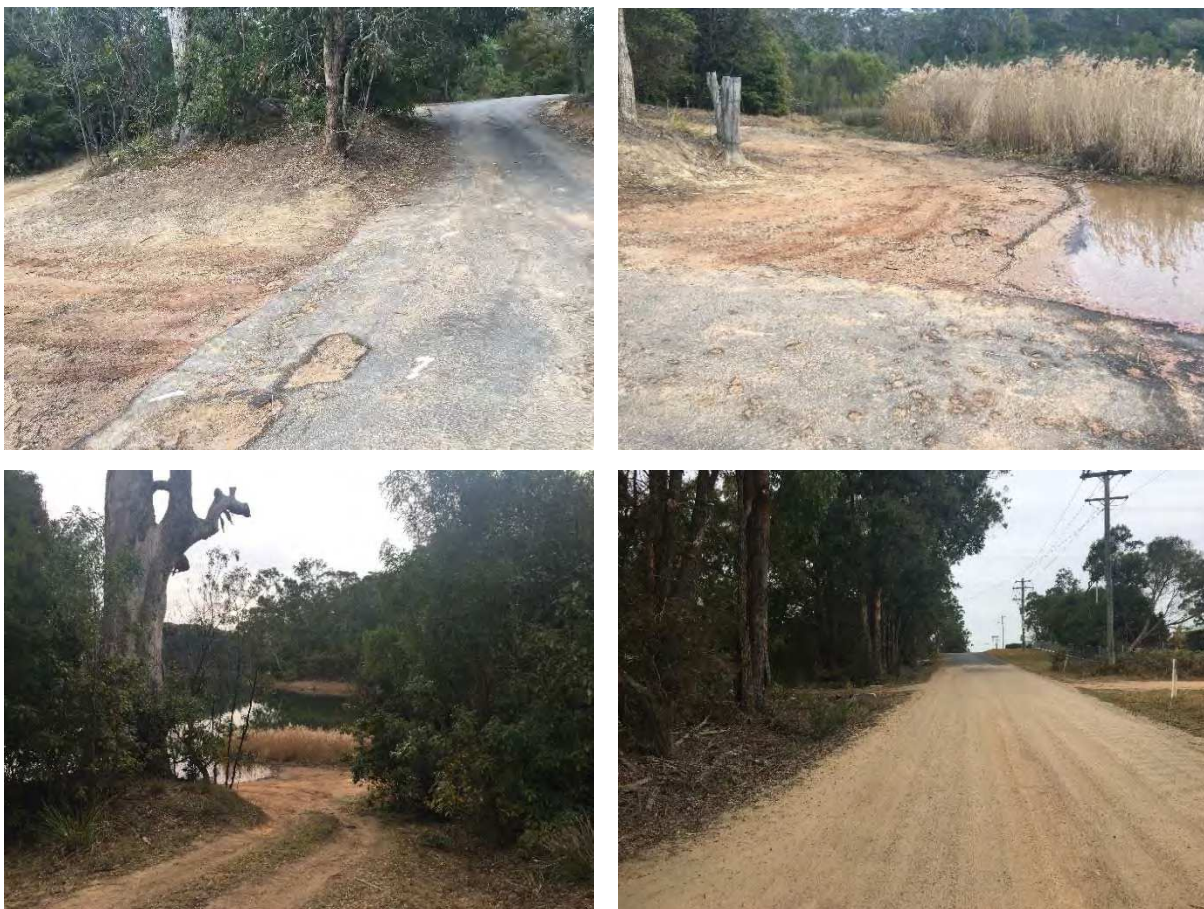
Figure 2-1 Existing boat ramp and access track at Blackfellows Lake.

Blackfellows Lake Boat Ramp is a bitumen sealed ramp that becomes gravel within the lake. The boat ramp has become degraded with portions of bitumen now eroded. The boat ramp also includes an unsealed informal parking area and limited turning area. The access road to the ramp is unsealed with no formal drainage. Erosion is evident at the boat ramp, parking area and access track. This would be resulting in sediments entering Blackfellows Lake during rainfall events. The existing infrastructure can be seen in Figure 2-1.

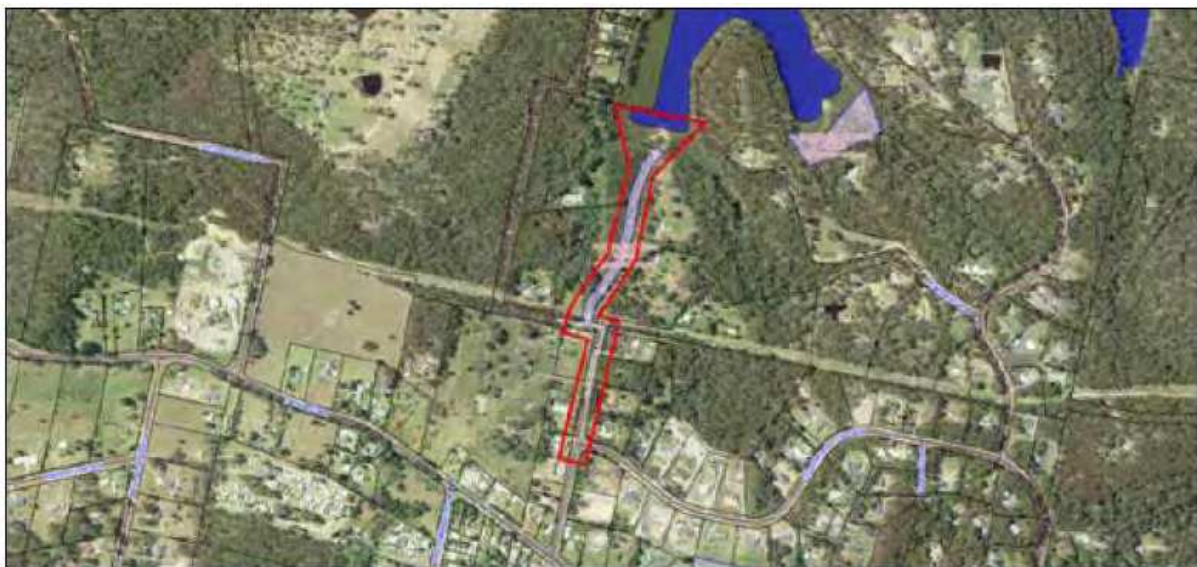
Figure 2-2 Proposal location Blackfellows Lake boat ramp.

Figure 2-2 shows the location of the proposed works at Blackfellows Lake, Kalaru. The proposed works would be located:

- At the existing boat ramp, Lot 7313 DP 1164453.
- Along the access road to the boat ramp, Lot 5 DP 263996
- Within the Blackfellows Lake Road reserve.

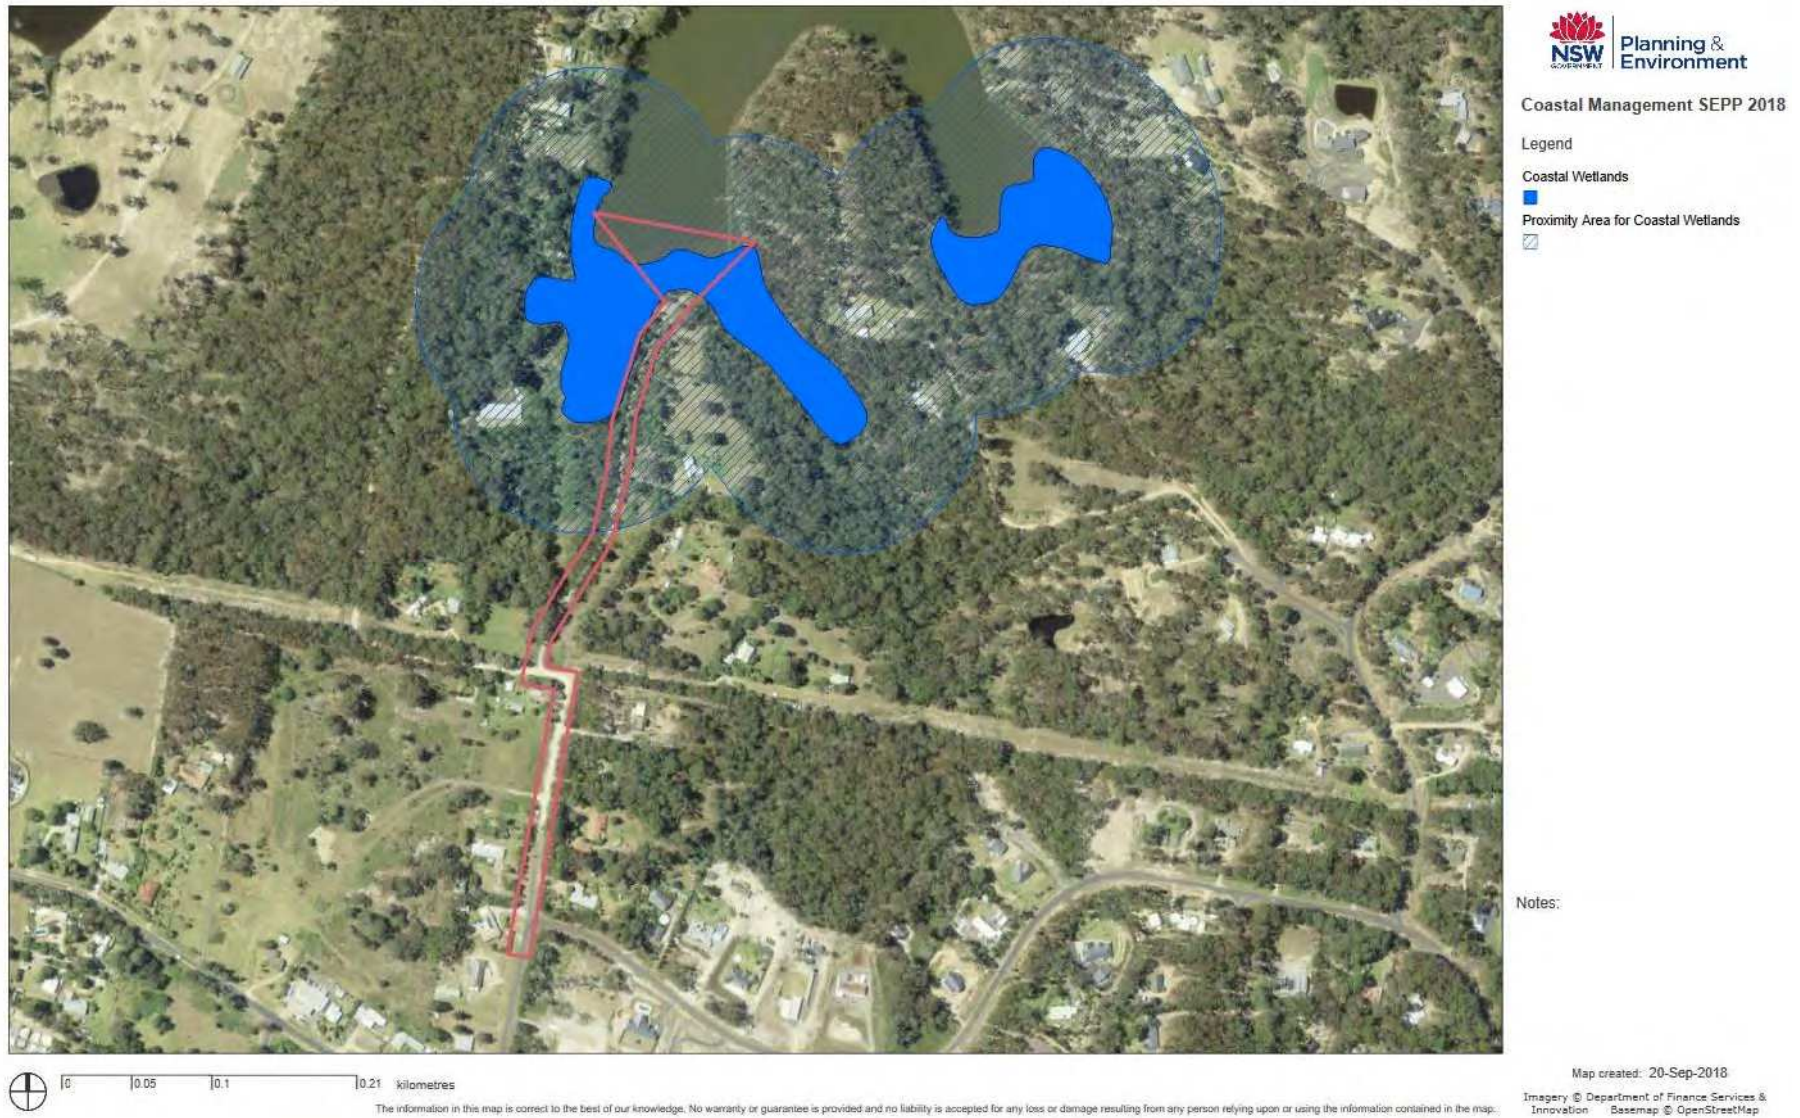
Figure 3-1 Works within coastal wetland and proximity to coastal wetland (proposal is in red).

The proposed boat ramp, finger pontoon jetty and northern extent road sealing occur within the land mapped as 'coastal wetland' and the access road occurs within land mapped as 'coastal wetlands proximity area' under *State Environmental Planning (Coastal Management) 2018* (refer to Figure 3-1).

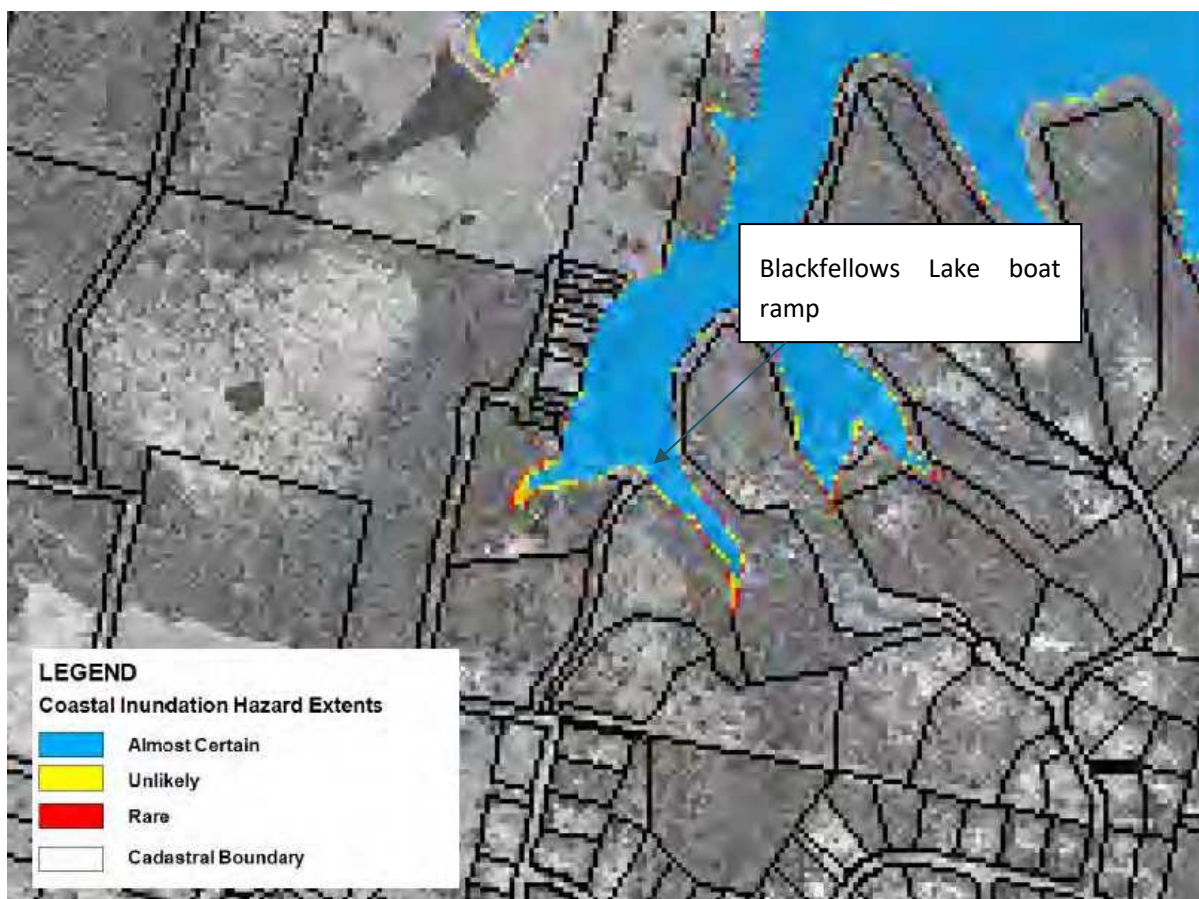
Figure 5-2 Estuary Storm Tide Inundation Hazard 2050 horizon (BMT WBM, 2015).

Since 1910, the average surface temperature in Australia has increased 0.9°C and between 1901 and 2010 sea levels have risen 0.19 m. Higher mean temperatures, rising sea levels and more severe storms are a pattern that is expected to continue into the future. BMT WBM (2015) published a *Bega Valley Shire Coastal Processes and Hazards Definition Study – Volume 1: Final Report* that Identify, assess and maps the potential extent of coastal hazards for the current year, 2050 and 2100 timeframes. The study identifies areas of inundation during storms. These areas are shown in Figure 5-2.

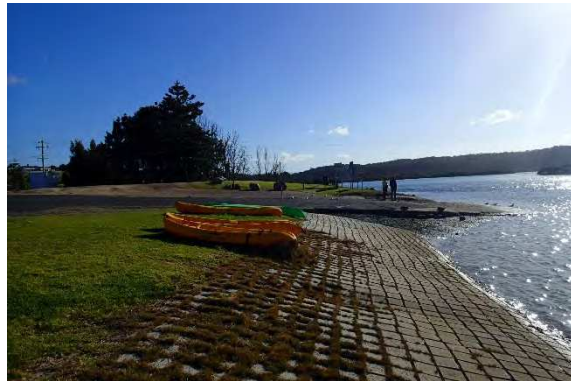
Plate 1. View west along edge of river to boat ramp.

The edge of the Bermagui River at this location has largely been impacted through the construction of the existing boat ramp but also through placement of concrete block paving along the edge of the river bank on the eastern side of the ramp (Plate 1) and some rock walling on the western side of the existing ramp. This has reshaped the natural surface of the bank and the grassy area behind it. There is an existing sealed carpark adjacent to the boat ramp with a large (30 m x 30 m) area of bare ground most likely used as a turn-around area or overflow parking (Plate 2) on slightly higher ground to the west.

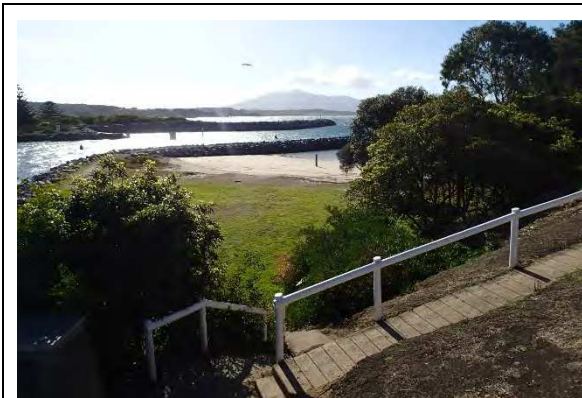
Plate 3. View north from top of bank to Pool and breakwater.

The Bruce Steer pool area appears to be largely man-made. The natural river bank forms the eastern side of the pool and a breakwater has been constructed northwards from a natural bend in the river bank (Plate 3). There is a small sandy beach, between the rock wall and the natural river bank with the car park constructed on largely reclaimed land behind the rock wall forming the current bank of the eastern side of

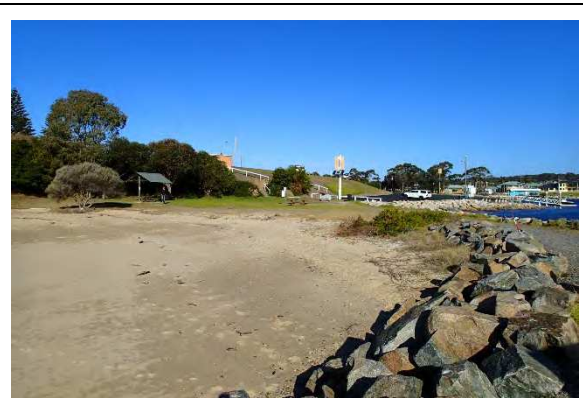
Plate 4. View south east across sand flat to natural bank showing existing path and toilet block. Note the carpark and sand flat are not natural.

the river. The existing toilet block is on top of the approximately 4 m high natural eastern bank, although the construction of the toilet block and the associated concreted path and stairs leading to the pool has greatly disturbed the natural ground surface (Plate 4).

The sandy deposits extending from the car park north to the edge of the pool are not considered to comprise intact natural sand deposits, they appear to be largely made from yellow beach sand and therefore most likely have been imported into this area. The proposal therefore, to construct an all abilities access ramp across the sand to the pool and to modify the carpark to include disabled parking is unlikely to impact of natural ground surfaces and therefore has negligible potential to impact on Aboriginal heritage objects.

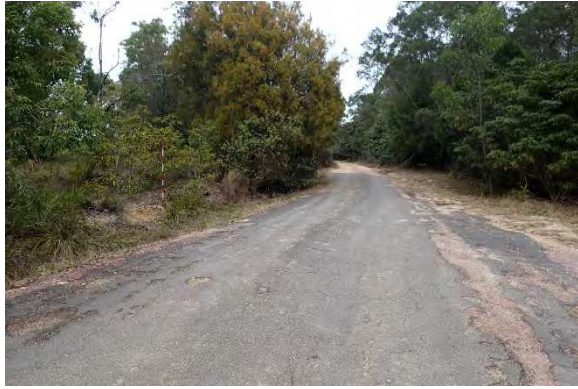
Plate 7. View south to start of site at range pole on road cutting. Artefacts also present along unsealed section of track in distance.

The site *Blackfellows Lagoon AFT 1* was a scatter of stone artefacts spread for 120 m from the edge of the drop-off south along the access road. Artefacts were found on the edge of the road cutting near the termination of the spur and also along the unsealed section of the access track (Plate 7). Artefacts were observed in the run-off channels along the edge of the track as well as in the middle of the track (Plate 8). Thirteen artefacts were recorded in detail but the site is estimated to contain about 20 artefacts. It is unlikely that there would be substantial subsurface deposit remaining on the access track but some may exist within the undisturbed spur crest.

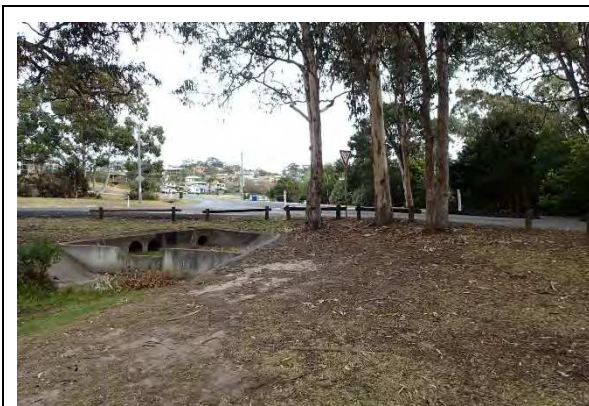
Plate 9. View west to road intersection showing built up roadway and underground stormwater drainage structures.

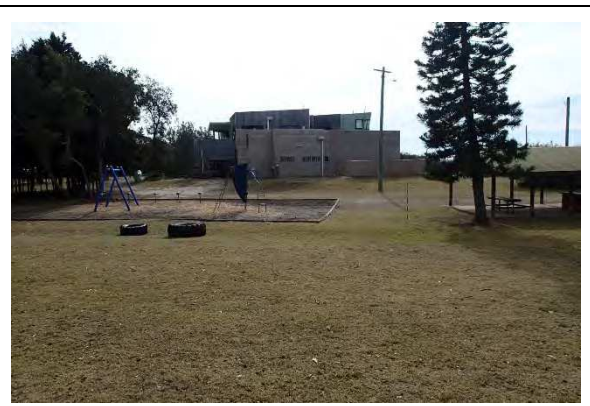
Plate 10. View north across existing facilities to club, note some exposures and planted conifers on left.

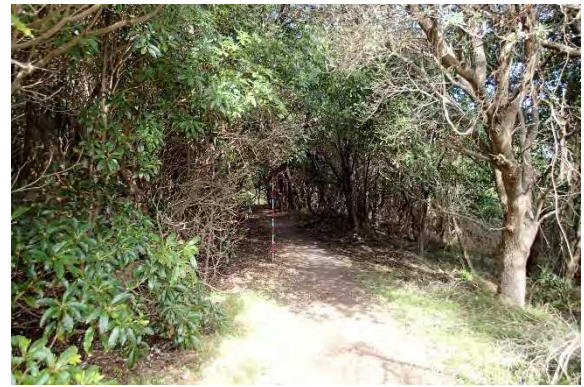
Plate 14. View south to location of Murunna Walking Track IF 1.

was a primary flake with 95% pebble cortex. It was situated in a similar environment to the midden being in a grey sandy humic loam deposit, eroding from the track which had about 50% visibility but with surrounding leaf litter and grass severely restricting further finds. The site is likely to be larger. It was also situated at the top of the cliff line, on a relatively low gradient slope (Plate 14).

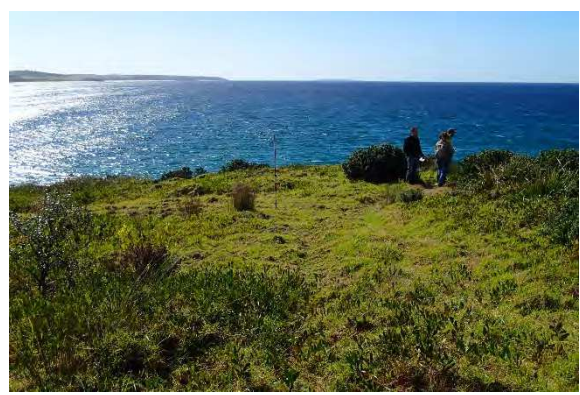
Plate 18. View north to Murunna Point headland.

The proposed walking trail turns south and then east to the Murunna Point headland. This section crosses relatively low to moderate gradient slopes and down a spur crest to the headland. Visibility was very poor with thick grass cover but there were areas of level ground at the top of the cliffs and back towards the ridge of high ground forming the headland. All of these areas and across areas of high archaeological potential, although nothing was found during the current inspection. These areas are also relatively undisturbed, with a lack of previous vehicle tracks that led to the erosion that exposed the sites further west on the headland recorded by Webster and Kuskie (Plates 18 and 19).

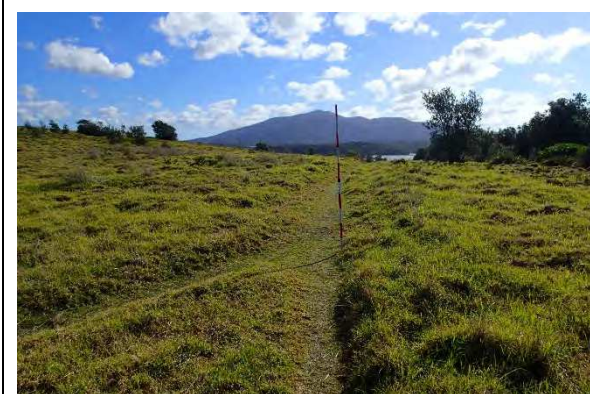
Plate 19. View north across level area of proposed path, note poor visibility.

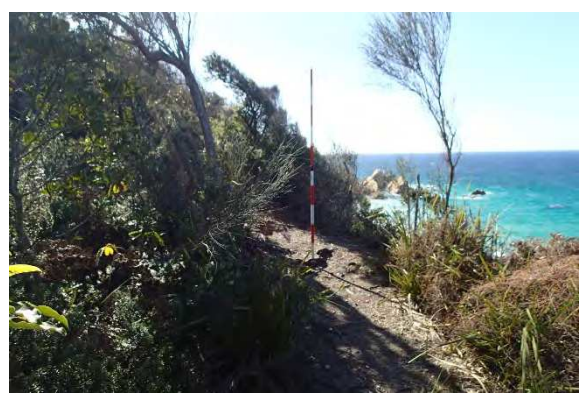
Plate 20. View north to exposure of shell, associated with site 62-7-0254 Locus B.

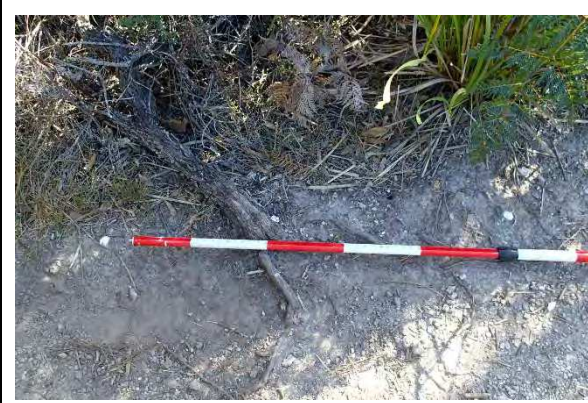
Plate 21. View of exposure of shell, associated with site 62-7-0254 Locus B.

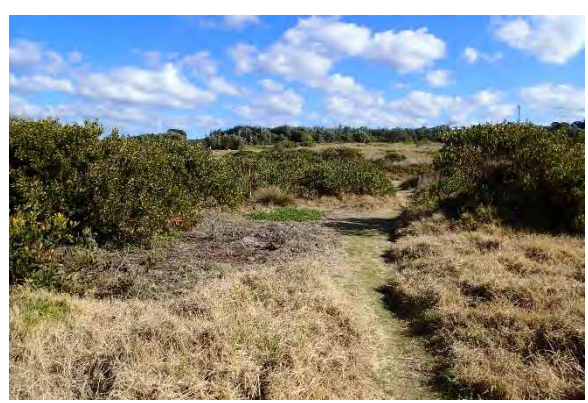
Plate 22. View west across lower slope to Murunna Walking Track Midden 2 at left of track near range pole.

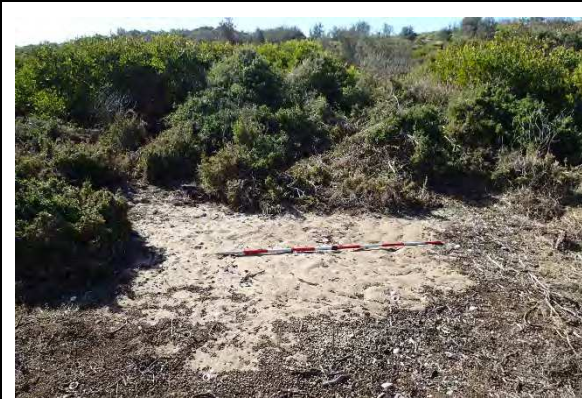
Plate 23. View of exposure showing midden material of Murunna Walking Track Midden 2.

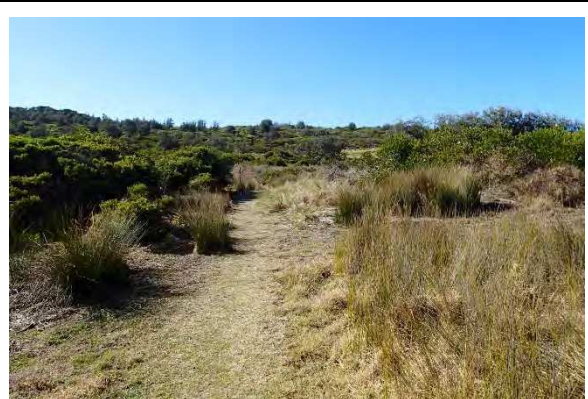
Plate 24. View north east to location of site 62-7-0267 on edge of walking track at range pole.

The walking trail alignment crosses a small outlet creek from the wetland and then crosses another small *Anadara* midden, previously recorded as site 62-7-0267 (Plate 24). This site contains a small exposure of shell on the southern edge of the drainage line with high potential to be larger and contain subsurface material.
