Coastal Zone Management Plan for Pambula Lake Estuary - Final Report

Reference: R.B02375.001.02.docx
Date: August 2015

Prepared for: Bega Valley Shire Council

Prepared by: BMT WBM Pty Ltd (Member of the BMT group of companies)

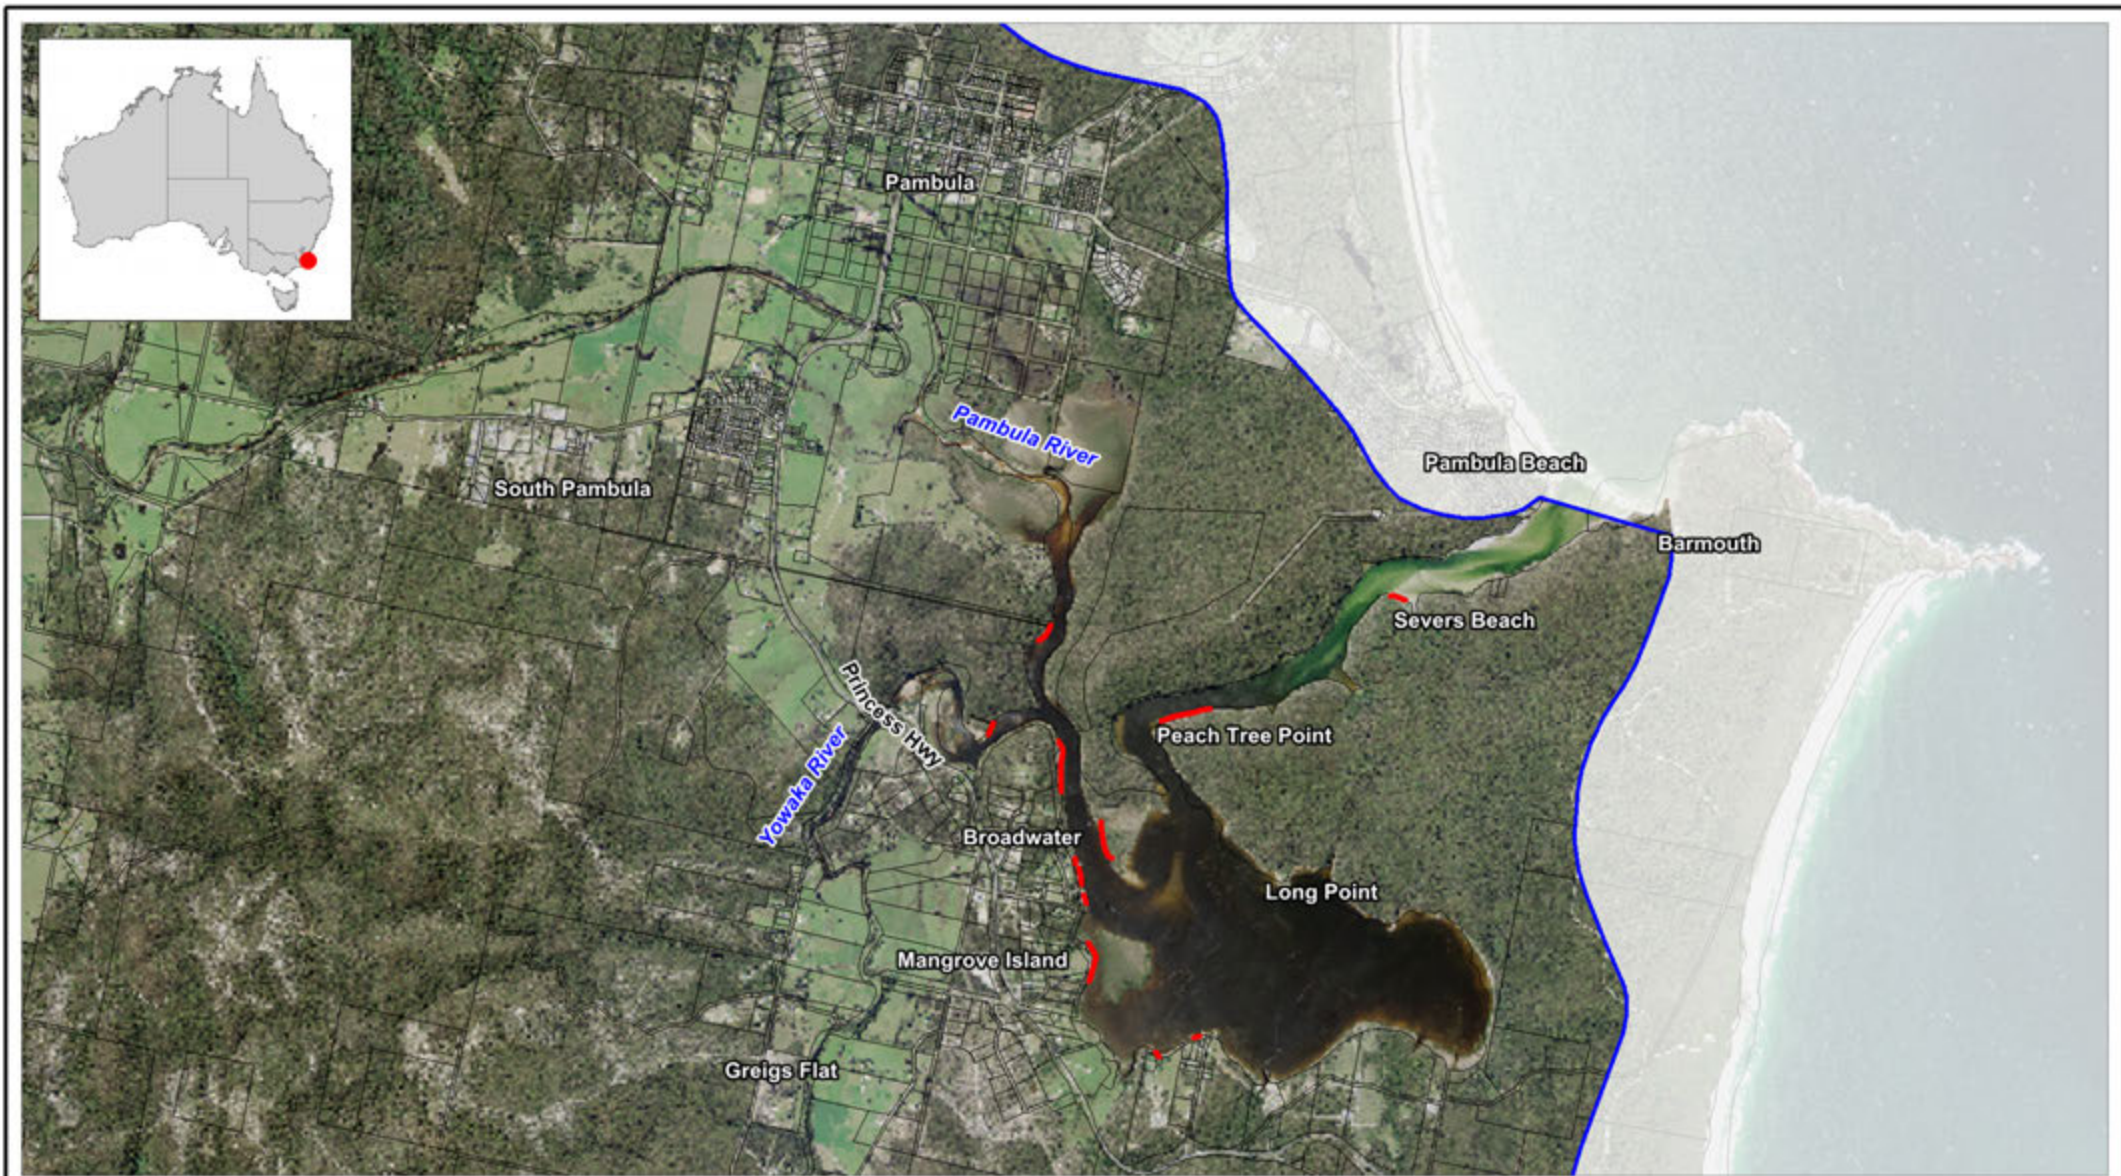
Locations of assessed erosion are provided in Figure 3-5 and are denoted by the red lines. It should be noted that the Foreshore Unit Q (on the far east of the main basin) is not a location of erosion despite also being mapped in the same colour.

The location of bank erosion (and geomorphic condition) is provided in below (and in Figure 3-5 and Figure 3-6), while locations for priorities for action in the river sections are outlined in Figure 8-2, and Figure 8-3 later in the section.

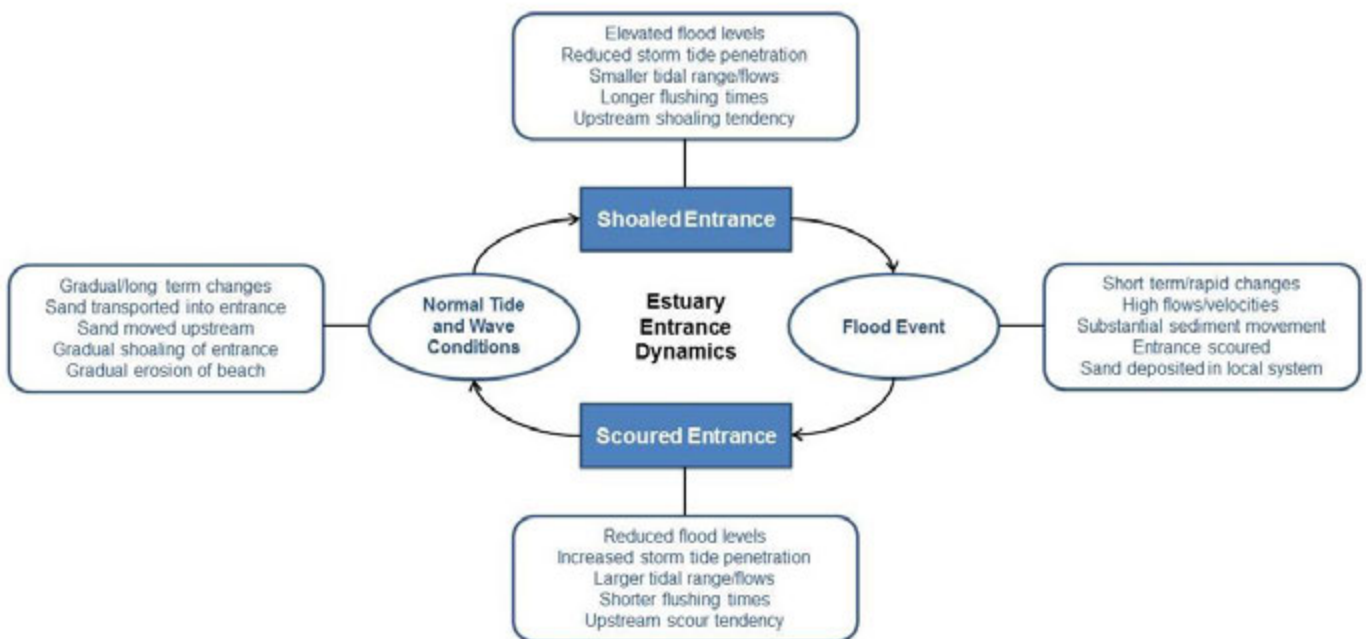
Figure 3-7 Schematic Flow Chart Showing Cycle of Entrance Conditions

Figure 3-7 provides a schematic flow chart of the state of estuarine entrances. These patterns are most applicable to wave-dominated inter-barrier type estuaries, but are likely to be applicable to the Pambula Lake estuary as well (noting it is a wave-dominated, drowned river valley estuary). Cardno (2012) identifies that the entrance displays tidally formed sand waves on the upper surface of the flood-tide delta, which extends approximately 1.5km up the tidal inlet channel, indicating an upstream transport of sand by wave action and tidal currents in this location. Furthermore, it was identified through a review of aerial photography and anecdotal evidence from community members that the entrance is morphologically dynamic (i.e. subject to change), and that the entrance channel can become constricted due to progradation of the flood-tide delta.

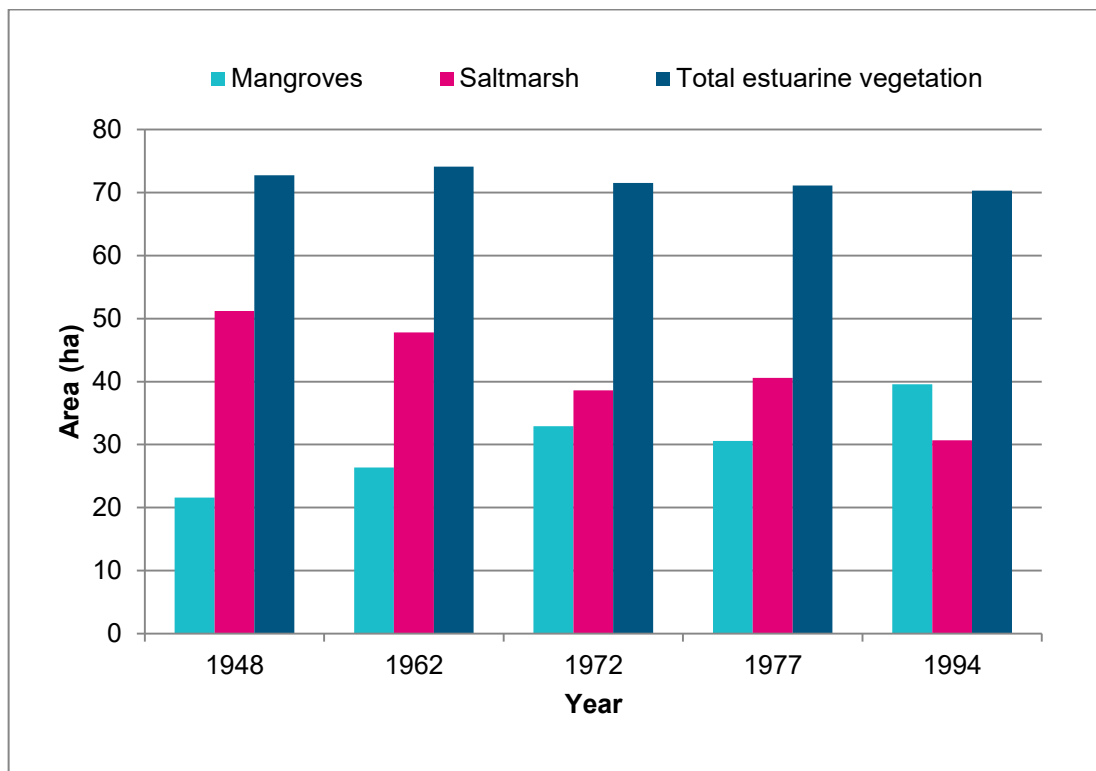
Weed invasion and historical disturbance (clearing, draining, grazing) have adversely affected wetland condition, structure and extent in places, particularly in the Pambula Estuarine Wetlands. Extensive rehabilitation work has been carried in the Pambula Estuarine Wetlands in order to reinstate flows and restore vegetation.

Figure 3-11 Changes in the extent of mangrove and saltmarsh between 1948 and 1994 at Pambula estuary (Source: Meehan 1997)

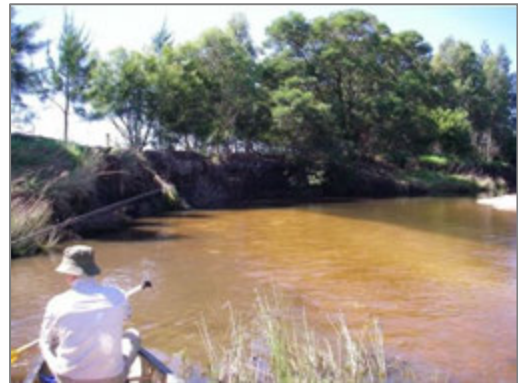
Example of Bank Erosion in Pambula Estuary (SRCMA, 2012)

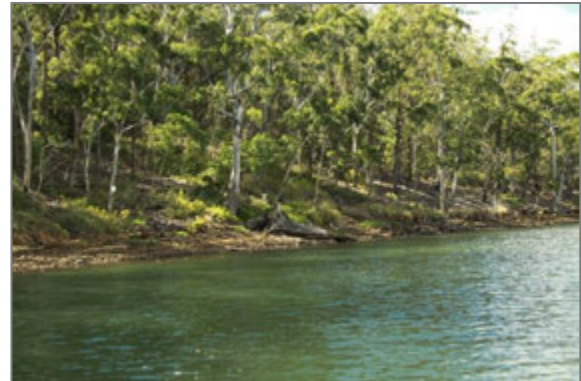
Example of Riparian Vegetation on Pambula Lake estuary foreshore

The riparian zone (taken to extend up to 100m from the highest astronomical tide) of the estuary will contain a mixture of marine and terrestrial plant species depending on elevation and regularity of inundation. Monitoring as part of this action aims to investigate the extent and condition of all vegetation within the riparian zone, which also includes mangroves and saltmarsh.

To assess extent, it is recommended that use is made of suitable resolution ortho-rectified aerial photography. This information is commonly viewed and utilised using Geographical Information Systems (GIS) on desktop computers. Determination of the extent of the estuary will require delineation of the water edge and 100m buffer lines. Within these buffered zones around the estuary, digitisation of vegetation boundaries will be required to allow for calculation of the percentage of vegetation coverage within these zones. Methods for mapping saltmarsh and mangroves are outlined within the publication 'Assessing estuary ecosystem health: Sampling, data analysis and reporting protocols' (OEH, 2013). This methodology could also be applied to map vegetation in non-tidally influenced riparian areas.

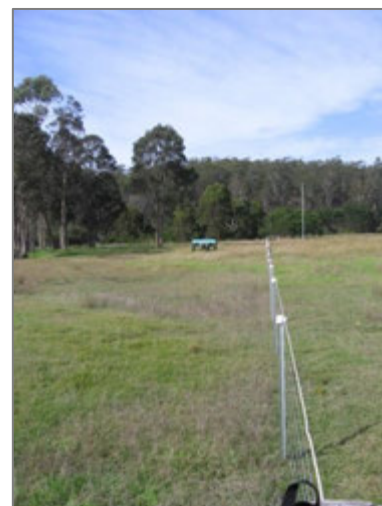
Example of Stock Exclusion Fencing (Source Council)

Priority areas for riparian fencing include:

- Areas where cattle currently access the banks and waters of the estuary and cause degradation. Fencing off creek areas may necessitate additional works to supply water from the creek to watering troughs within the boundary of the new fencing.
- Areas for bank restoration that coincide with priorities identified in the Pambula Catchment Rehabilitation Plan and Estuary Processes Study. These priorities are further discussed in **Action C1** (Page 97).

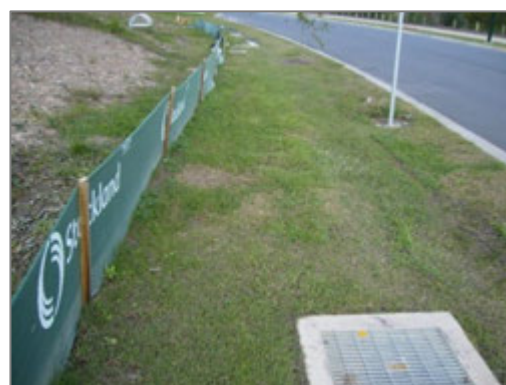
Example of Sediment Fence on a Construction Site

It is recommended that Council implement an educational program for relevant staff involved in Soil and Water Management (also called Erosion and Sediment Control (E&SC)).

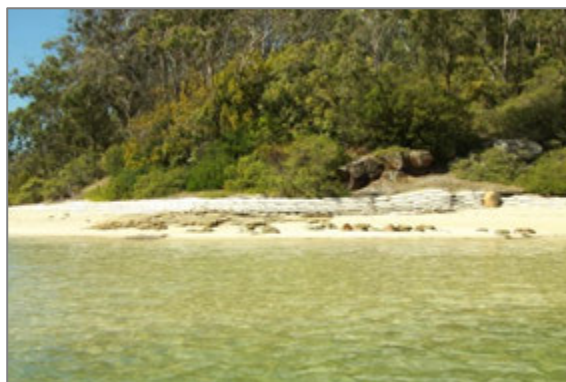
Severs Beach Midden and Protection Works

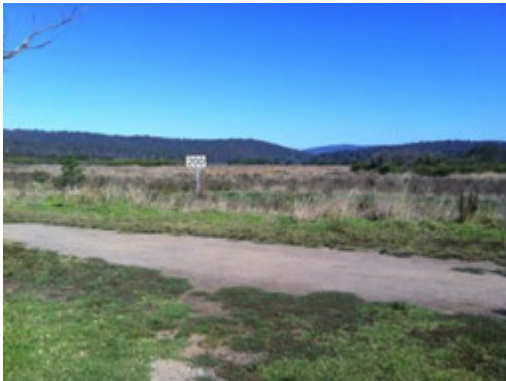
Likely Future Inundation Areas – Old Pambula Racecourse

Use of this predicted inundation line within Council's GIS system will identify the ownership and zonings of lands (both private and public) as per Council's Local Environment Plan, 2013 at both timeframes. It is noted that the 2100 inundation extent is far greater in select areas of the catchment and as such the initial use of the 2050 inundation line may be appropriate to allow staging of acquiring land buffers to allow other land uses to occur in the intervening period.

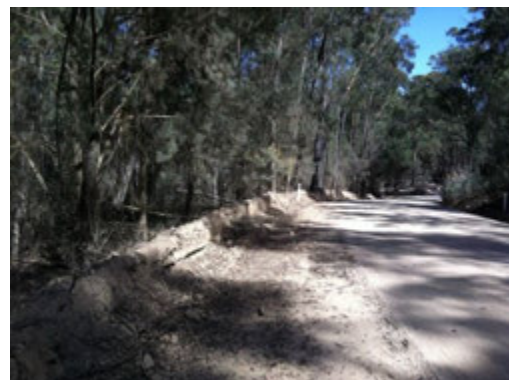
Example of Unsealed Road in Catchment

Undertake rapid catchment appraisal for Pambula Lake catchment based on SRCMA Roads and Track Survey Summary and Volume 2 of the NSW EPA Managing Urban Stormwater – Soils and Construction Guide (2008). This should include consideration of drainage structures, suitable road base materials, minimum grading requirements, design adequacy and compliance. The appraisal will assist in the establishment of road and track management priorities including those relating to permanent sealing.

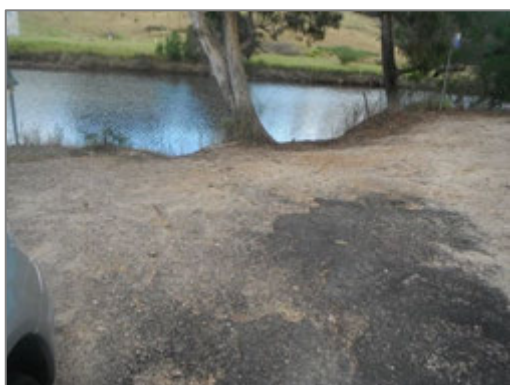
Foreshore Erosion on Yowaka River from shoreline fishing

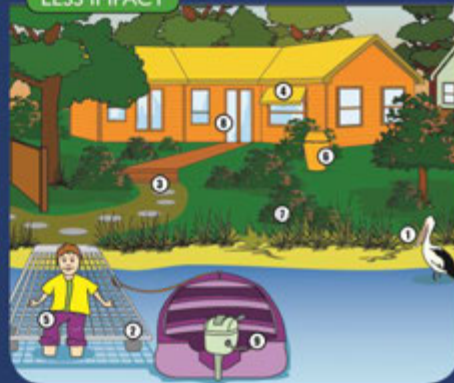
1. Natural sloping shoreline - allows dead sea grass to wash out, improving water quality
2. Small shared jetty with open mesh deck - low impact on "ribbon of life"
3. Stepping stones for footpath - less chance of water runoff and erosion
4. Trimmed trees and adjustable awnings - natural air conditioning with view maintained
5. Work less - relax more
6. Kitchen compost - improves your soil's quality
7. Low maintenance native plants for stabilisation and filtration - provides shoreline buffer
8. Building - set back from shore and in character with setting
9. Well maintained motor - electric or modern 4-stroke outboard, operated with low wake near shore

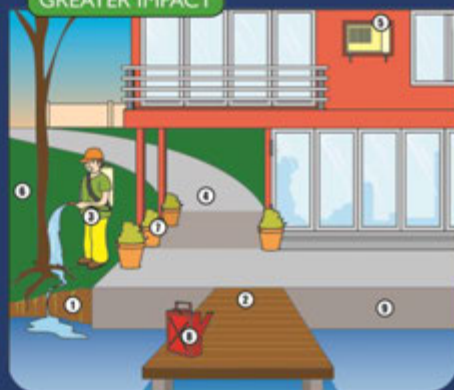
1. Bare shoreline - subject to erosion
2. Solid deck on jetty - affects sealife habitat
3. Fertiliser spills and chemical runoff from lawn damages water quality
4. Paved driveways - pollution-laden runoff flows to water
5. No shade trees - overworked air conditioner adds to your electric bill
6. Removal of natural vegetation - more work for you and more runoff
7. Ornamental shrubs - require chemicals and extra work
8. Poor fuel management - spills are deadly
9. Hardened seawall shoreline - eliminates "natural filter", degrades water quality and causes erosion elsewhere
