Bega & Brogo Rivers FRMSP

APPENDIX

COMMUNITY CONSULTATION

Bega and Brogo Rivers Floodplain Risk Management Study and Plan

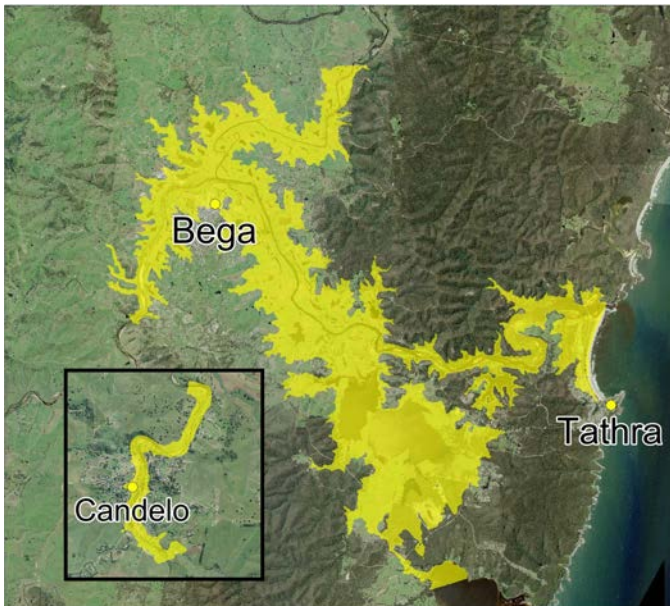
Study area (including Candelo shown in inset) with existing Probable Maximum Flood (PMF) extent, shown in yellow

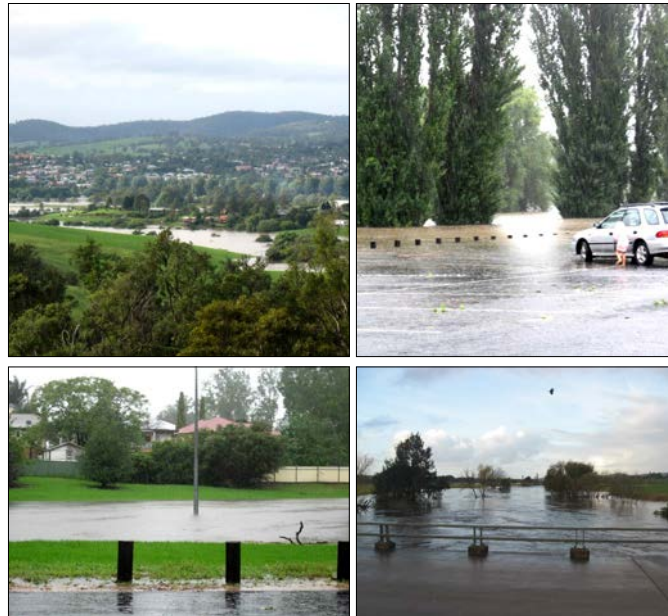
Flooding Around Bega Township February 2010

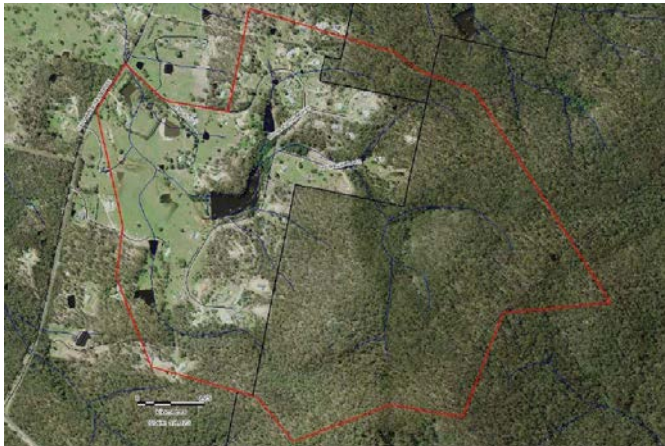
Bournda Parkway Dam Location and Catchment

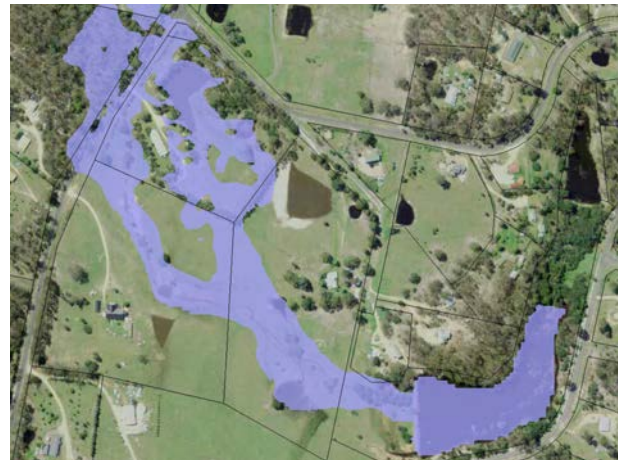
Bournda Parkway Dam Break Flood Extent (Sunny Day)

If the dam wall were to fail during a day with no rainfall then the area impacted downstream would be contained primarily to the natural low point that extends from the dam to Sapphire Coast Drive. No residential properties are impacted by this flooding. Ponding at Sapphire Coast Drive results in some flooding of the road and impacts on the boarding kennels and cattery.

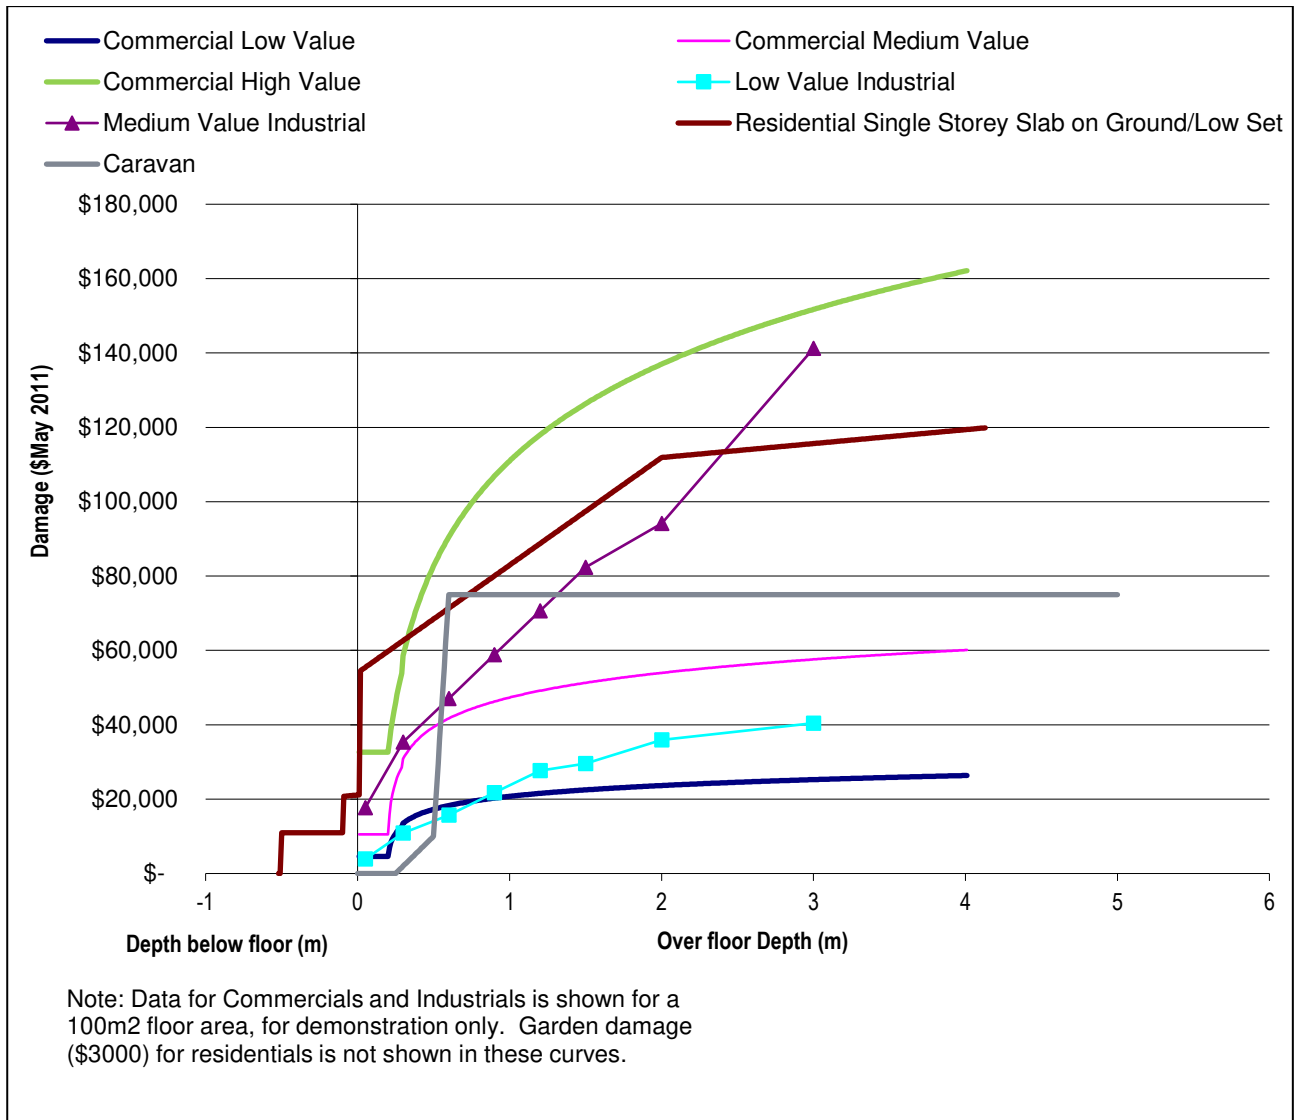
Figure C-2 Adopted Damage Curves

(Damage data sourced from FLDamage, and plotted for a 100 m² property. Refer **Section C.1** and **Section C.2** for further details)

The adopted damage curves are shown in **Figure C-1**. For purposes of illustration, the residential and commercial damage curves are shown for a property with a floor area of 150m², although the size will be individually determined for each residential and commercial property when calculating catchment damages.
