Review of Environmental Factors

QUARANTINE BAY BOAT RAMP UPGRADE

AUGUST 2019

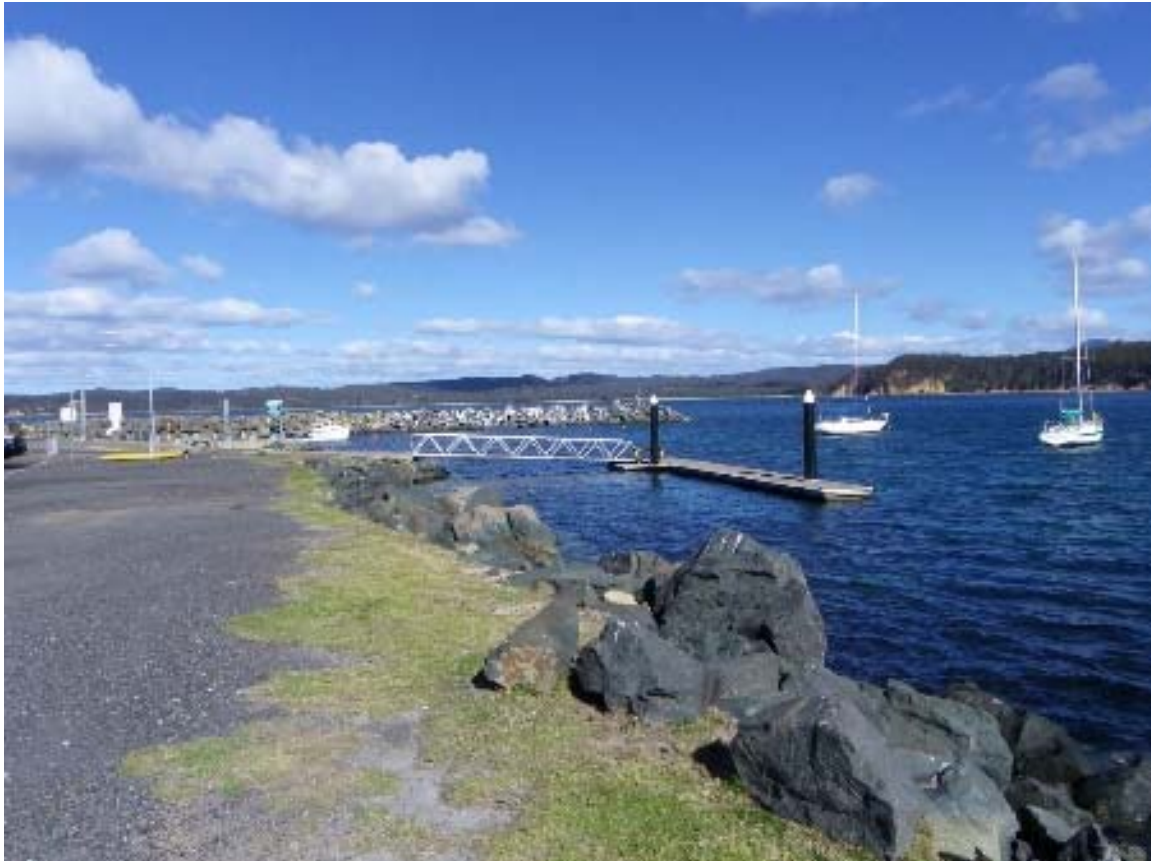
Figure 2-1 Existing finger pontoon jetty at Quarantine Bay.

Quarantine Bay, Eden currently has a stepped timber jetty that has reached the end of its useful life as a mooring location. Pending further investigation to confirm structural integrity there is potential to decrease the size of the jetty to create a recreational fishing platform; hence the works definition identifying either partial or complete demolition of the structure. The existing finger pontoon jetty has been identified as being heavily used and requires upgrades to provide adequate capacity. The existing Quarantine Bay facilities can be seen in Figure 2-1, and Figure 2-3.

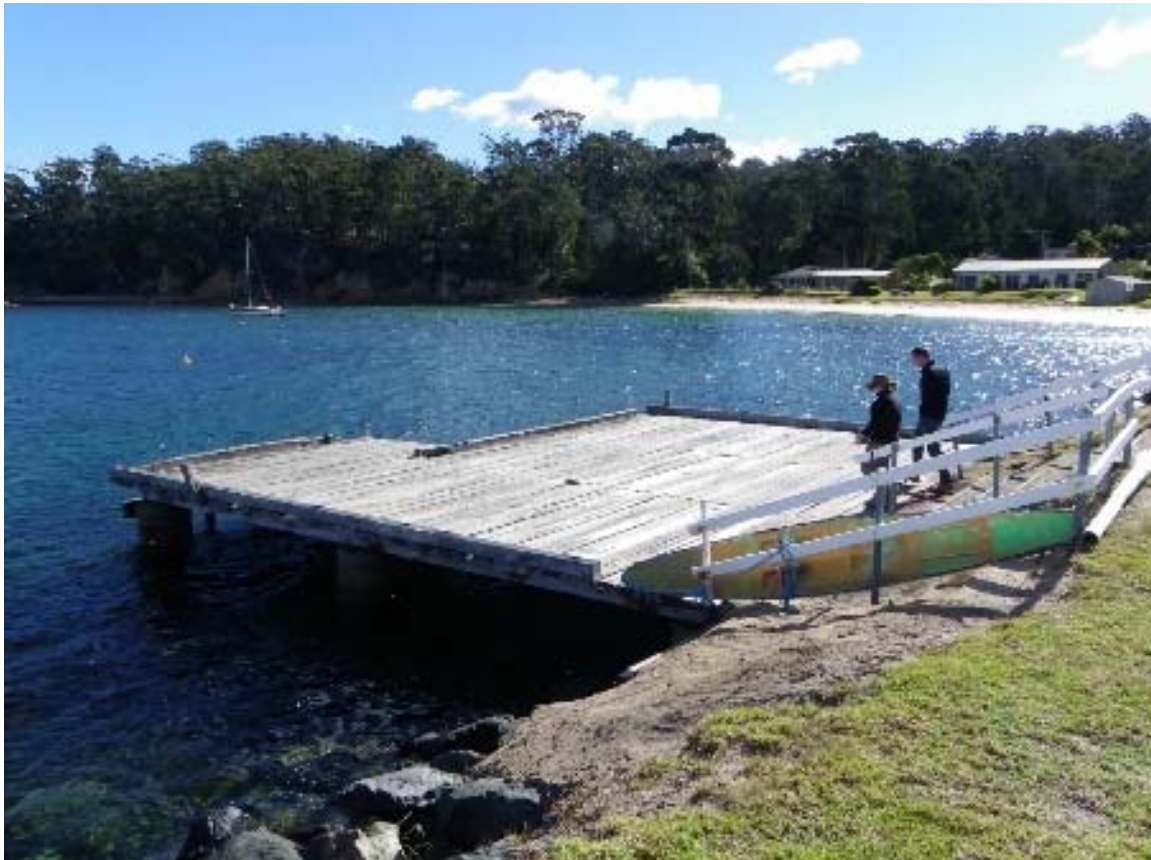
Figure 2-2 Existing stepped timber jetty at Quarantine Bay.

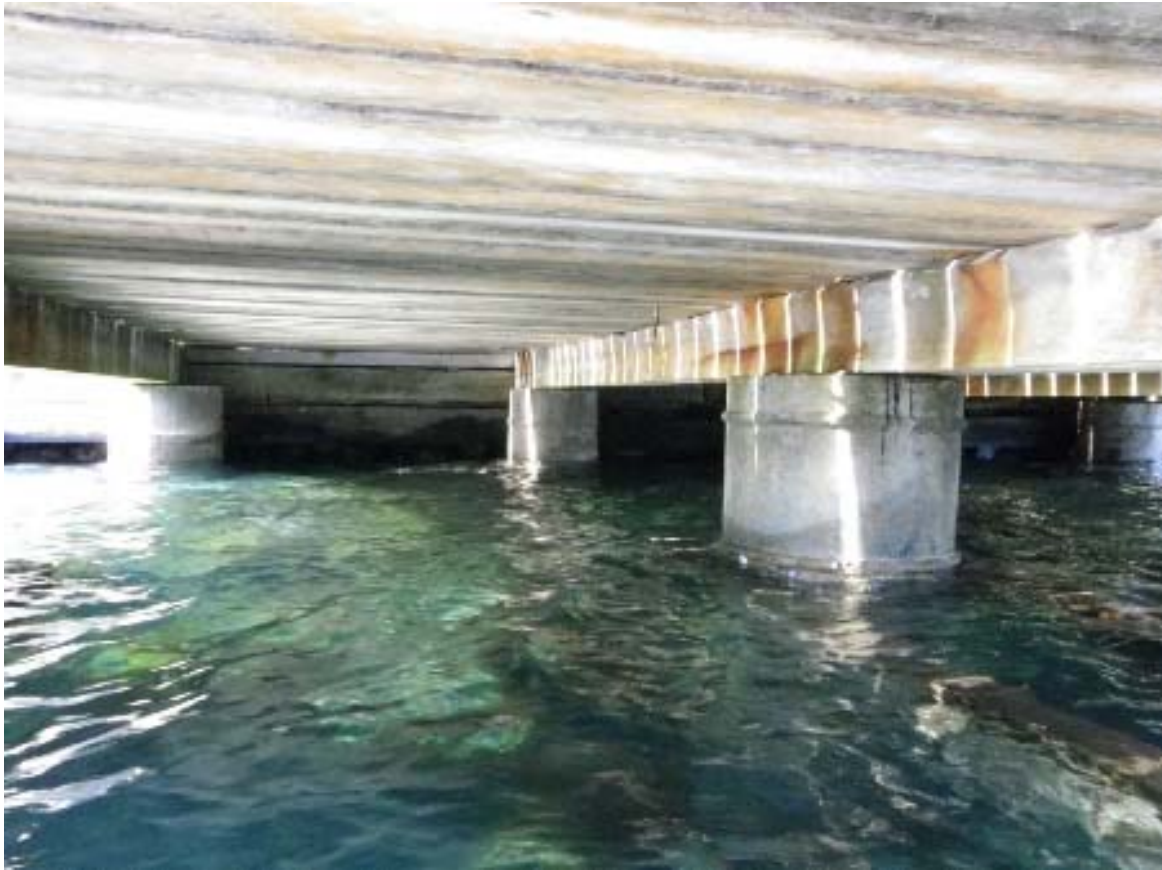
Figure 2-3 Existing stepped timber jetty at Quarantine Bay.

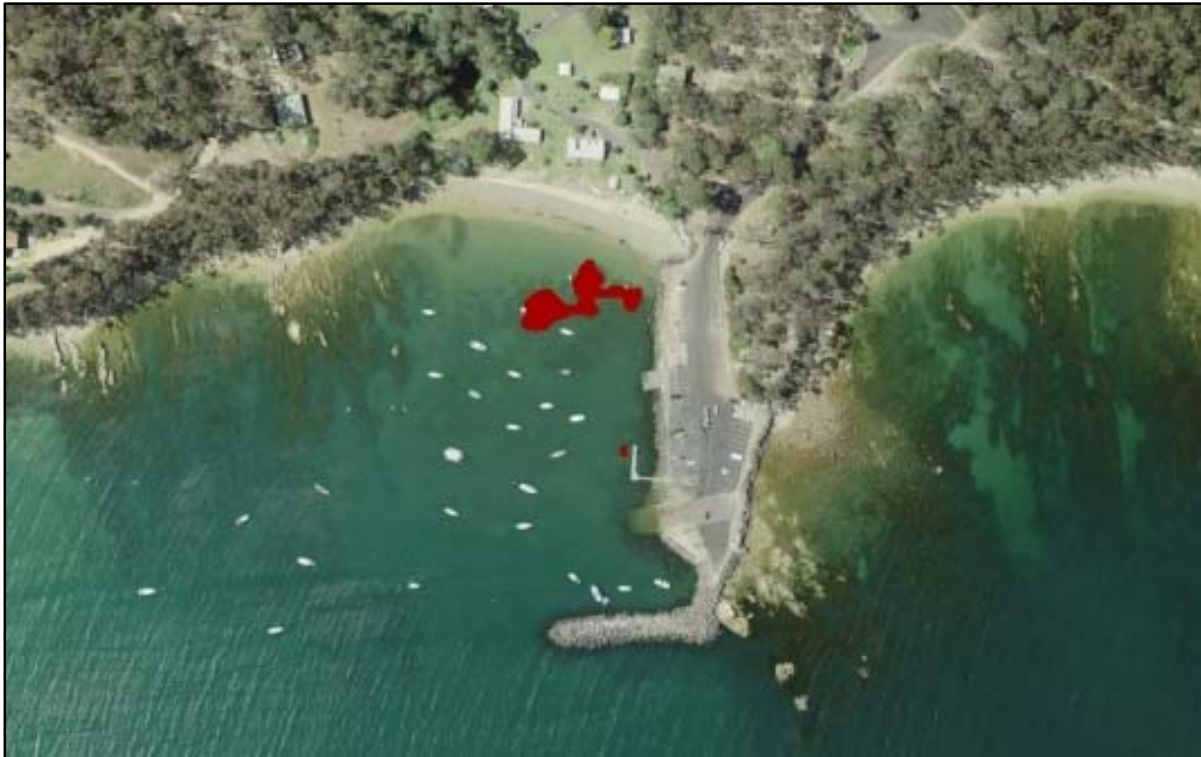
Figure 5-1 Distribution of mapped seaweed in relation to works area.

Patches of Seaweed (macroalgae) were identified growing on the existing pontoon and rocks forming the artificial break wall. The NSW DPI Fisheries Spatial Data was accessed to review the extent of mapped estuarine macroalgae within the locality of the works area (DPI, 2018b). DPI mapping shows the existing pontoon to lie adjacent the edge of a small patch of mapped estuarine macroalgae (*Posidonia* sp.) but not within it, with a larger patch further east of the works area (Figure 5-1).

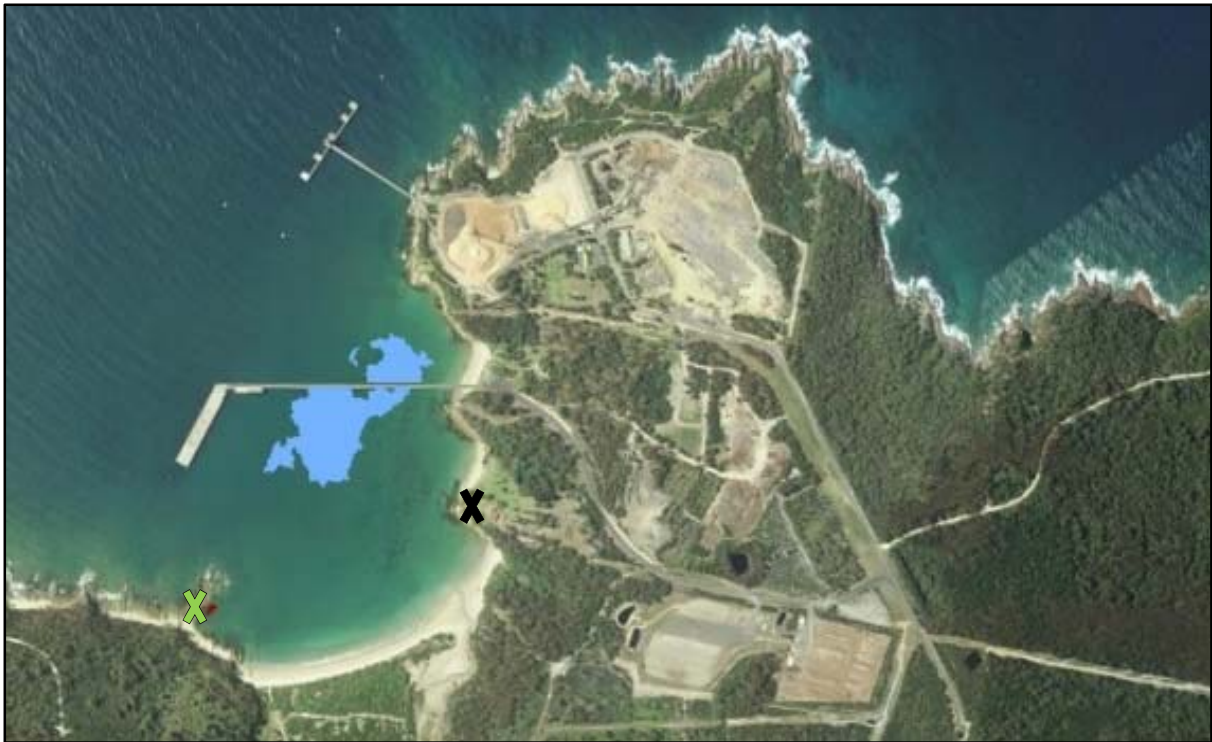
Figure 5-2 Distribution of mapped seagrass in relation to site (green X) and Edrom Lodge (black X) at the south end of Twofold Bay.

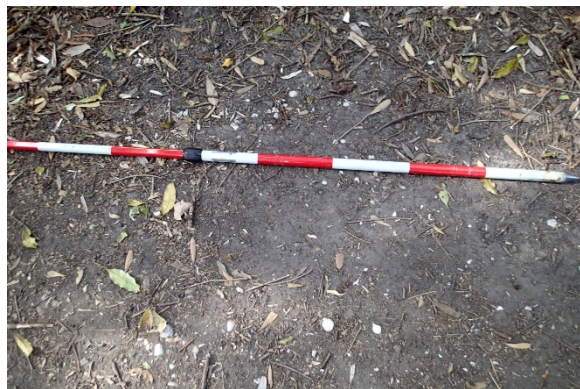
Plate 13. Close up view of midden material eroding from track at Murunna Walking Track Midden 1.

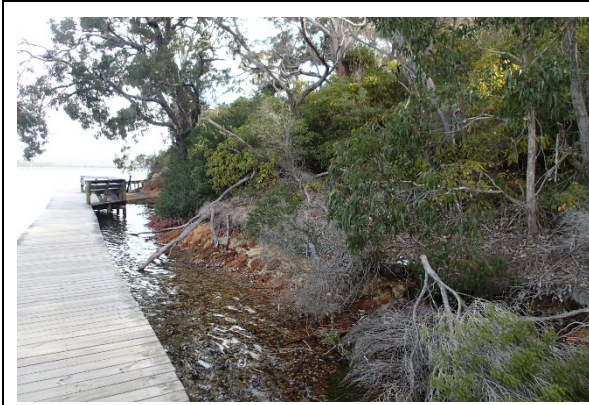
Plate 25. View south west showing shell midden material eroding from the lake shore. This is part of the previously recorded site #62-6-0097.

Shell material was noted eroding from the shore at a minor headland in the lake where the wooden boardwalk across the water meets the land and changes to a concrete pathway (Plate 26). The shell was eroding from the flat above exposed bedrock. The nearest recorded site is Merimbula Heights Estate 8 (#62-6-0135) about 90 m from the exposure of shell observed. However, after checking the site card and the associated map it is clear that the original recording of the site comprised a number of separate shell midden concentrations, including the area observed during this survey. It is concluded therefore that the shell midden material observed is covered by the AHIP.

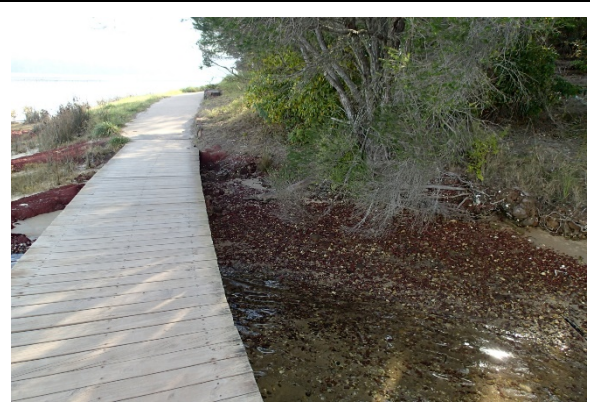
Plate 26. View west showing shell midden material eroding from the lake shore. This is part of the previously recorded site #62-6-0135.

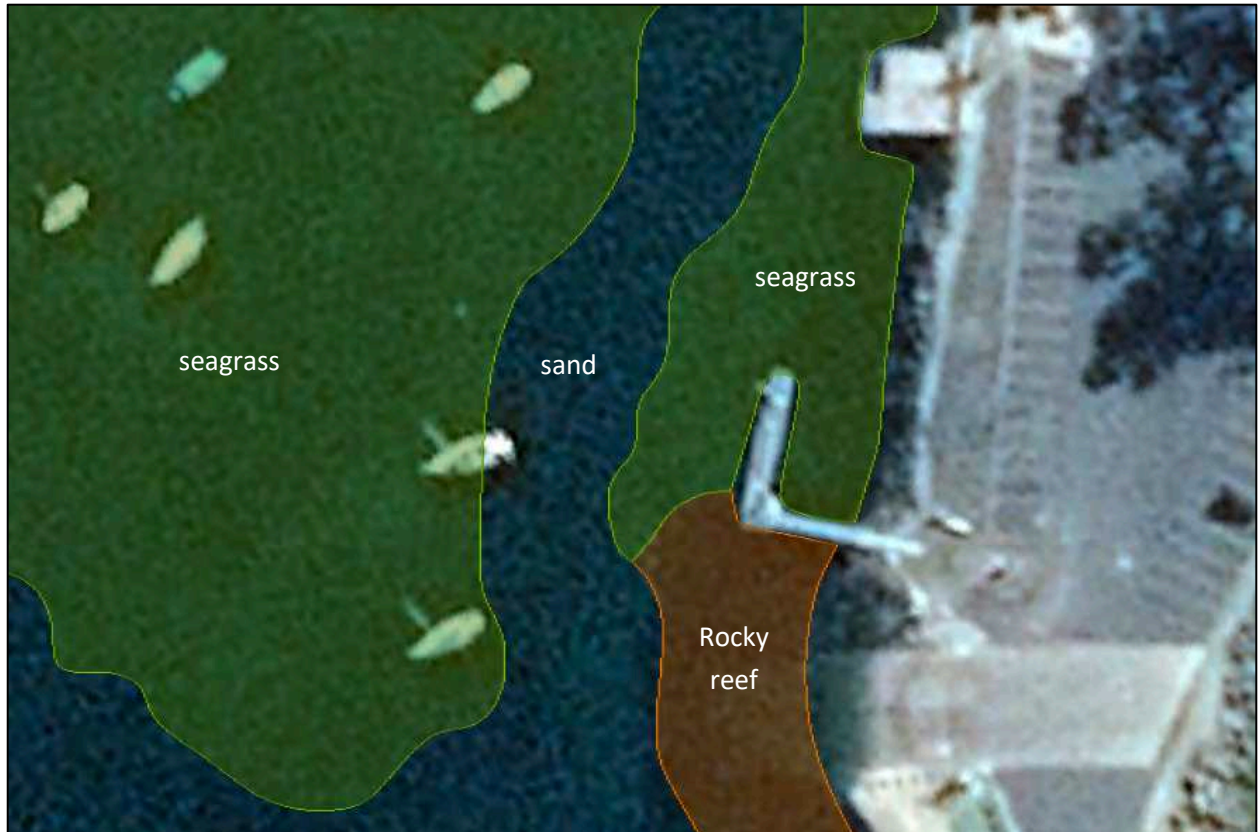
Figure 2. Existing seabed mapping of Quarantine Bay, Eden (data from NSW coastal nearshore reef extent 2017).

A review of the existing seabed mapping dataset, coastal nearshore reef extent 2017, for Quarantine Bay indicates that the immediate area surrounding the pontoon to be seagrass with rocky reef occurring between the concrete ramp and pontoon (**Figure 2**).

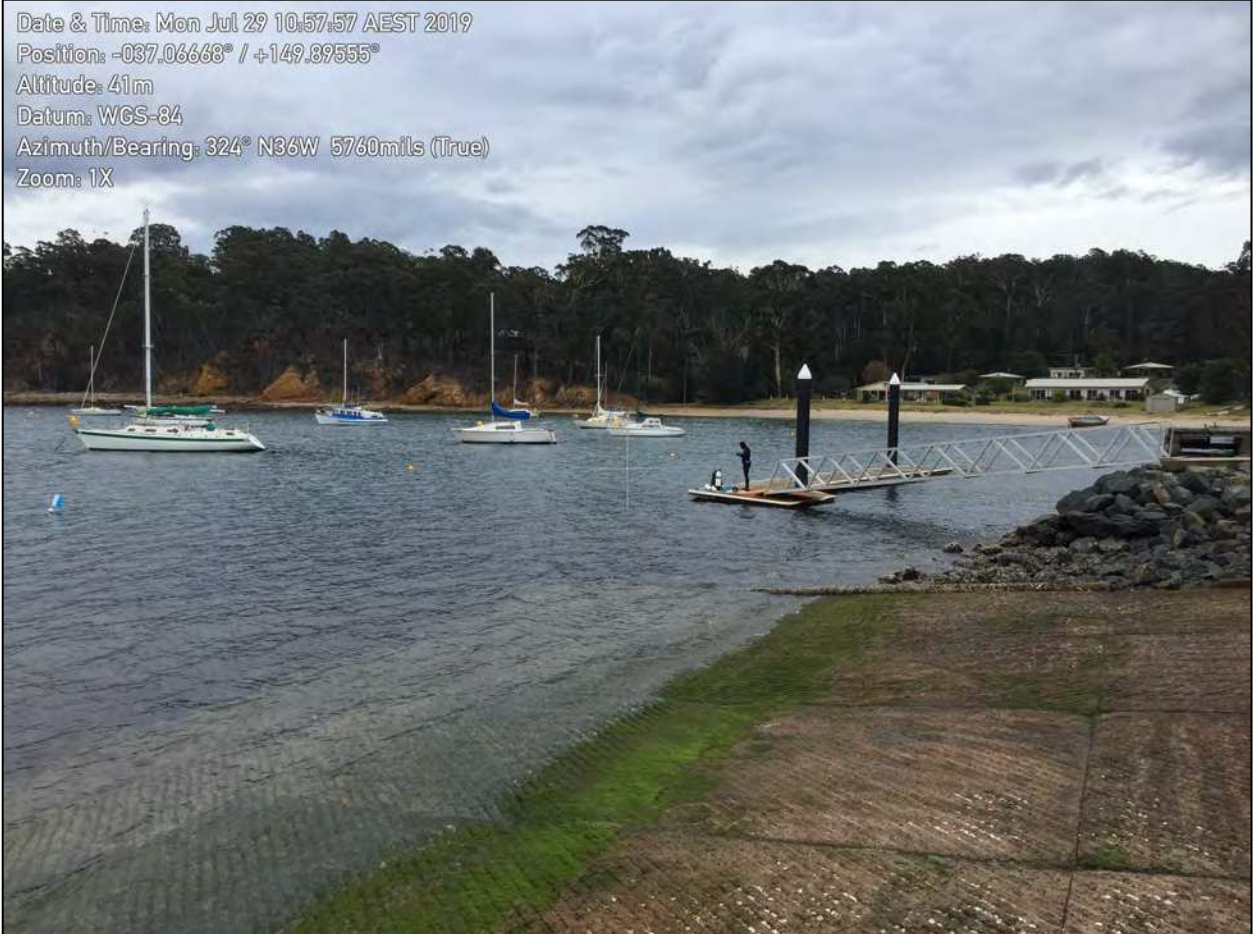
Figure 3. Site survey area established with marker buoys placed approximately 30m from shoreline.

Field survey work was conducted on 29 July 2019. A survey area was established around the development footprint by placing a dive-flag buoy and two yellow marker buoys at approximately 30m from the shoreline (**Figure 3**). Inspection surveys were undertaken by ADAS commercial diver on SCUBA towing a dive-flag with GPS being supervised by standby diver from the shoreline.

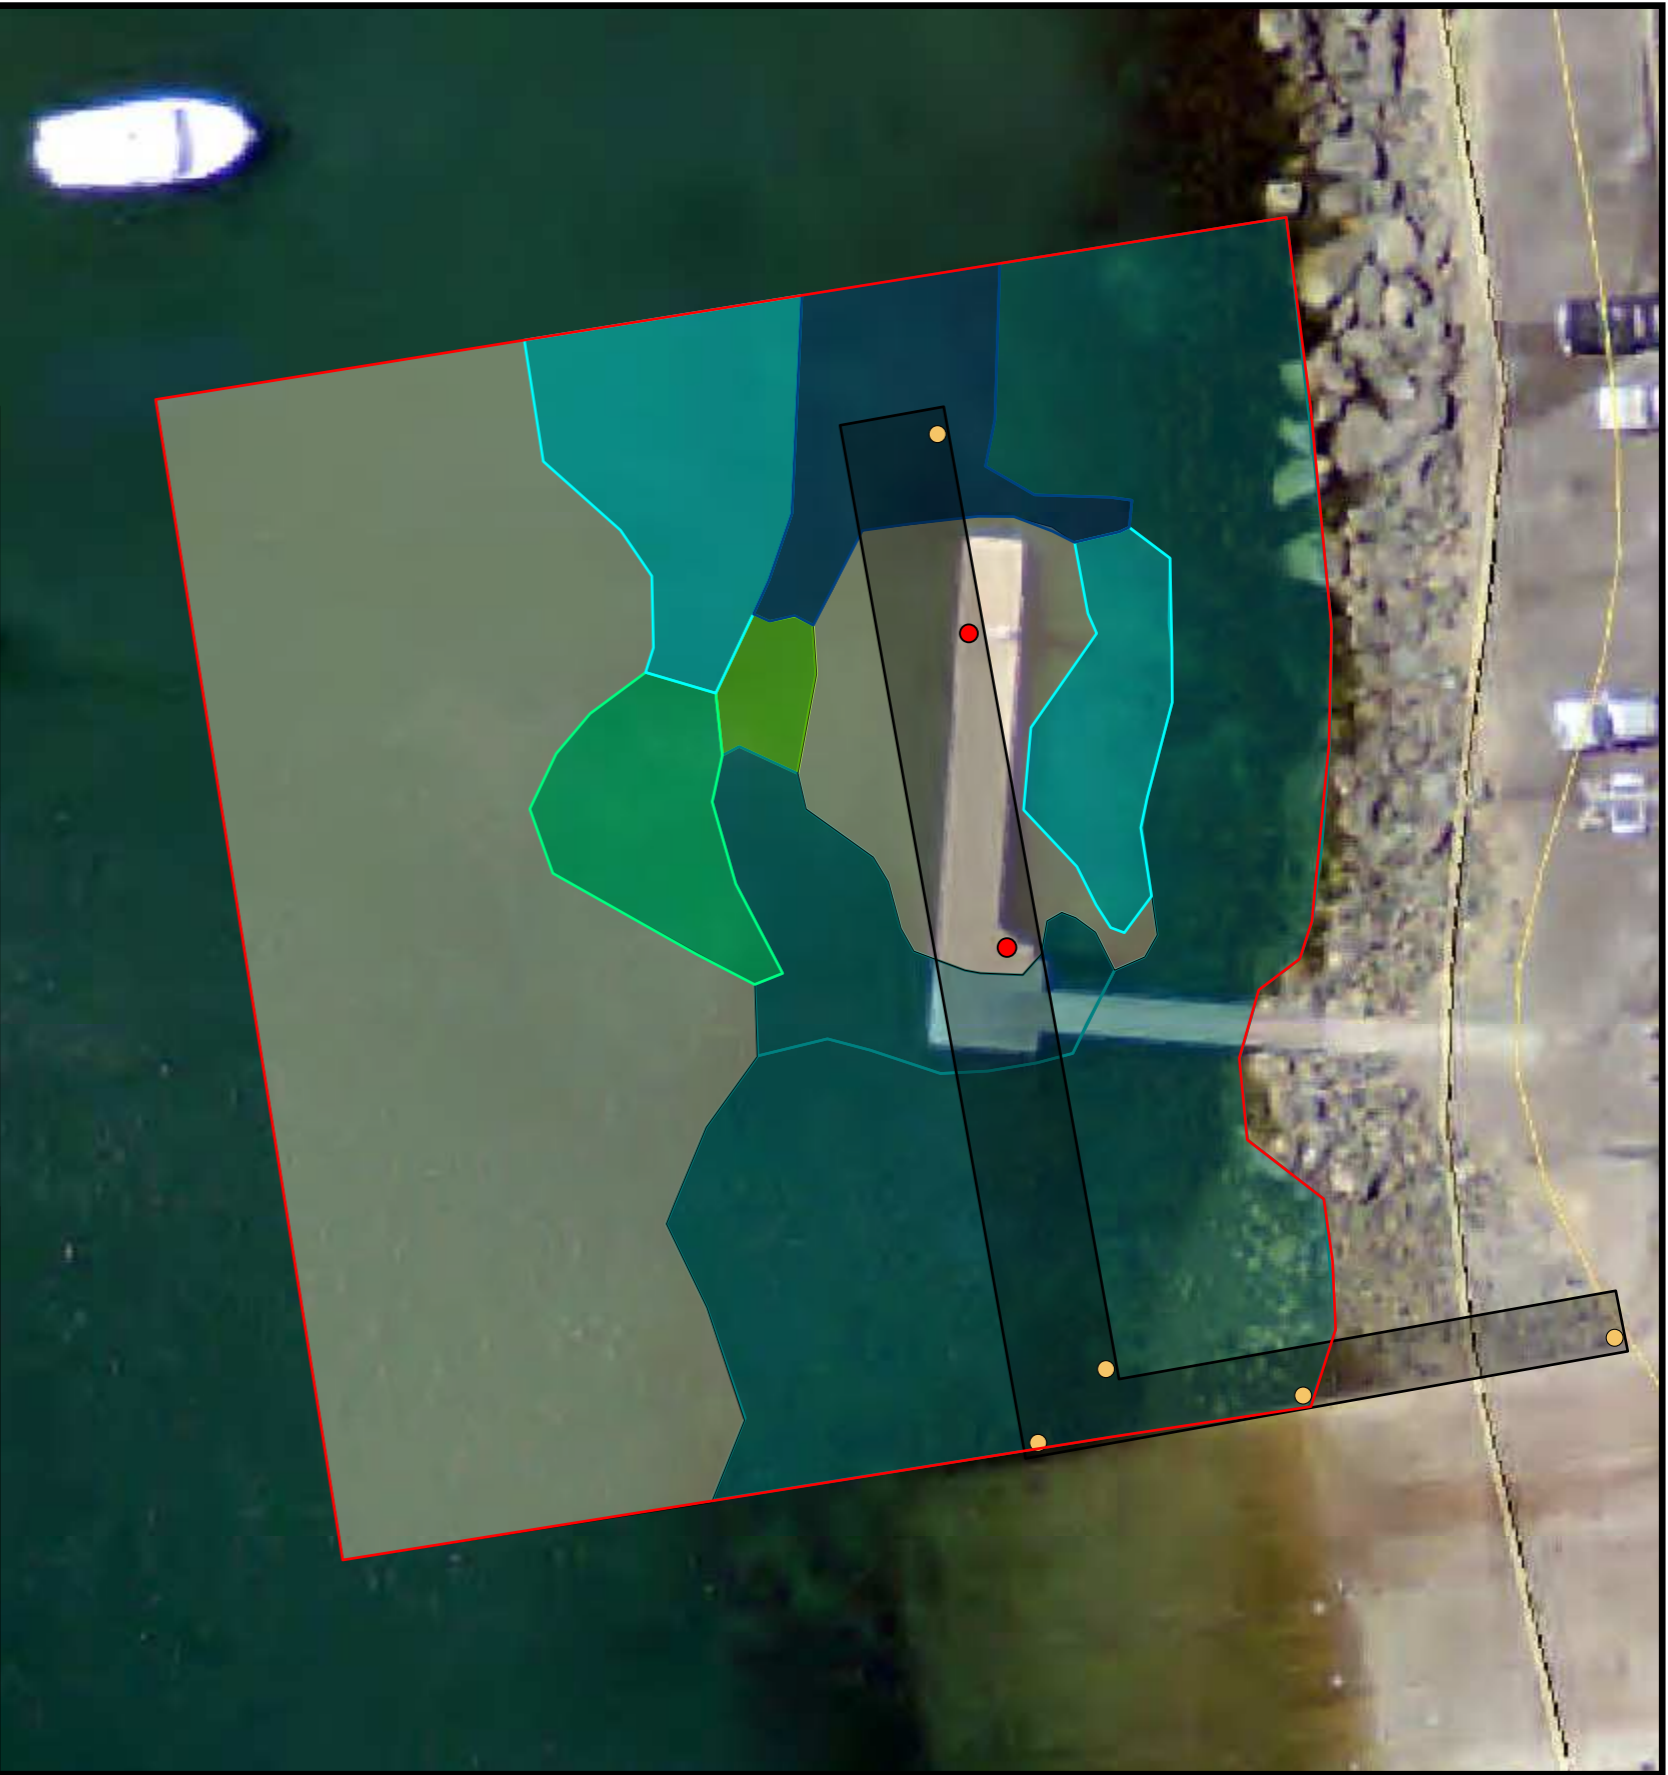
Client: Bega Valley Shire Council	Project: Quarantine Bay Boat Ramp Upgrade	Title: Sub-tidal habitat distribution and habitat types

Summary of habitats affected the upgrade of Quarantine Bay boat ramp

Habitat Type	Key Fish Habitat Type	Estimated Area (m ²) below new floating pontoon	Estimated Area (m ²) below new gangway
sand	Type 3	68	0
rock, rubble, macroalgae	Type 2	62	23
rock, rubble, macroalgae, patchy <i>Posidonia</i>	Type 2	14	0
