G512
Towamba
2011 Calibration

G513
Towamba
1978 Calibration

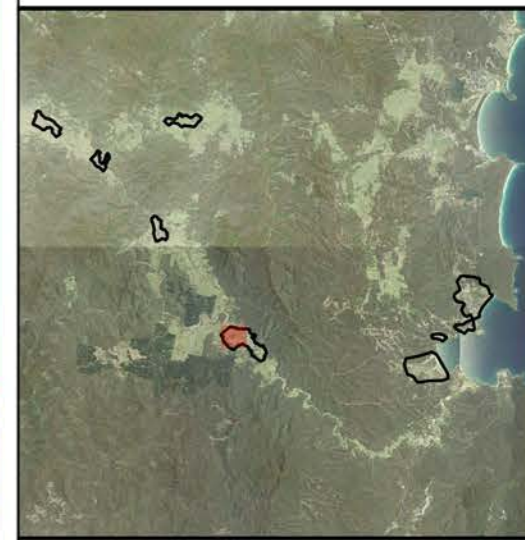
Community observed flood reached approximately the 40 mAHD contour (extent indicated on map at community drop in workshop)

Survey: 38.64 mAHD
Model: 38.54 mAHD
Difference: -0.1m

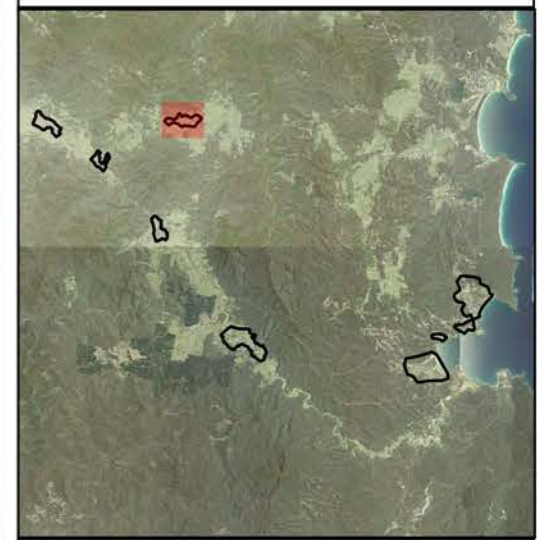
G516-a
Wyndham
ARR87 Differences

Difference (m)
ARR2016 less ARR87

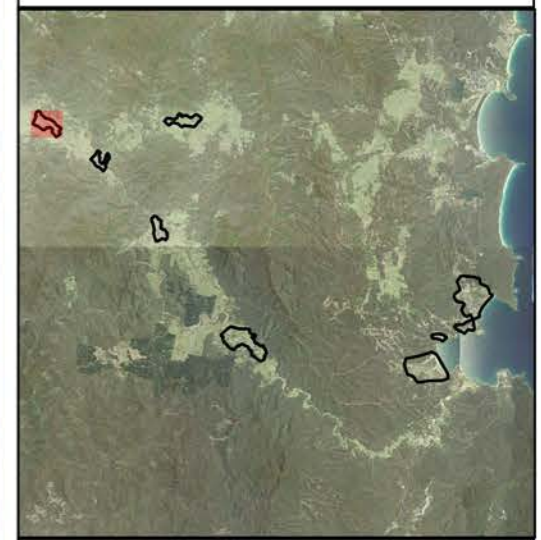
G516-b
Rocky Hall
ARR87 Differences

- Model Area
- Difference (m)
ARR2016 less ARR87
- ≤ -1
- $-1 - -0.5$
- $-0.5 - -0.25$
- $-0.25 - -0.01$
- $-0.01 - 0.01$
- $0.01 - 0.25$
- $0.25 - 0.5$
- $0.5 - 1$
- > 1

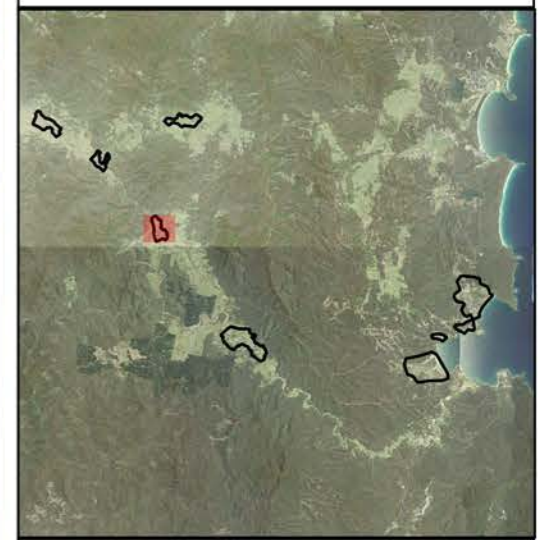
G516-d
Burragate
ARR87 Differences

Difference (m)
ARR2016 less ARR87

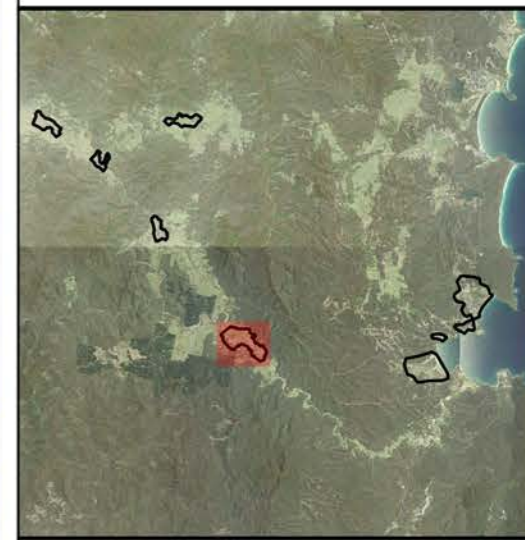
G516-e
Towamba
ARR87 Differences

Difference (m)
ARR2016 less ARR87

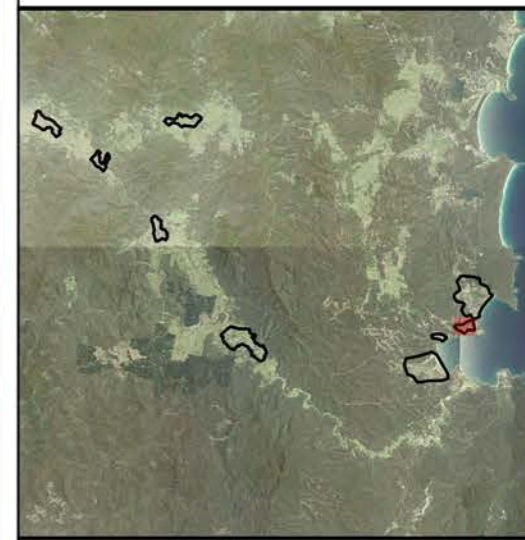
G516-g
Eden - South
ARR87 Differences

Difference (m)
ARR2016 less ARR87

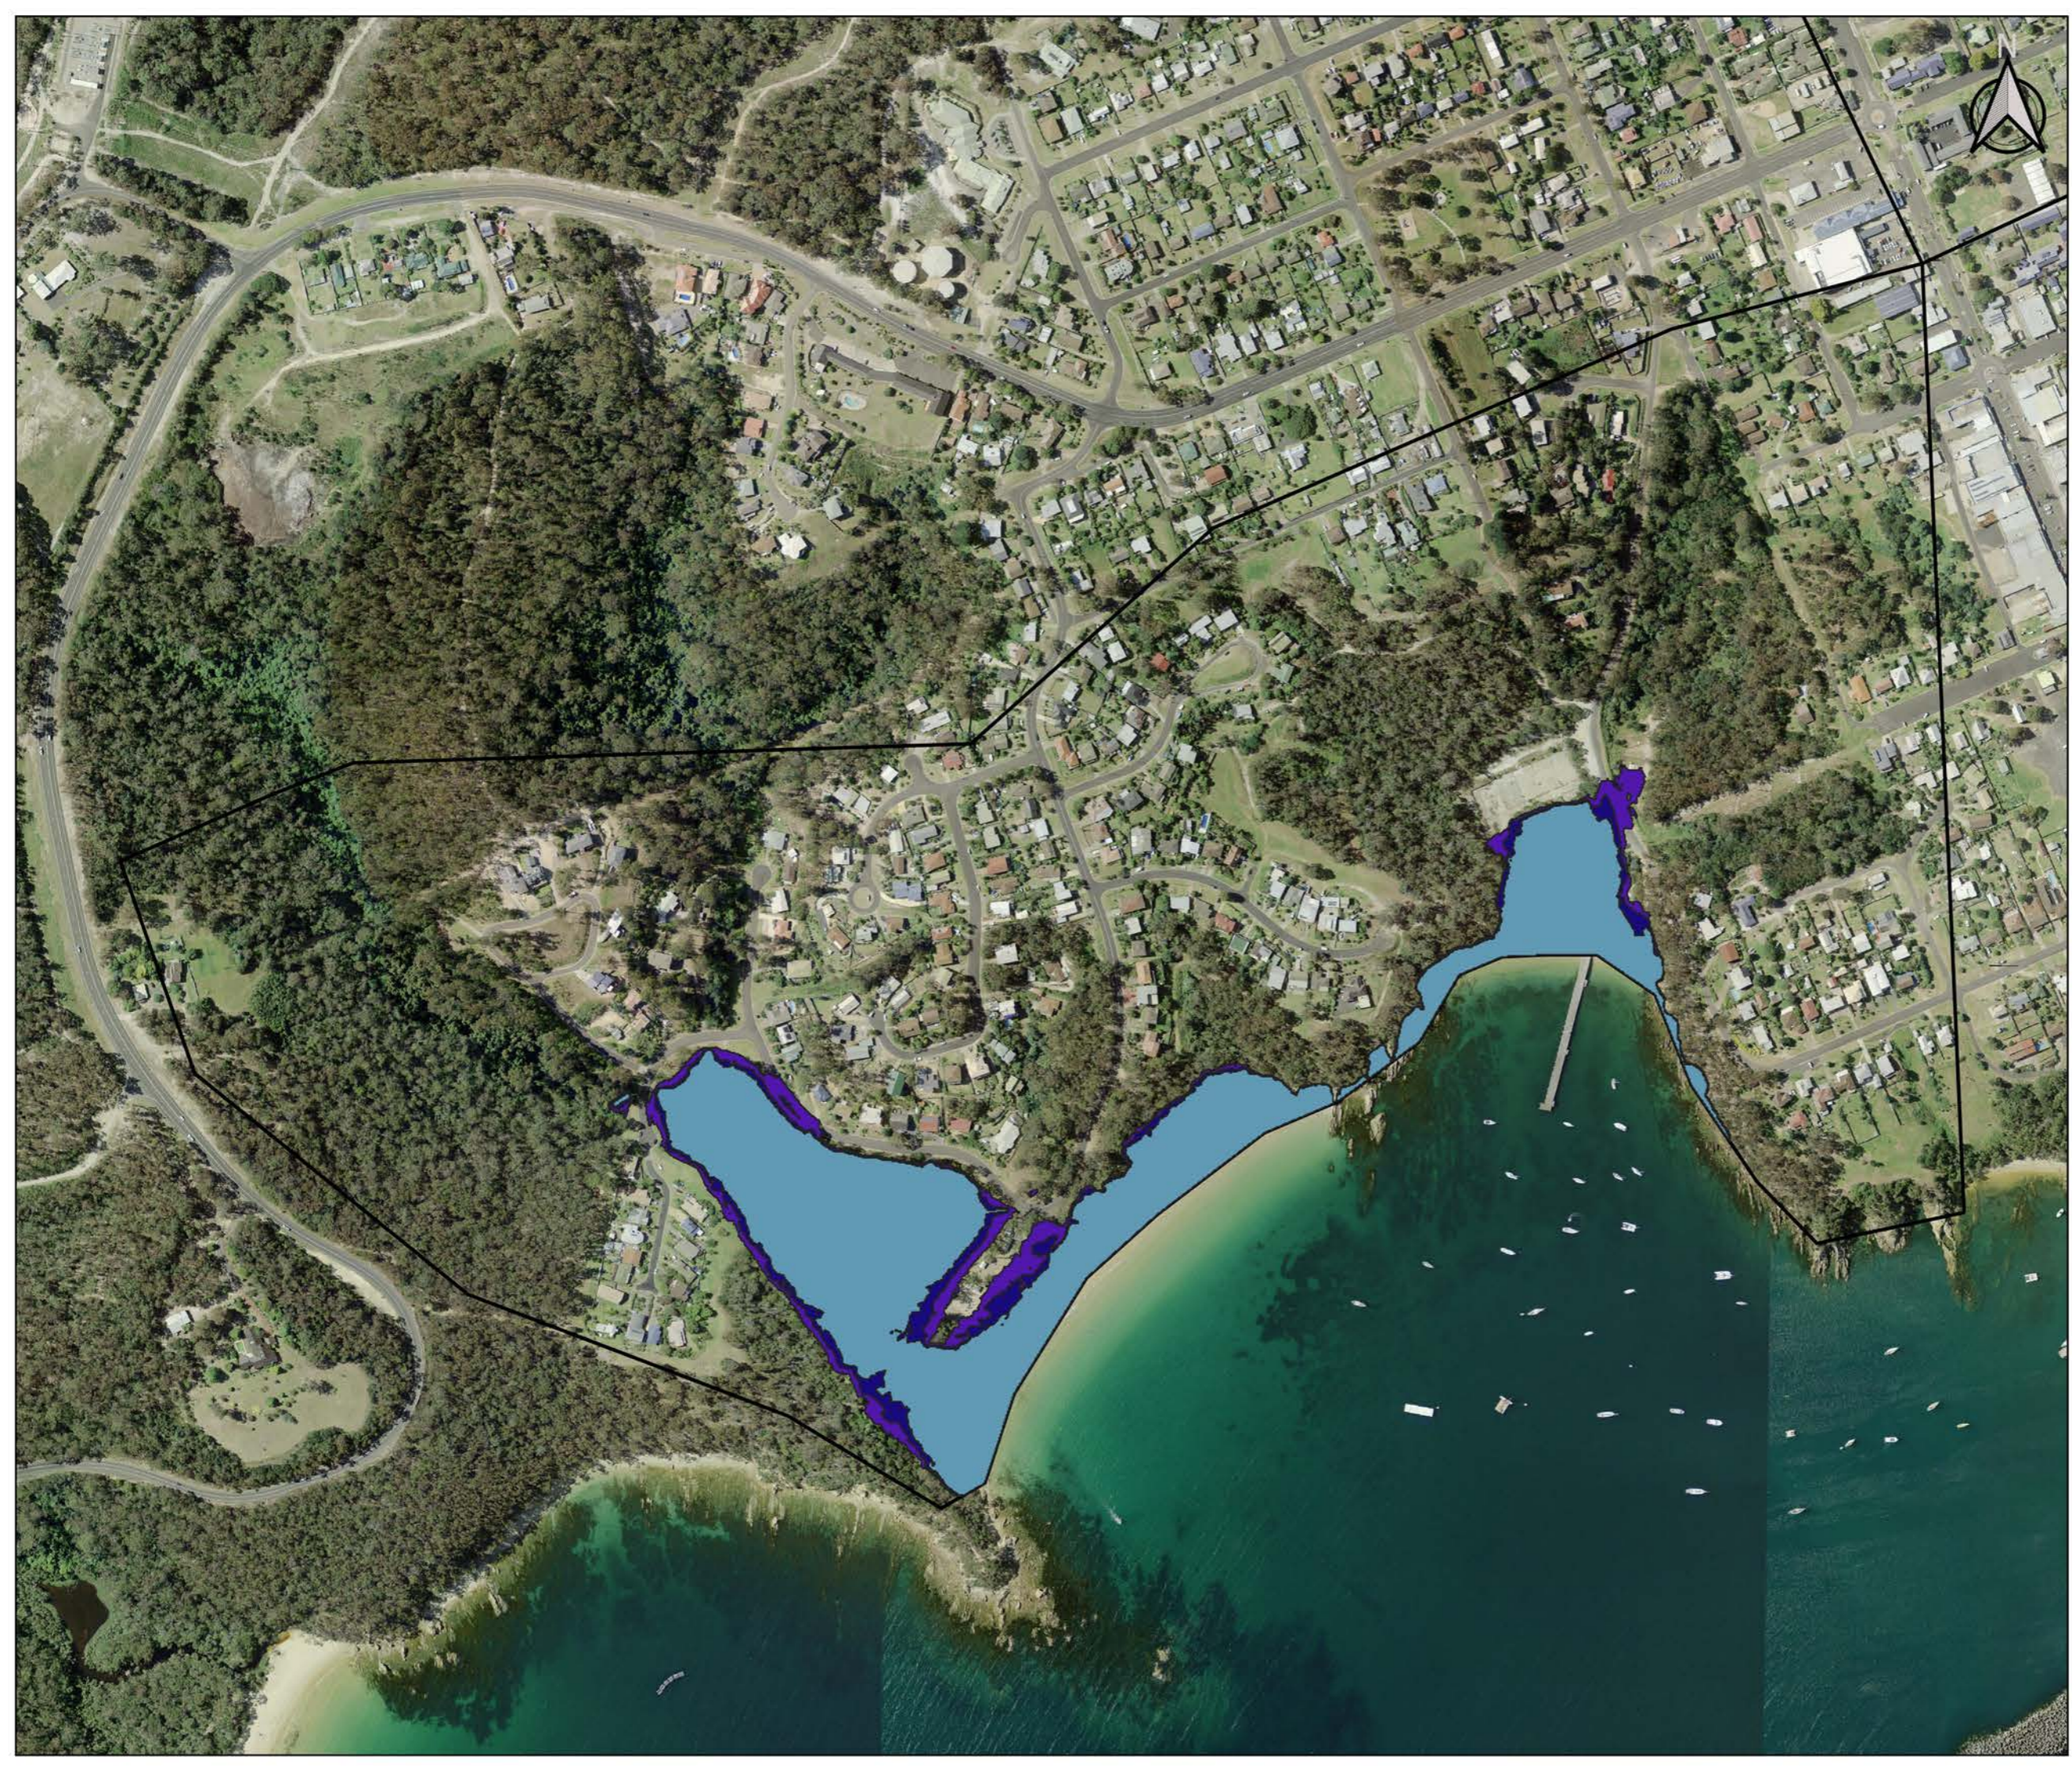
G517-g
Eden - South
Sea Level Rise Impacts

-   Model Area
-   Existing Extent
-   0.4m SLR Extent
-   0.9m SLR Extent

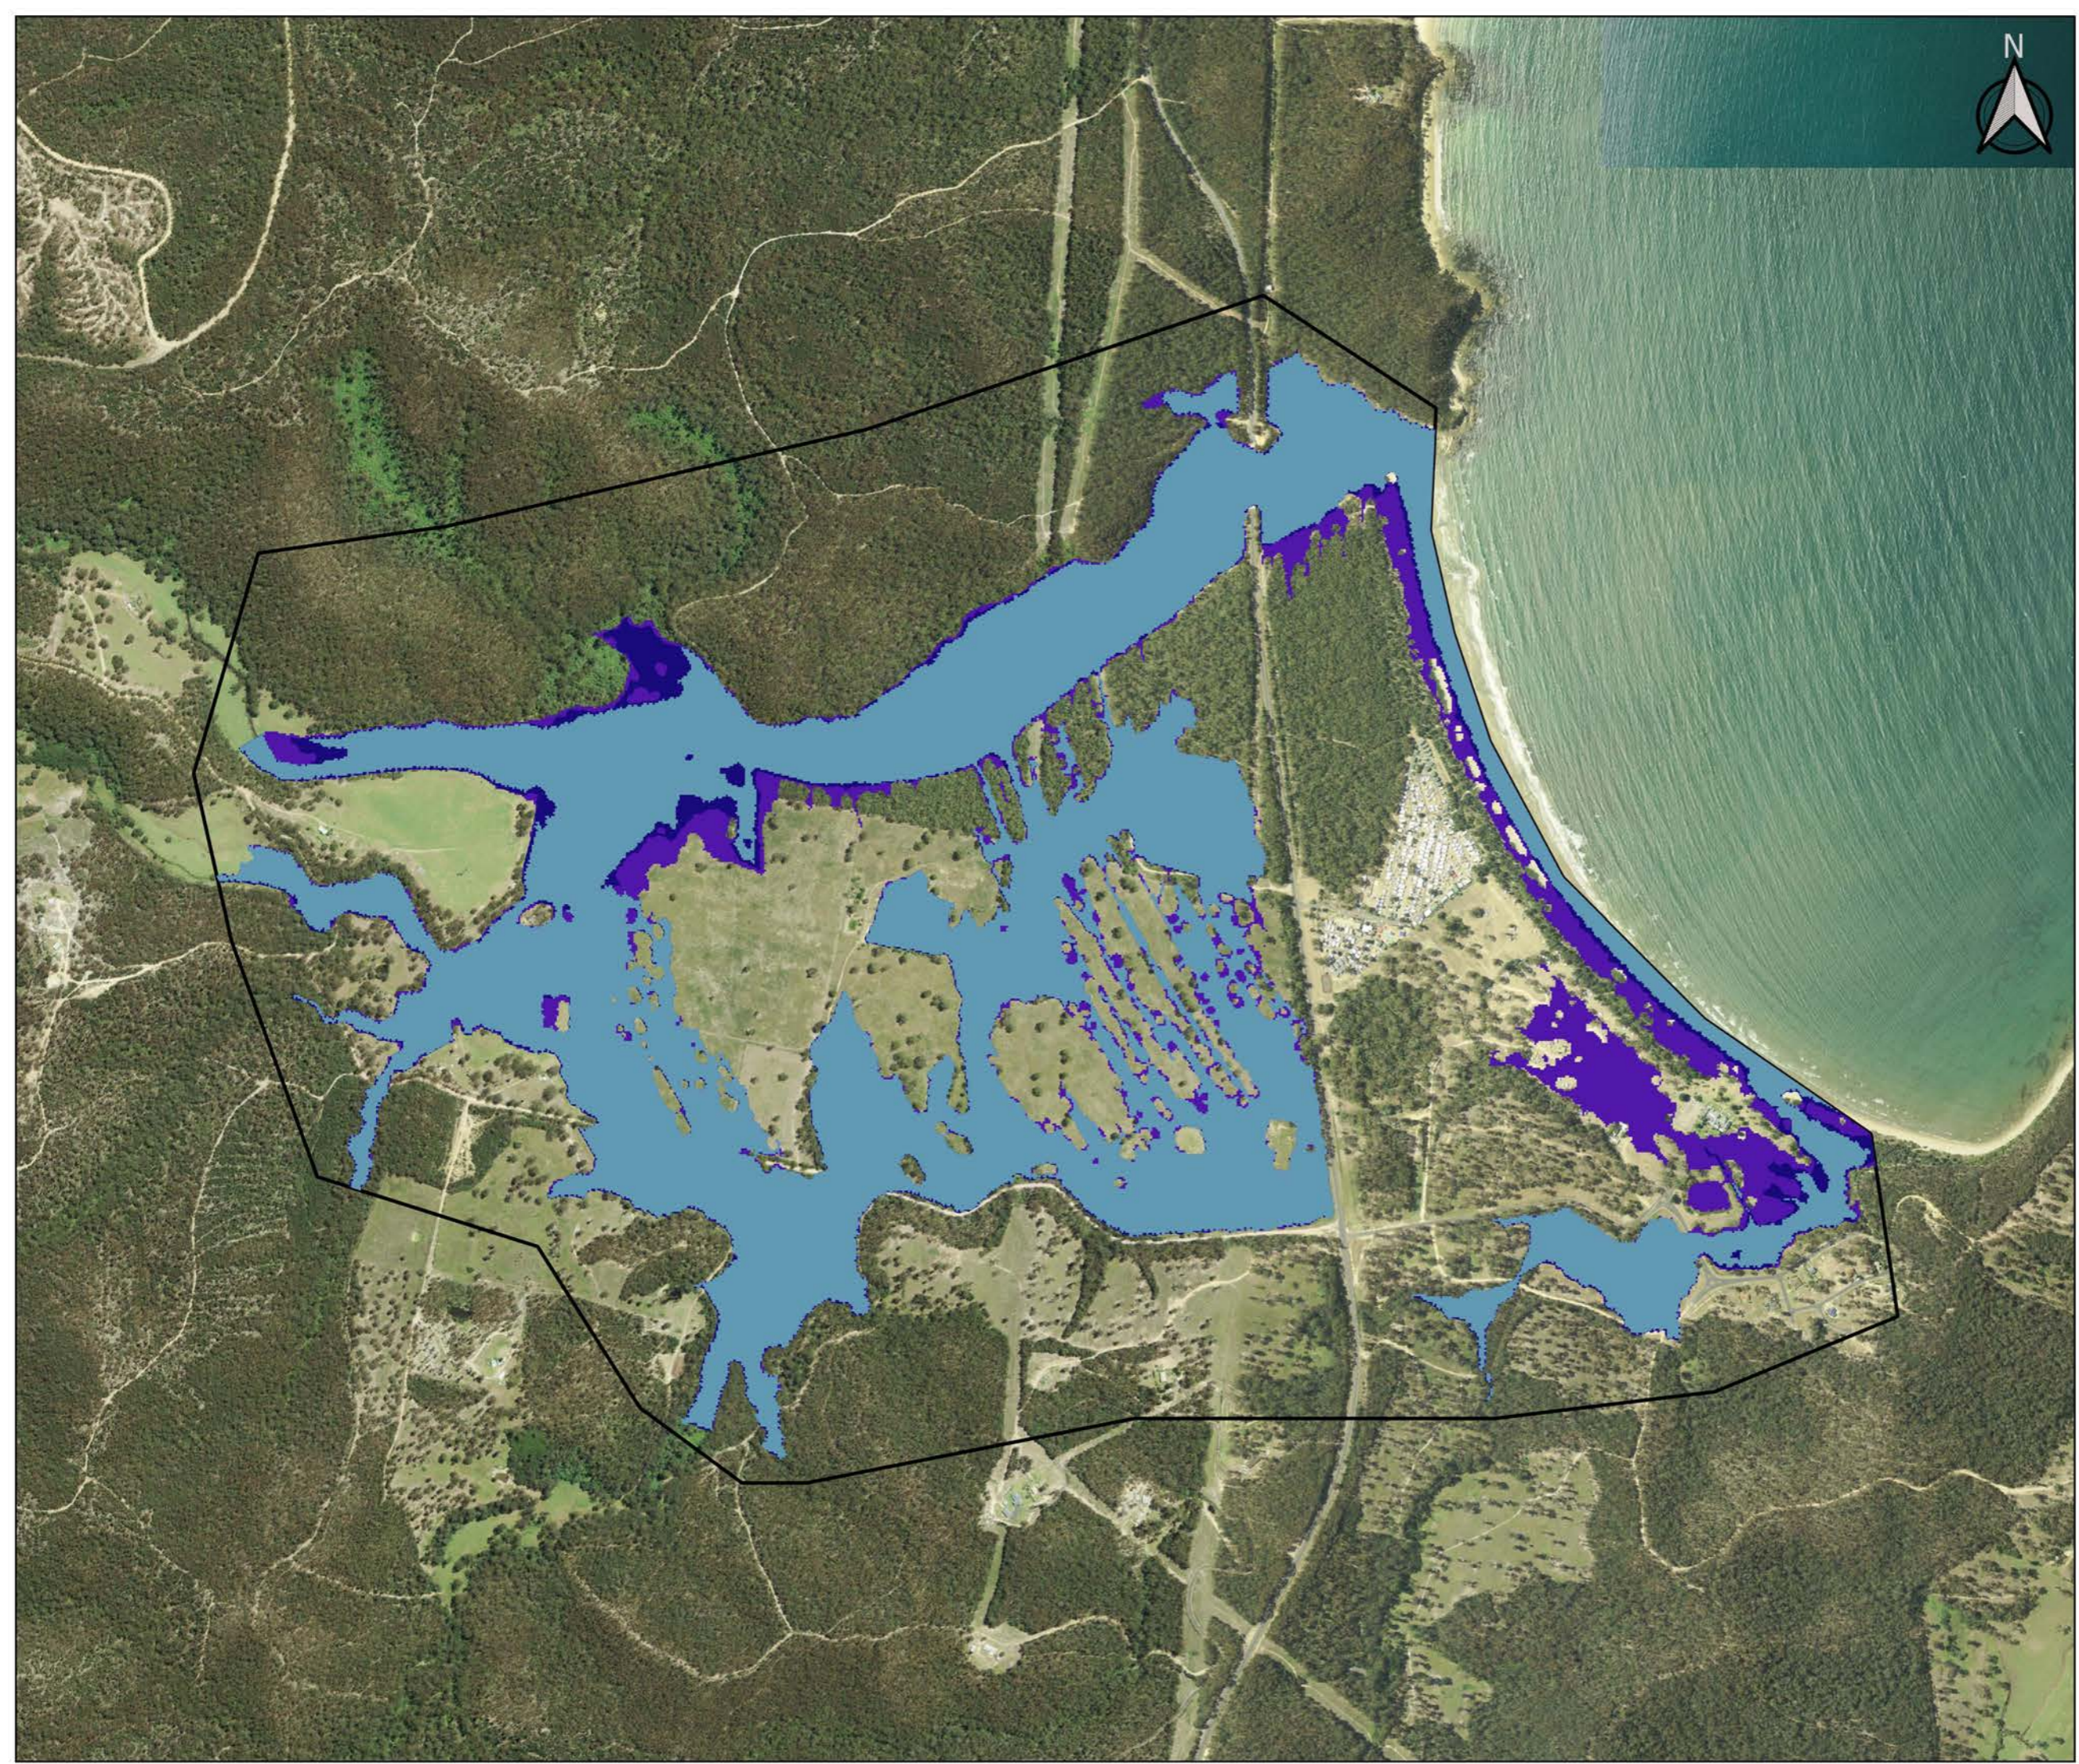
G517-i
Nullica / Boydton
Sea Level Rise Impacts

-   Model Area
-   Existing Extent
-   0.4m SLR Extent
-   0.9m SLR Extent
