# Review of Environmental Factors

## BERMAGUI RIVER BOAT RAMP AND BRUCE STEER POOL UPGRADE

Project Title: Bermagui River Boat Ramp and Bruce Steer Pool Upgrade

Project Number: 18-328

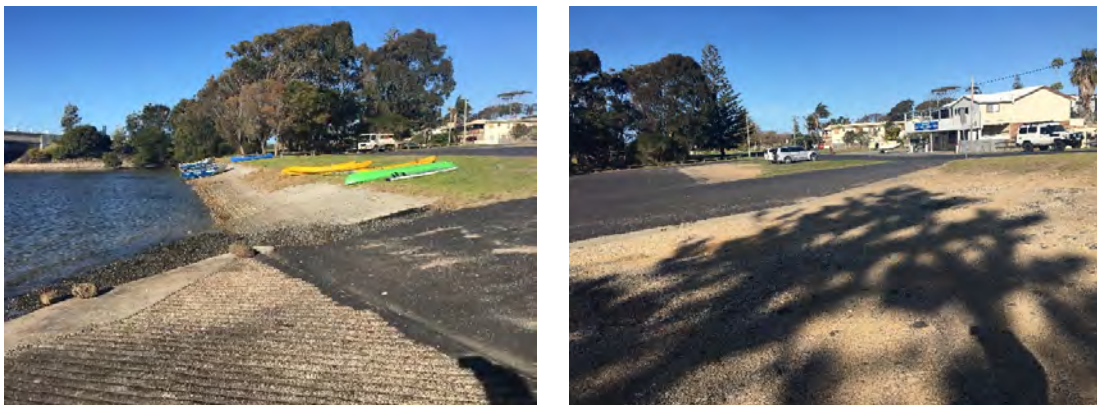
Figure 2-1 Existing infrastructure and facilities at the Bermagui River boat ramp precinct.

The Bermagui River Boat Ramp precinct currently includes a boat ramp, sealed access, unsealed and sealed carparking and grassed areas. The existing infrastructure and facilities can be seen in Figure 2-1.

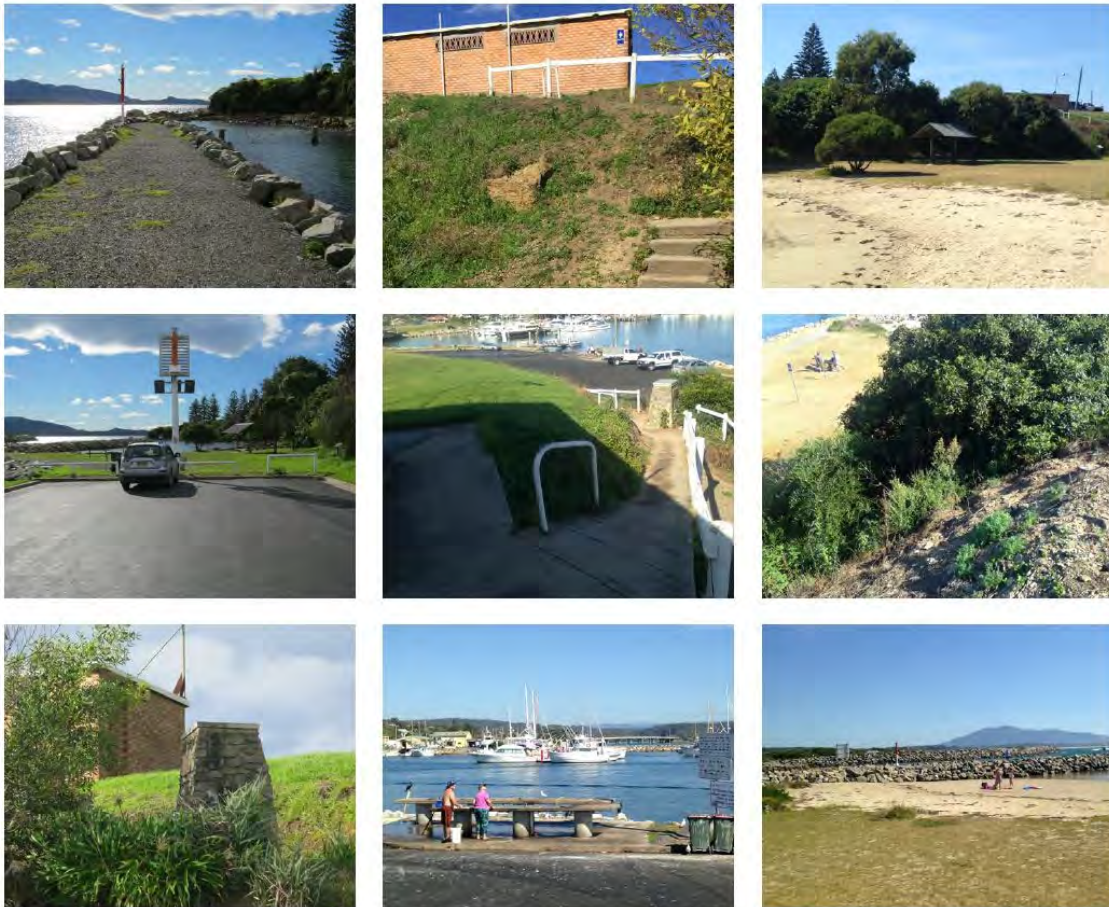
Figure 2-2 Existing infrastructure and facilities at the Bruce Steer pool precinct (Spirre, 2016).

The Bruce Steer pool precinct contains an existing boat ramp, jetty, sealed carpark, beach access, grassed areas and rocky groyne, navigational beacon and cairn. The existing infrastructure and facilities can be seen in Figure 2-2.

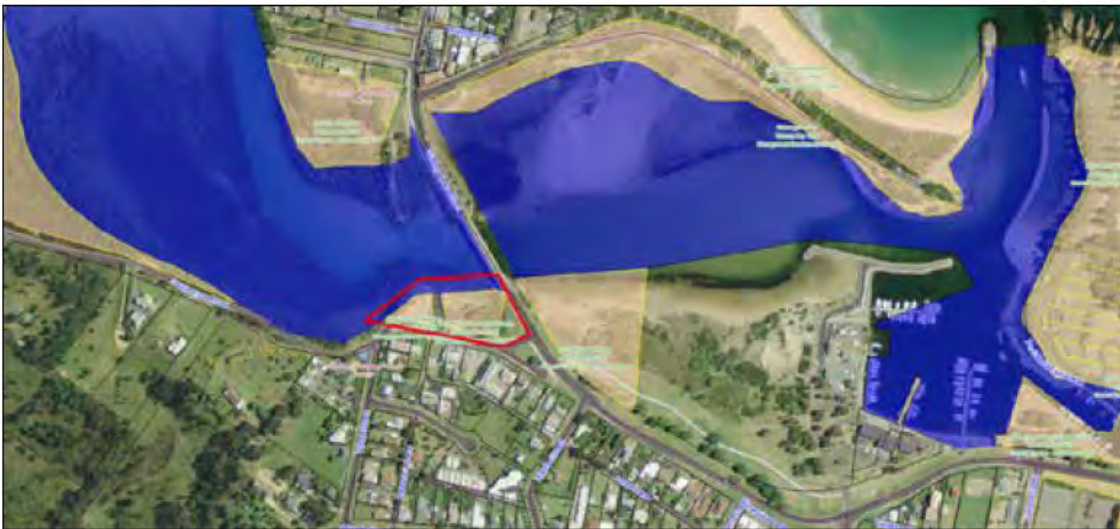
Figure 2-3 Bermagui River boat ramp location.

Figure 2-3 shows the location of the Bermagui River boat ramp, located at:

- Site address: Bridge Motors Reserve, Lamont Street, Bermagui.
- Lot and DP: Lot 7027 DP 1052701 and Lot 7056 DP 1052702.
- Reserve: 97765 BVSC managed Crown Land.

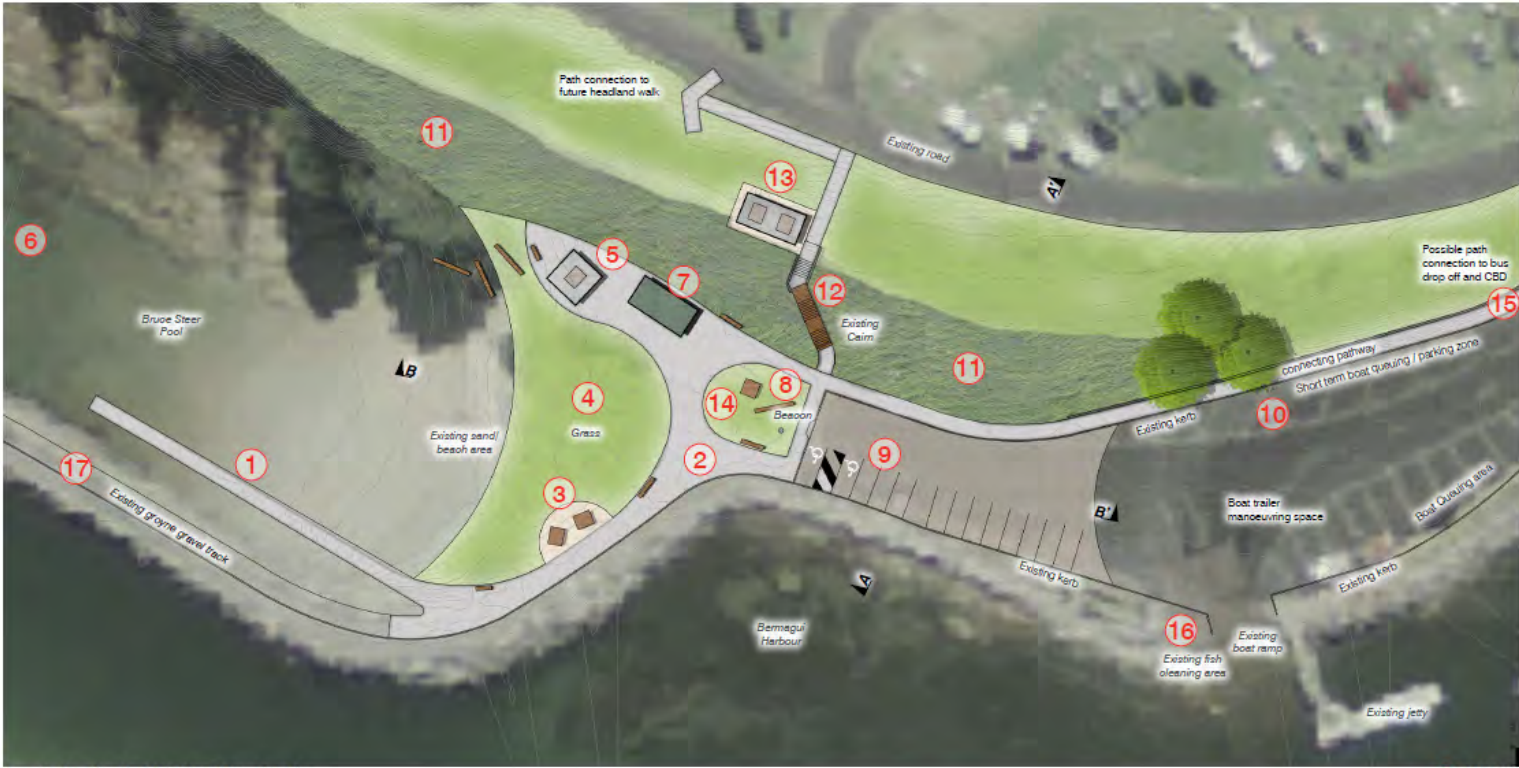
Figure 11: Bruce Steer Pool DRAFT Coastal Accessibility Plan

1:500 @ A3

Replace the old amenities block with a secondary picnic area that is accessible from the top of the embankment and provides a viewing area. Investigate opportunity to re-use existing concrete slab. Provide a bespoke shade structure which references the existing Bermagui 'timber wharf' design language, and includes two picnic settings.

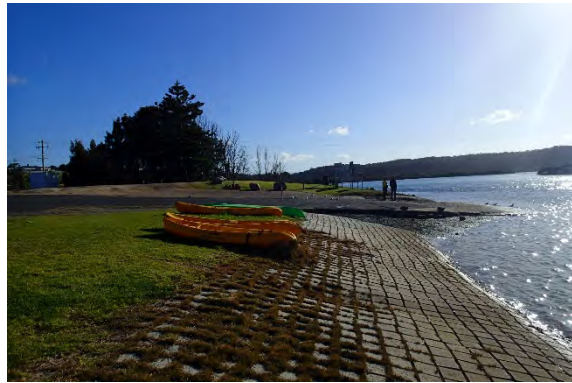
The following plant and equipment would be used during construction:

The edge of the Bermagui River at this location has largely been impacted through the construction of the existing boat ramp but also through placement of concrete block paving along the edge of the river bank on the eastern side of the ramp (Plate 1) and some rock walling on the western side of the existing ramp. This has reshaped the natural surface of the bank and the grassy area behind it. There is an existing sealed carpark adjacent to the boat ramp with a large (30 m x 30 m) area of bare ground most likely used as a turn-around area or overflow parking (Plate 2) on slightly higher ground to the west.

This exposure provided an excellent opportunity to assess the ground surface and the potential for any Aboriginal cultural material to be present. The area was on a slight rise but consisted of a clayey deposit with rill erosion showing a continual clay substrate. It was sparsely covered in imported gravels and some remnant bitumen possibly indicating it was once sealed. Visibility within this area was excellent at about 75% effective visibility but no stone artefacts or shell material indicating midden was observed. It is not considered likely that subsurface cultural material would be present within the area identified for the boat ramp upgrade or the sealing and formalising of the carparking area.

While the Bermagui waterhole site is only about 80-100m to the south of the proposed boat ramp upgrade, it would not be affected by the proposal. While the location of the proposed works may once have been an ideal location for a campsite with midden and artefacts, it is considered that the disturbance and modification of the area has likely removed any site that may have been present.

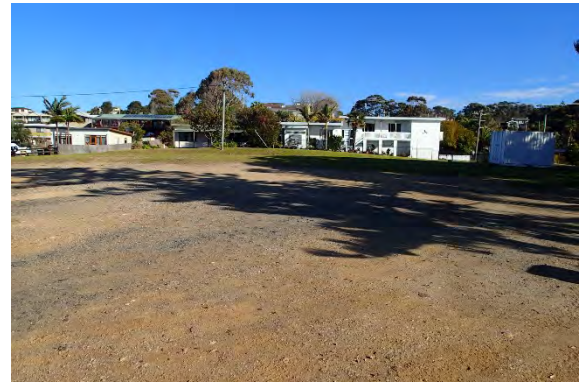
Plate 2. View south to large eroded carpark extension.

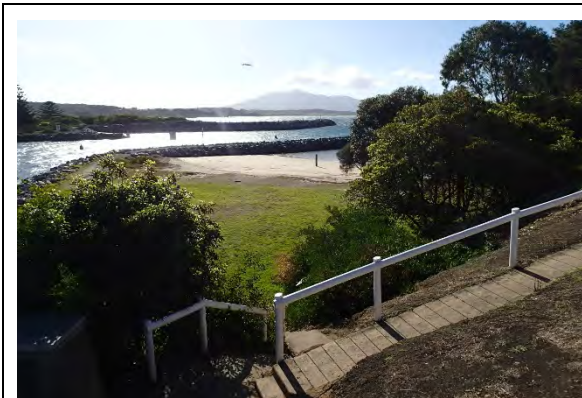
A draft concept plan has been developed for this site (Figure 2-4 and Figure 2-5). The Bruce Steer pool upgrade proposal consists of the following features:

The Bruce Steer pool area appears to be largely man-made. The natural river bank forms the eastern side of the pool and a breakwater has been constructed northwards from a natural bend in the river bank (Plate 3). There is a small sandy beach, between the rock wall and the natural river bank with the car park constructed on largely reclaimed land behind the rock wall forming the current bank of the eastern side of

The sandy deposits extending from the car park north to the edge of the pool are not considered to comprise intact natural sand deposits, they appear to be largely made from yellow beach sand and therefore most likely have been imported into this area. The proposal therefore, to construct an all abilities access ramp across the sand to the pool and to modify the carpark to include disabled parking is unlikely to impact of natural ground surfaces and therefore has negligible potential to impact on Aboriginal heritage objects.

The removal of the existing toilet block from the top of the high bank is also unlikely to impact Aboriginal objects as no new construction is proposed, merely removing the existing facility. Construction of the new toilet block and associated picnic amenities on the sand flat is also unlikely to impact Aboriginal heritage sites due to this area mostly being of modern fill material and not *in situ* natural sand. Revegetation of the steep embankment is unlikely to impact on Aboriginal heritage due to the steepness (near vertical) of the bank. Although visibility was poor on the embankment due to existing vegetation, there is unlikely to be objects present. For the same reasons, and due to the previous construction of the existing footpath, construction of new path from the sand flat to the top of the bank is also unlikely to impact on Aboriginal heritage objects.

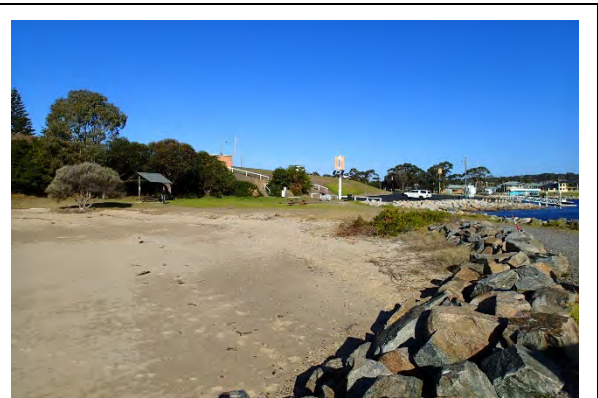
Plate 4. View south east across sand flat to natural bank showing existing path and toilet block. Note the carpark and sand flat are not natural.

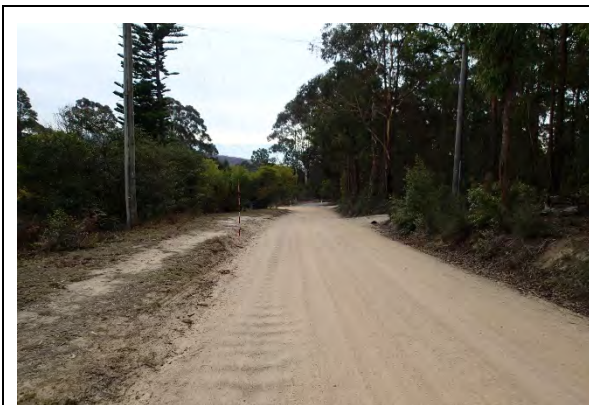
Plate 5. View north along road showing cutting and imported road base.

Any work to be undertaken on the access road including grading, widening, gravelling or sealing would impact Aboriginal artefacts and an Aboriginal Heritage Impact Permit (AHIP) would be required. If work was restricted to the current width of the track, from cutting to the table drain and bench there is unlikely to be any subsurface deposits present and therefore no testing would be required.

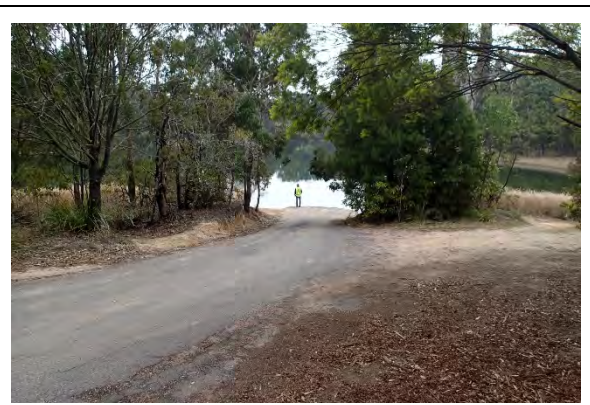
Plate 6. View north to lagoon at end of road.

At the end of the access road there is a steep but short drop off at the termination of the spur to the lagoon, about 3 m below the spur crest. The road is cut through the natural surface exposing a section of the deposits which reveal a 20-30 cm grey brown loam over a light yellow brown silty clay over a yellow gravelly clay. The edge of the lagoon is low lying and eroded and considered to be disturbed by the sealed road to the waters edge and two loop roads used for turning circles cut in either side of the main access road (Plate 6).

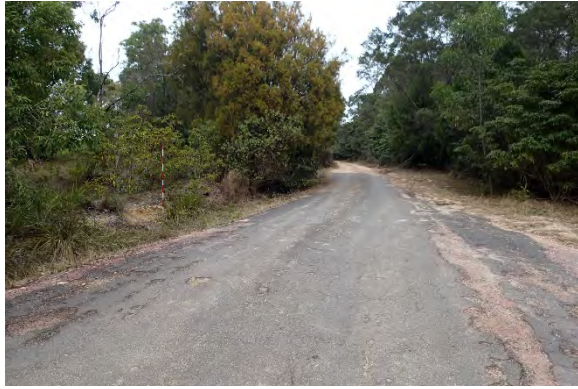
Plate 7. View south to start of site at range pole on road cutting. Artefacts also present along unsealed section of track in distance.

The site *Blackfellows Lagoon AFT 1* was a scatter of stone artefacts spread for 120 m from the edge of the drop-off south along the access road. Artefacts were found on the edge of the road cutting near the termination of the spur and also along the unsealed section of the access track (Plate 7). Artefacts were observed in the run-off channels along the edge of the track as well as in the middle of the track (Plate 8). Thirteen artefacts were recorded in detail but the site is estimated to contain about 20 artefacts. It is unlikely that there would be substantial subsurface deposit remaining on the access track but some may exist within the undisturbed spur crest.

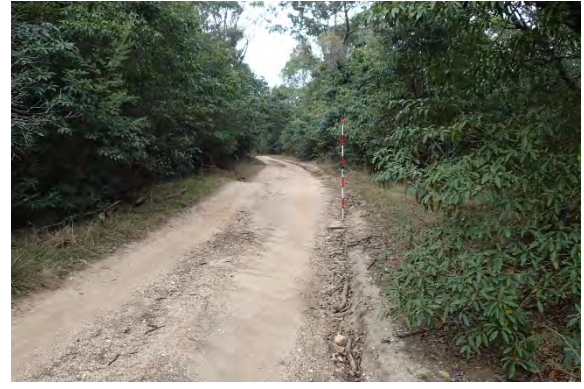
Plate 8. View south along track, artefacts scattered along track and in erosion channel.

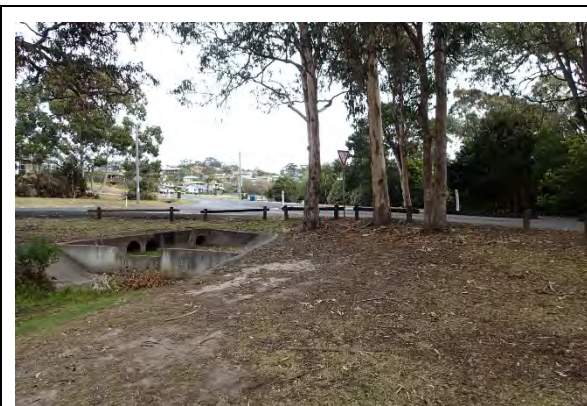
Plate 9. View west to road intersection showing built up roadway and underground stormwater drainage structures.

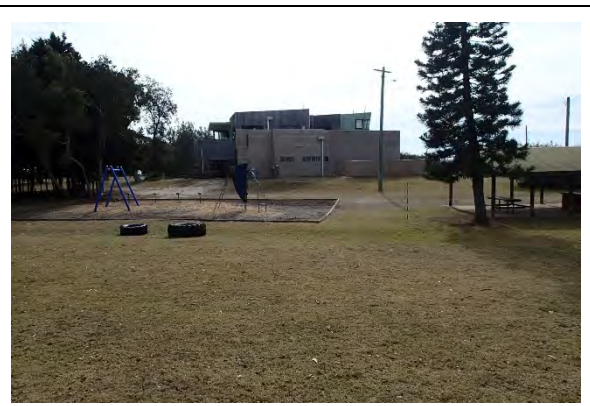
The carpark has been sealed and the location of the toilet block is clearly on imported reddish gravelly clay. The existing surf club situated in the midst of the open area has been built on a raised sandy pad. The material for the pad appears to be a white sand mostly and the similar colours and textures of the surrounding area suggest the pad material was scraped up from the immediate area. The exposures present provided excellent visibility of up to 80% showing a compacted white to light yellow sandy clay, with some patches of gravels (Plate 10). No artefactual material or midden shell was observed, either in the pad on which the building sits or in the surrounding exposures, including at the edges of the carpark.

Plate 10. View north across existing facilities to club, note some exposures and planted conifers on left.

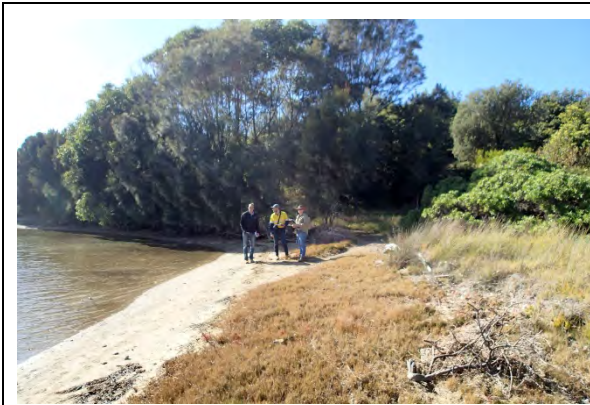
Commencing at the Wallaga Heights carpark, the site inspection proceeded along the edge of Wallaga Lake towards the entrance. The proposed alignment is for a boardwalk to be constructed along the edge of the sandy lake shore (see Plate 11). The boardwalk would then turn onto the solid ground forming part of the base of the headland, following an existing pathway rising up to the headland. Previously recorded site 62-7-0268 has been recorded on the shoreline in this vicinity, about 30 m east of this point, extending for 50 m along the shoreline and consisting of a moderately dense scatter of shell and three stone artefacts (Webster and Kuskie 2002). Little evidence of this site was observable during the current survey although some small fragmented pieces of shell were noted.

Plate 11. View east to point where proposed boardwalk leaves sandy shore to enter headland proper behind the trees.

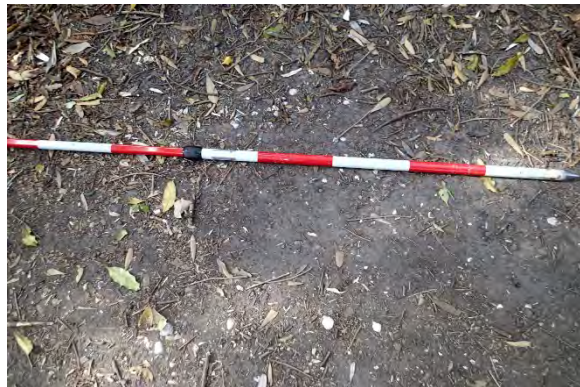
Plate 13. Close up view of midden material eroding from track at Murunna Walking Track Midden 1.

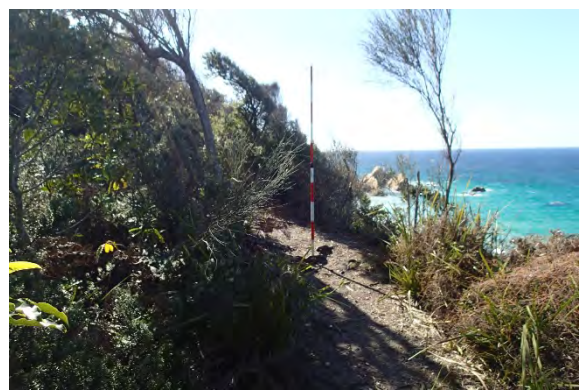
Plate 20. View north to exposure of shell, associated with site 62-7-0254 Locus B.

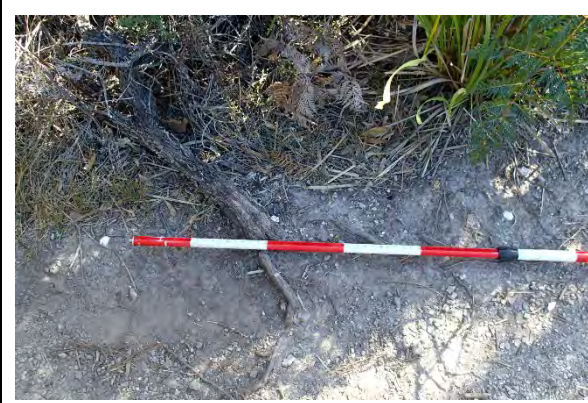
Plate 21. View of exposure of shell, associated with site 62-7-0254 Locus B.

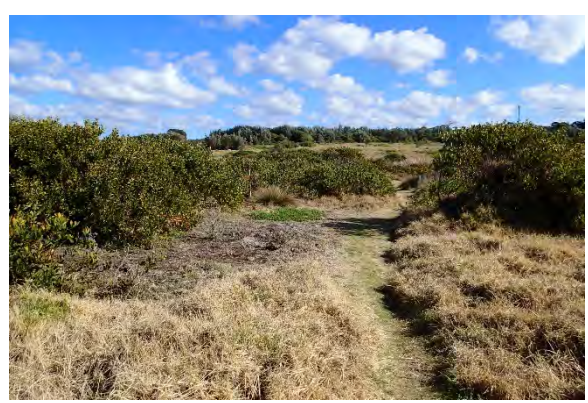
Plate 22. View west across lower slope to Murunna Walking Track Midden 2 at left of track near range pole.

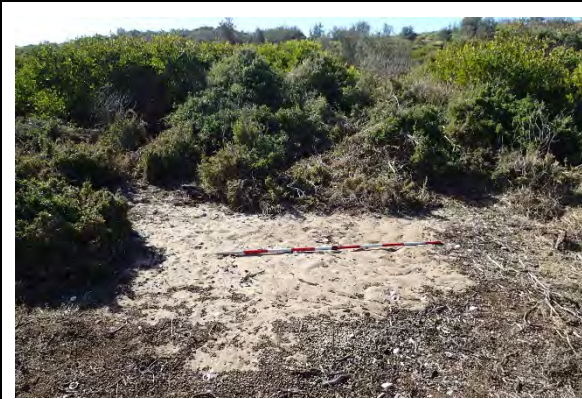
Plate 23. View of exposure showing midden material of Murunna Walking Track Midden 2.

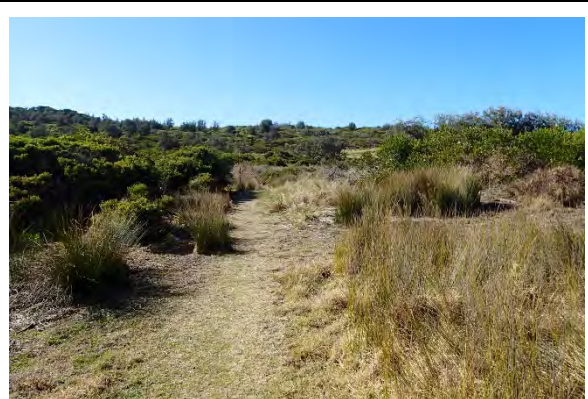
The walking trail alignment crosses a small outlet creek from the wetland and then crosses another small *Anadara* midden, previously recorded as site 62-7-0267 (Plate 24). This site contains a small exposure of shell on the southern edge of the drainage line with high potential to be larger and contain subsurface material.

Plate 24. View north east to location of site 62-7-0267 on edge of walking track at range pole.

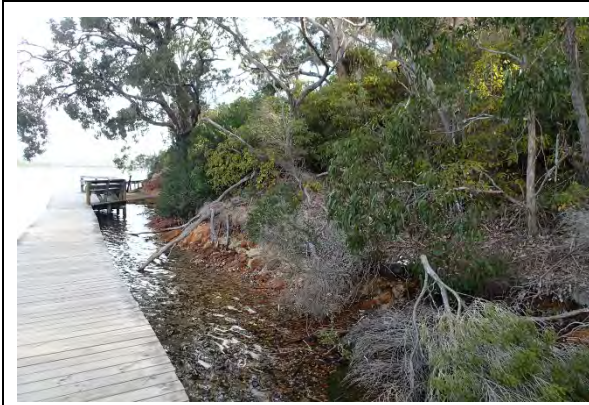
Plate 25. View south west showing shell midden material eroding from the lake shore. This is part of the previously recorded site #62-6-0097.

Shell material was noted eroding from the shore at a minor headland in the lake where the wooden boardwalk across the water meets the land and changes to a concrete pathway (Plate 26). The shell was eroding from the flat above exposed bedrock. The nearest recorded site is Merimbula Heights Estate 8 (#62-6-0135) about 90 m from the exposure of shell observed. However, after checking the site card and the associated map it is clear that the original recording of the site comprised a number of separate shell midden concentrations, including the area observed during this survey. It is concluded therefore that the shell midden material observed is covered by the AHIP.

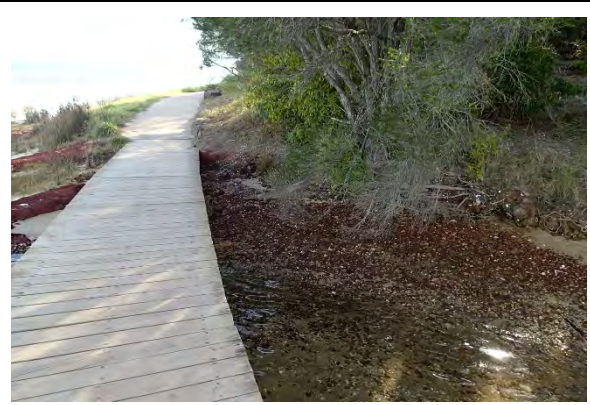
Plate 26. View west showing shell midden material eroding from the lake shore. This is part of the previously recorded site #62-6-0135.
