Cuttagee Bridge Heritage Assessment

Report prepared for BVSC by Pip Giovanelli

August 2021

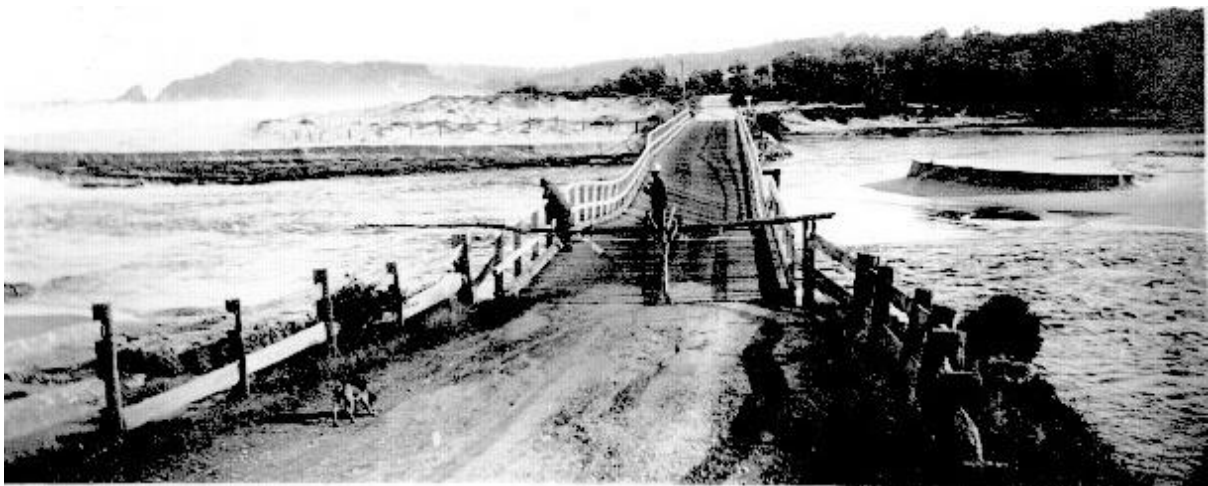
Cuttagee bridge looking south following collapse of spans 2 and 3 during heavy storms in 1934.

In 1934 bad weather caused the collapse of piers 2 and 3 as can be seen in the images below.

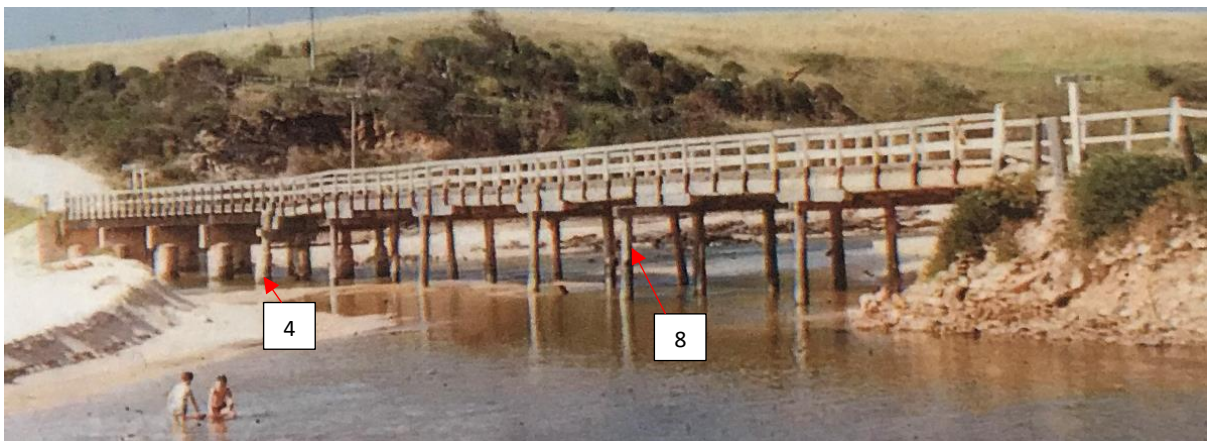
Cuttagee Bridge in the late 1960s. Photo taken by Sister Harris. Source Bermagui Historical Society.

A photograph taken in the late 1960s shows the bridge in apparently stable form but with a secondary channel forming toward its southern end. Close inspection of the photo shows apparent subsidence at pier 4 which, in the first iteration of the bridge circa 1892, was the southern abutment (note that the old timber piles were encased in concrete in 1934-5). The wider headstock on top of the piles can also be seen. Pier 8 was the southern abutment in the bridge's second iteration of 1898 and it too is wider as a consequence. There are no additional steel piles, or lateral or diagonal bracing between piles at the time of this image.

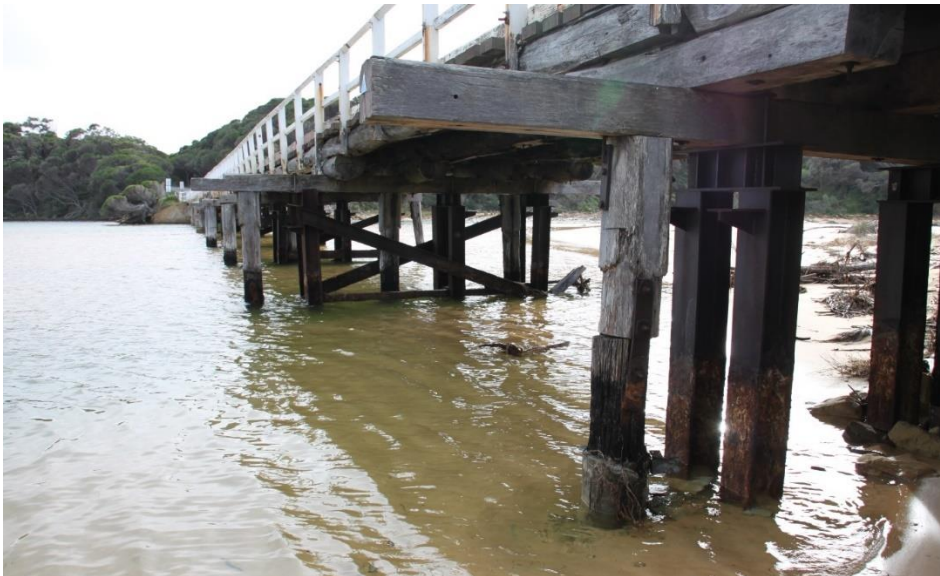
View from South abutment looking north at pier 9. June 2021. Note extended headstocks, introduced steel piers, butt-spliced timber piers and rust at base of steel work.

Over recent decades there have been extensive repairs to the bridge as many of the piles and headstocks reached the end of their life. The new or recycled headstocks can be seen extending beyond the edge of the bridge, supported on additional piles. Steel piles have been driven into the sand either side of the former timber piles. Diagonal bracing and horizontal ties have been added to the piles to provide additional strength and there is evidence of numerous repairs to the decking

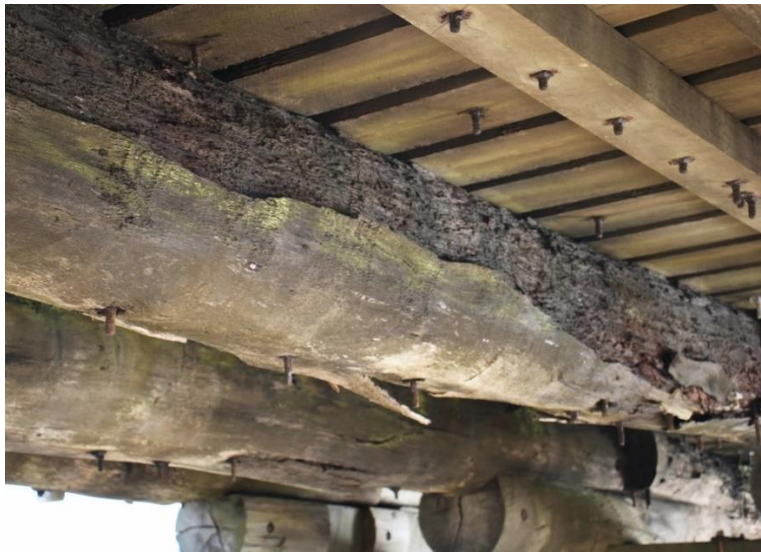
Cuttagee Bridge girders at Span 9, photographed June 2021. The good condition of the underside of decking suggests that timbers were replaced in relatively recent times.

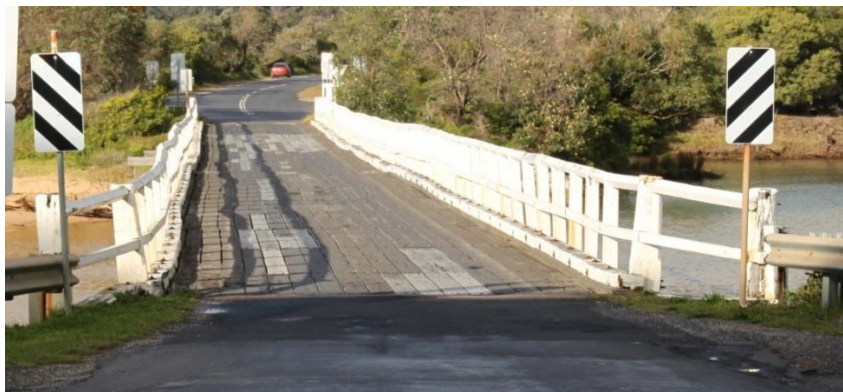
Cuttagee Bridge looking south. The many irregularities in the substructure are reflected in the 'wavy' lines of handrails, kerbing and the deck surface itself. Many timbers have decayed, and metal is rusting. June 2021

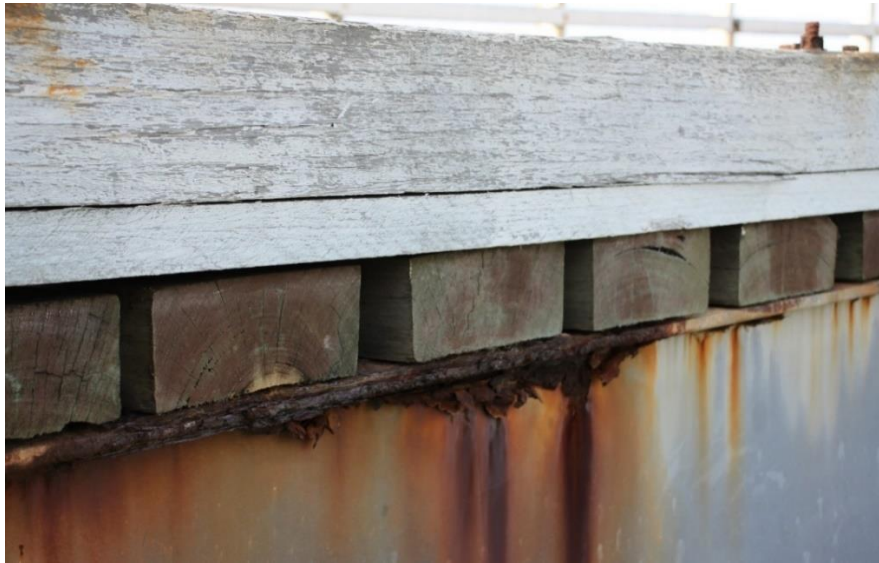
Rusting girders. June 2021

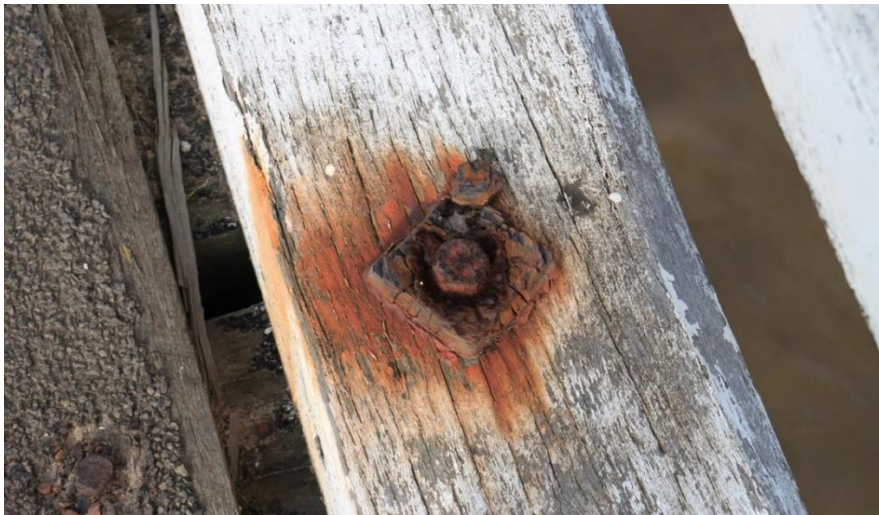
Rusting fixings holding down kerbs, June 2021

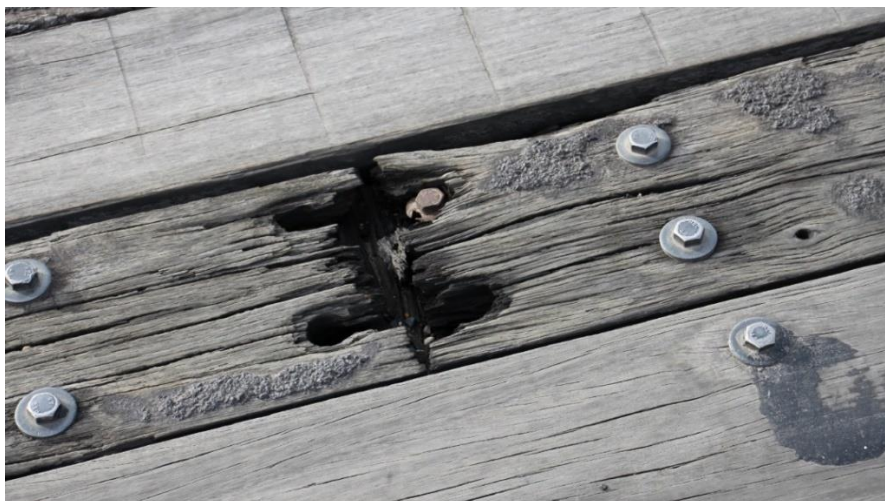
Failing deck timber. This common problem is caused by water entering the timber via the screw holes and causing decay. June 2021.

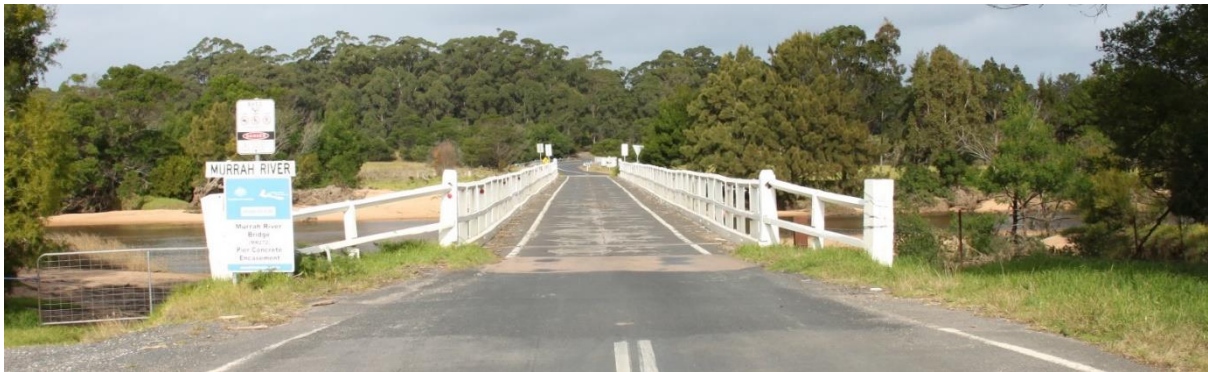
Murrah Bridge 2021. From the tourist perspective the bridge presents as a timber structure.

Murrah Bridge, located south of the Cuttagee Bridge, has had all its former timber piers replaced with concrete piers and concrete headstocks. Girders, deck and rails remain in timber, although it is likely that most of the timber has been replaced over the course of the bridge's life. The bridge is a single lane wide, although there may be capacity to expand it to double-lane given the width of the concrete piers. From the tourist perspective the bridge 'reads' as a timber structure and it continues to contribute to the historic character of the scenic drive.

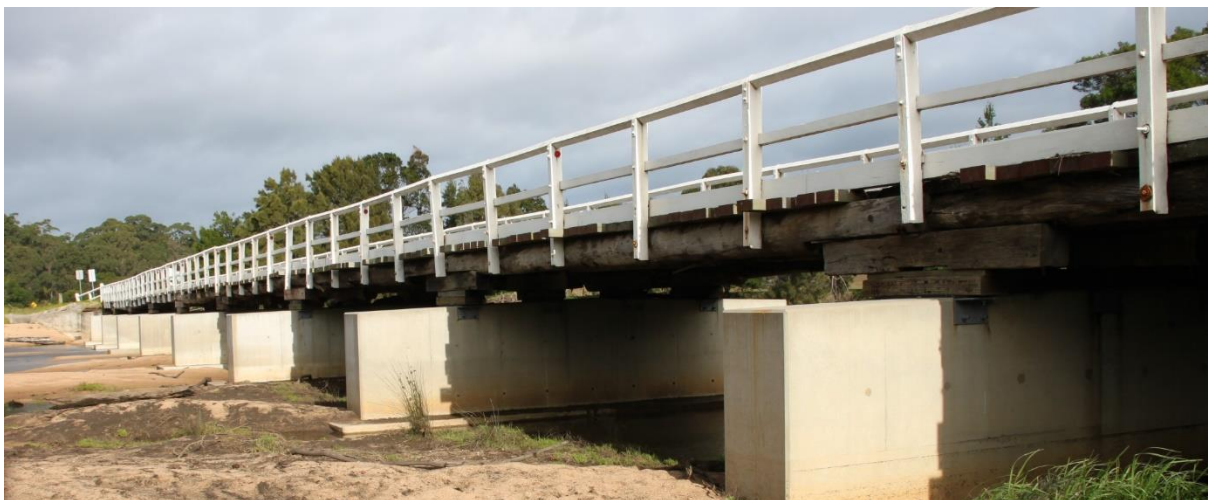
The timber upper structure is supported on relatively recent concrete piers that may be wide enough to support a second lane if the bridge needs to be widened.

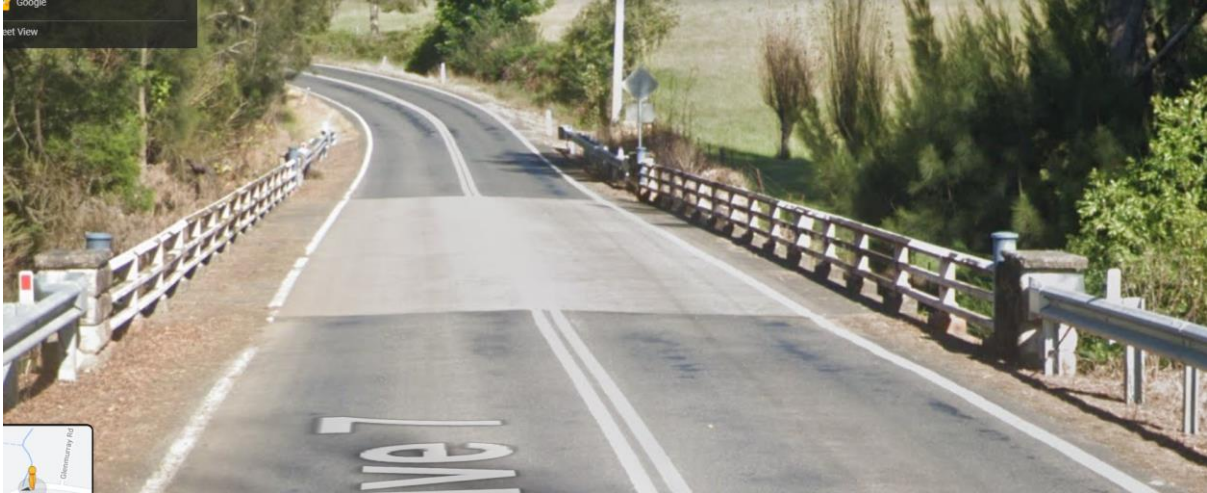
Glenmurray bridge sits well within its context. Google Image of 2021

Located in the Kangaroo Valley on Tourist Drive 7, the Glenmurray Bridge is a two-lane concrete bridge with steel handrails modelled on traditional timber detailing. The spacing of posts and rails, the dimensions of members and the diamond top rail closely reflect timber bridge construction. The pylons comprise a short sandstone pillar followed by a bespoke steel cylinder. The railing posts are bolted onto small concrete plinths in lieu of a kerb which prevents the build-up of detritus, and visually opens the bridge to the landscape. The small amount of leaf litter on the side of the carriageway reduces the visual impact of the concrete and contributes to the bridge's rural character.

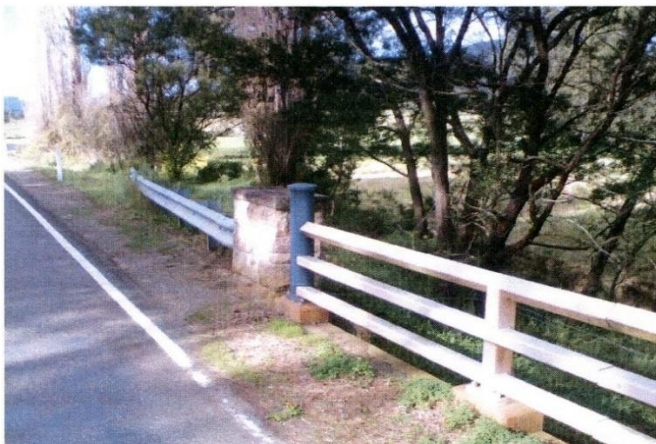
Note the combination of sandstone and painted steel pylon, plus absence of concrete kerb.

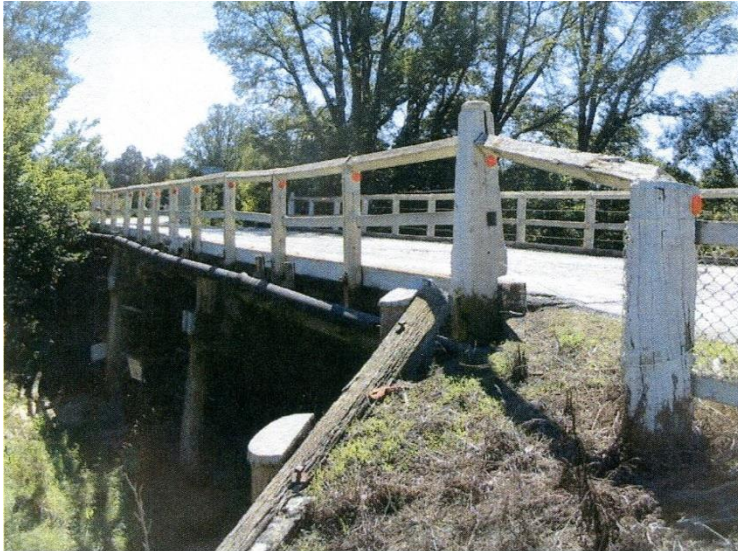
Turallo Creek, Bungendore (Palerang Shire), prior to demolition

The reconstructed Turallo Bridge at Bungendore is a concrete bridge that has a bevelled kerb structurally integrated into a half-height concrete wall. The white steel guard rail follows traditional details and proportions including a short obelisk pylon.

This bridge does not incorporate traditional details as successfully as the one at Glenmurray Creek.

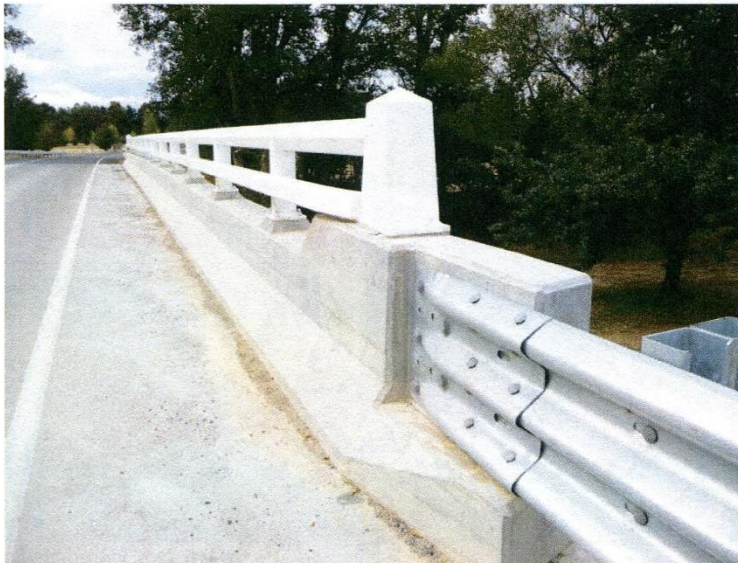
Turallo Creek, Bungendore april 2009

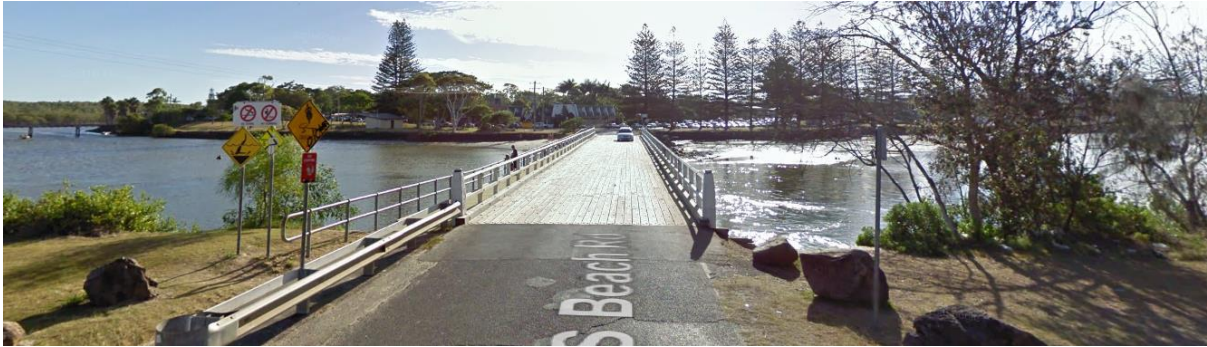
Brunswick Heads timber bridge. Google image capture dated January 2010

The two-lane timber bridge at Brunswick Heads is much valued by the community and seen as part of their tourist offering. The 63metre bridge was upgraded from 10 tonne to 44 tonne traffic loading. The attached pedestrian footbridge was also addressed as part of the restoration.

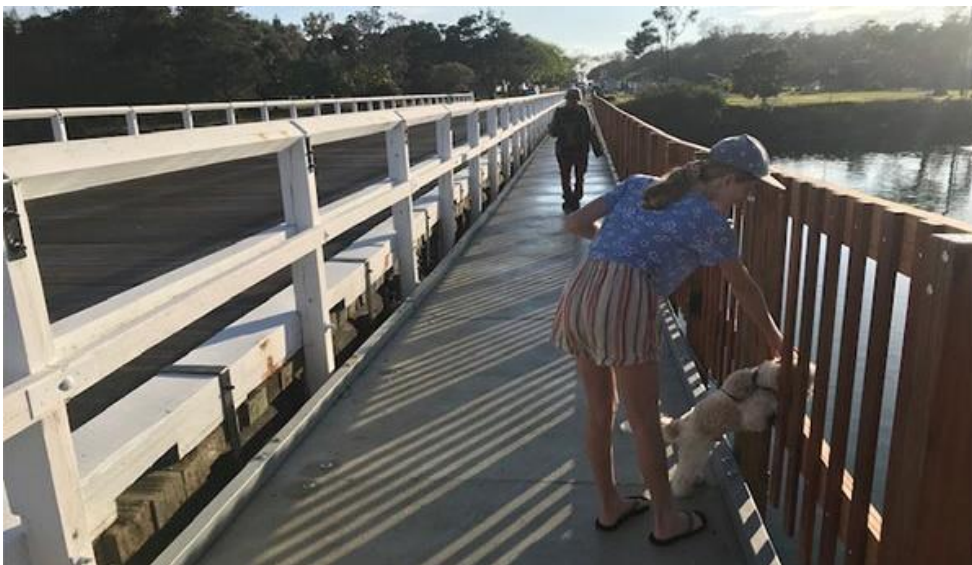
The historic timber railings on the vehicle bridge have been upgraded and painted. The balustrade on the pedestrian bridge has also been upgraded by changing from galvanised steel pipe to clear finished timber.

Timber Restoration Services (TRS) won the contract to upgrade the 63m bridge from 10 tonne to 44 tonne traffic loading. Part of the rehabilitation process was to recycle the existing timbers where possible and reuse the log timbers at the Council stockyard.

To ensure the recycled timber is given the best protection, wherever TRS made cuts or drilled holes, Copper Naphthenate Oil Emulsion (CN oil) was applied and a paraffin-based sealant, Anchorseal® was used to seal the cuts. The final touch was to diffuse all the timbers with borate salt rods, Decaystop® to inhibit fungi growth, allowing easy access to maintain the bridge elements.

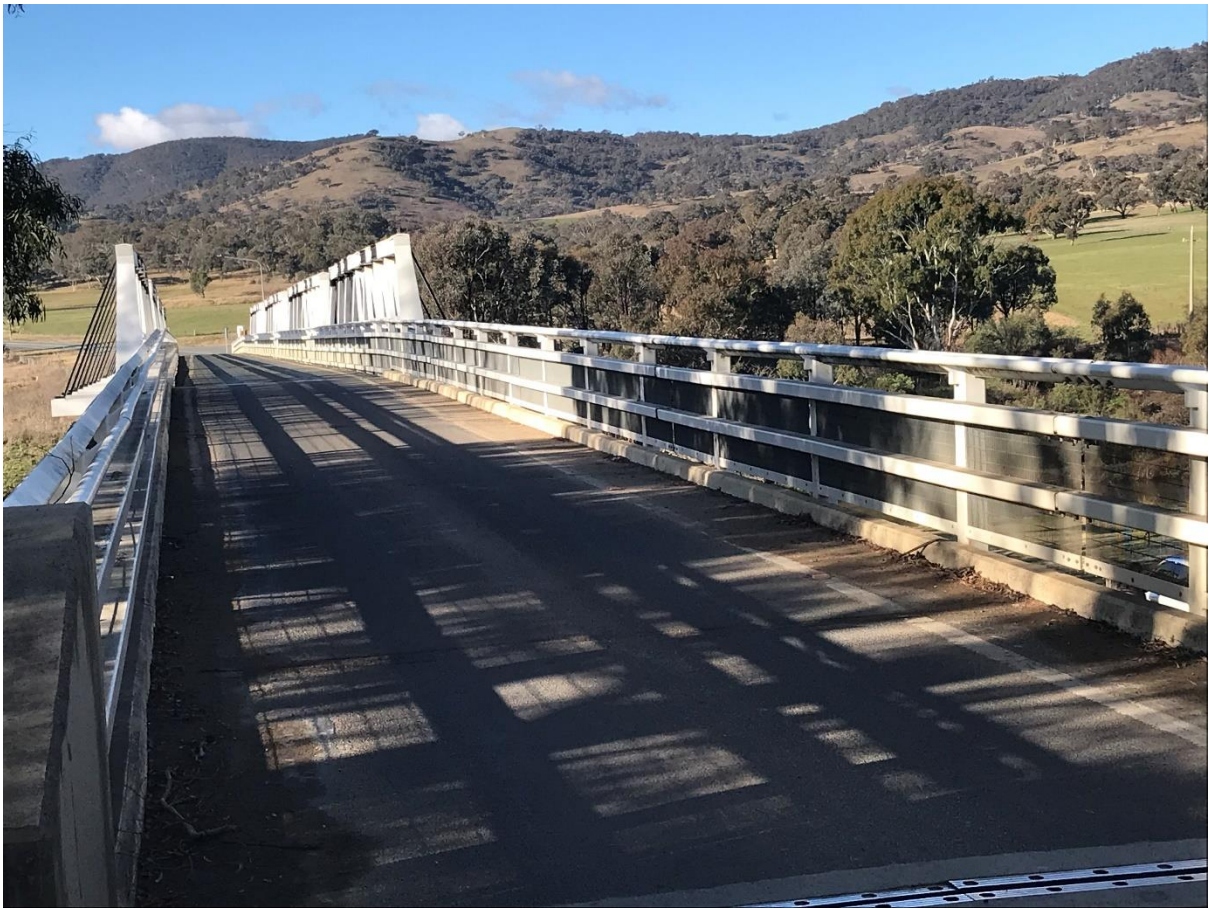
Tharwa bridge is one lane wide, with white painted steel rails closely modelled on traditional detail. Steel mesh is added to the rails to provide greater pedestrian security. The concrete deck on the approach spans has an asphalt surface which unifies the surface and visually ties the concrete approach spans and timber truss spans together.

Steel side rails reflect traditional timber design with a diamond top rail. Mesh has been added, presumably to provide for pedestrian security.
