Merimbula Lake entrance sediment study

WRL TR 2022/27, March 2023

UNSW
Water Research
Laboratory

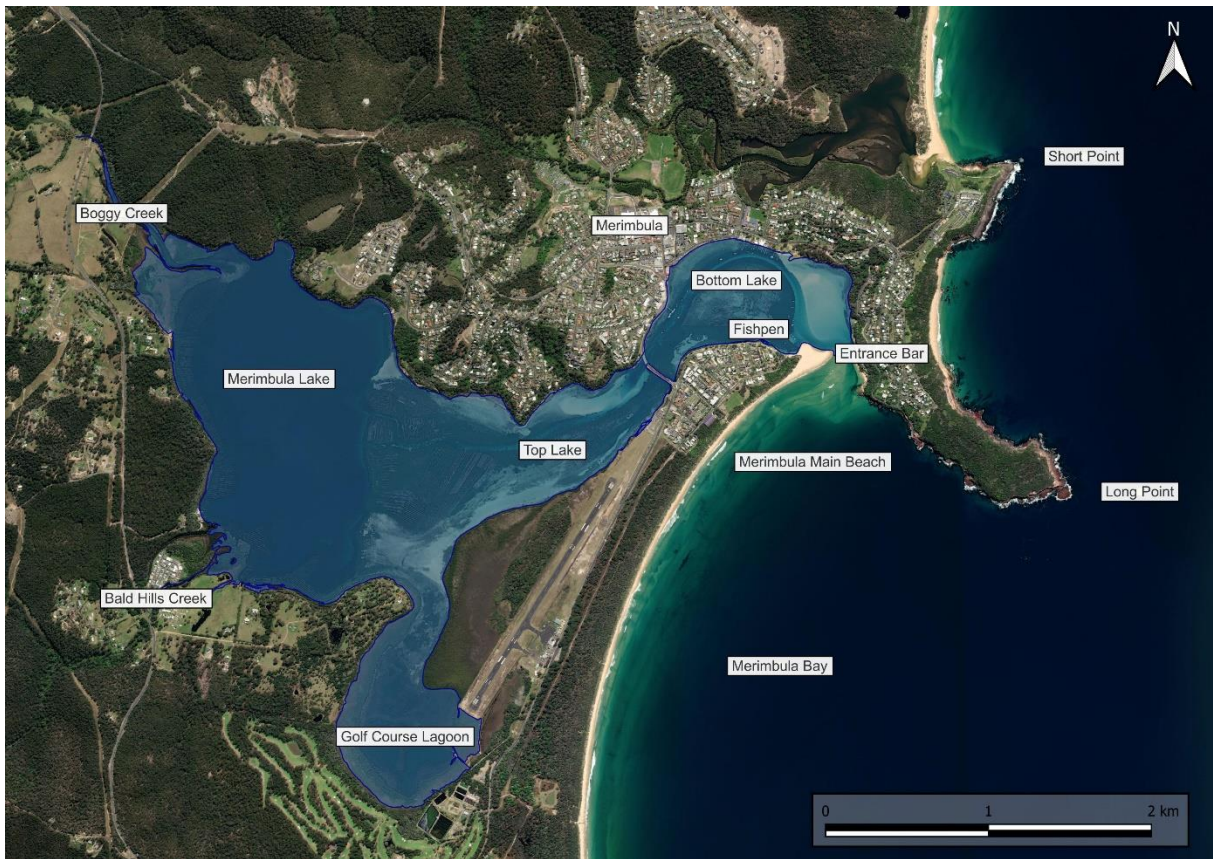
Figure 1 Merimbula Lake estuary system

The Merimbula Lake estuary system is located adjacent to the township of Merimbula within the Bega Valley Shire Council Local Government Area on the Sapphire Coast of NSW. Approximately 360 km south of Sydney, the Merimbula Lake estuary system is a small-sized system with a catchment area of 26 km² and two tributary creeks; Boggy Creek and Bald Hill Creek (MHL, 2003). Located at the complex morphological interface between this tide-dominated estuarine system and a wave dominated semi-open coast location is the Merimbula Lake entrance bar (refer Figure 1). An untrained estuary entrance, the Merimbula Lake entrance bar is a dynamic feature with no known history of closure and a typical channel width of 100-200 m with a channel depth of approximate 2 m. The ebb tide shoal immediately offshore of the site significantly dissipates incident wave energy which periodically reduces navigability of the channel into the estuary at low tides.

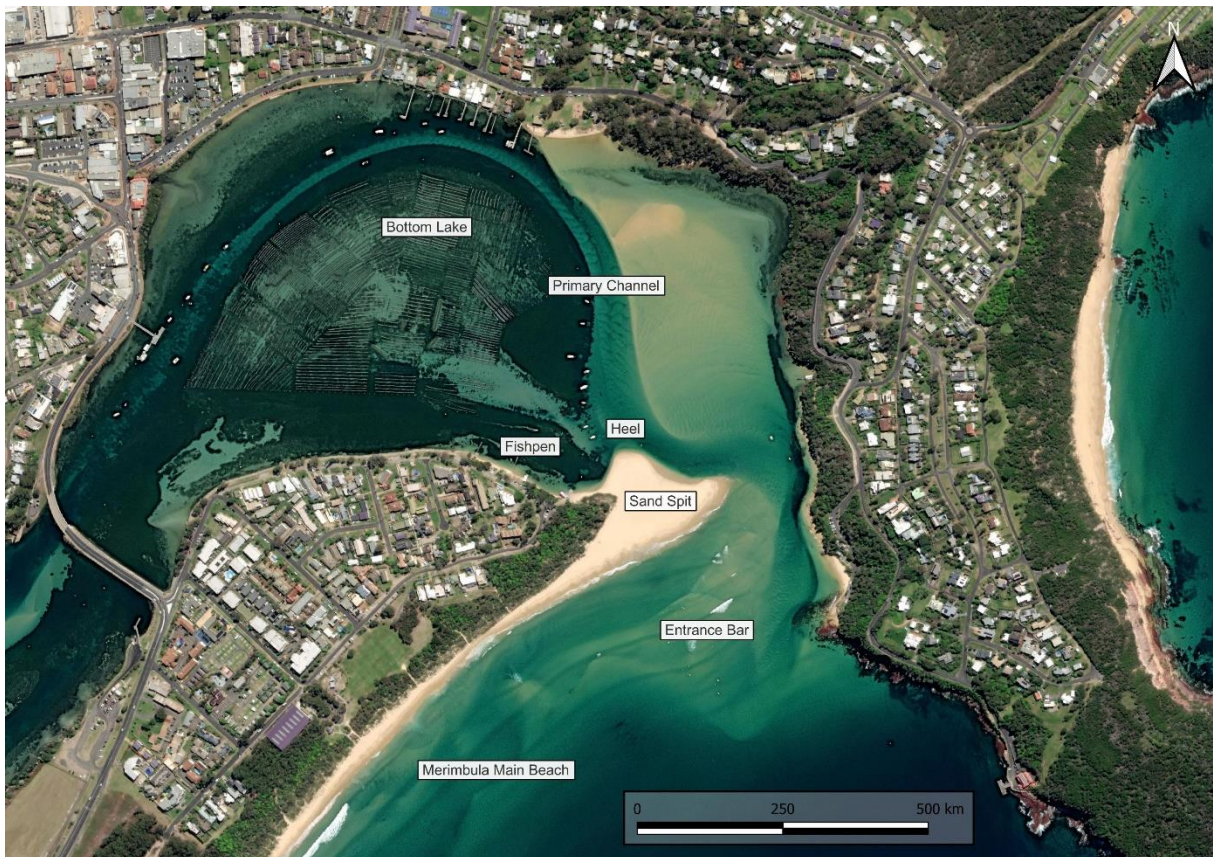
Figure 2 Merimbula Lake entrance bar

Based on visual observations of satellite and historic imagery, the alignment of the primary channel in the bottom estuary is largely consistent through time. Closer to the sand spit and entrance bar, channel alignment is more variable and responds to changes in sand spit morphology. During eroded states of the sand spit, sediment is deposited seaward onto the entrance bar, and upstream into the primary channel temporarily reducing the maximum depth of the estuary entrance system. This sediment transport results in a reduction in channel navigability and presents a hazard for boat users, particularly during low tides. During these periods, channel alignment adjacent to the sand spit migrates northward and results in increased tidal flow restrictions. This channel re-alignment in response to changed entrance bar bathymetry was observed to result in a landward deposition of sediment at the ‘heel’ of the entrance bar spit. This landward deposition and resultant spit width increase was observed in several of the historical images in response to erosion events, and is particularly evident following the 2019-2020 erosion event (see Figure 2 and Figure 3).

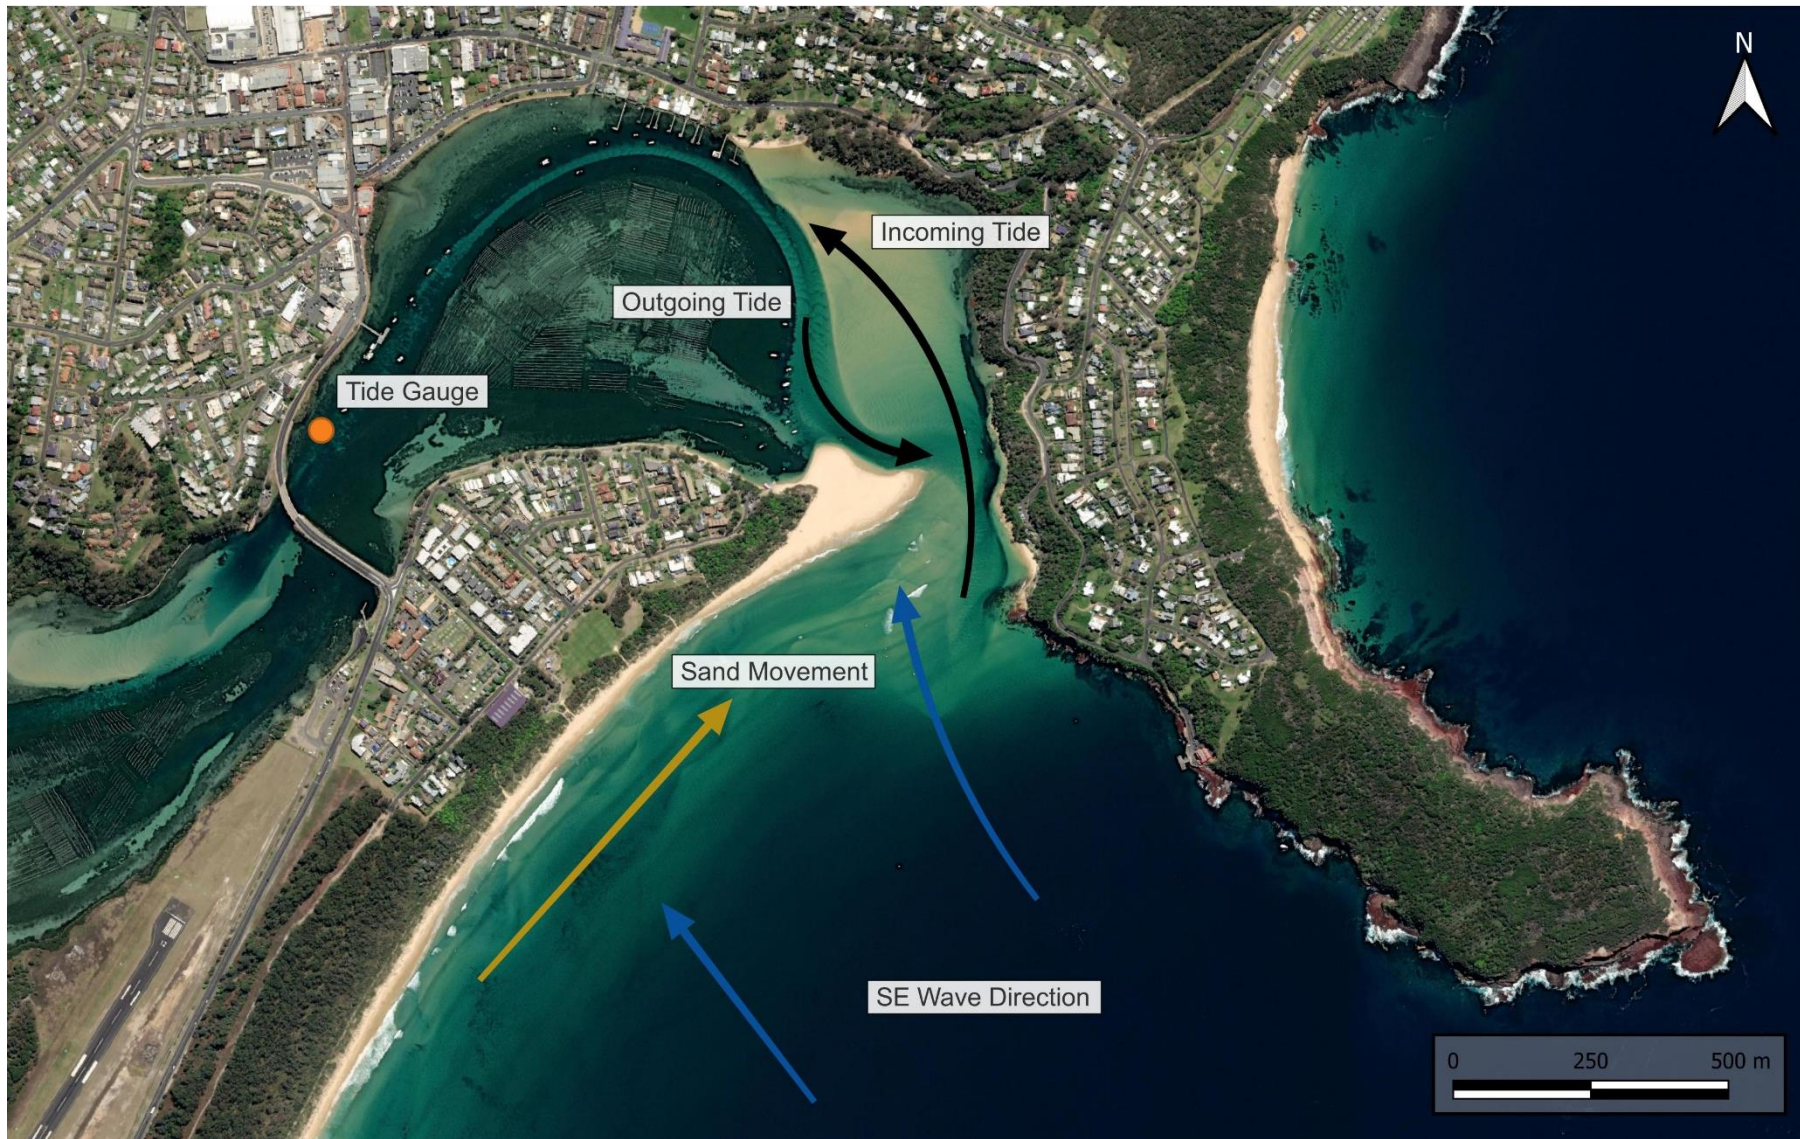
Figure 8 Merimbula Lake entrance bar sediment transport conceptual model

During large wave events from South to Easterly directions, wave refraction around Long Point redirects wave energy towards the entrance bar. Based on the timeseries of shoreline position along the entrance bar spit (refer Figure 4) and compared with a timeseries of offshore wave climate (refer Appendix A3.1), the primary driver of sand spit erosion and shoal blowout appears to be large storm wave events. With the increased water levels associated with storm surge, direct wave attack on the entrance sand spit during storm events pushes sediment into the estuary and into the primary tidal channel. Reducing channel depth, the resulting changes to entrance bar bathymetry temporarily alter the tidal hydrodynamics of the system. Resulting in a northerly channel alignment and deposition of sand on the landward sand spit 'heel', this eroded spit state and shallow bathymetry restrict tidal flow over the entrance bar and reduce the tidal range observed in Merimbula Lake (refer Appendix A3.2). As wave conditions return to normal, tidal forcing conditions push the channel alignment back to its long term equilibrium state and return the deposited oceanic sediment back to the entrance bar shoal. During this 6 month recovery period, channel navigability is impacted as the channel alignment migrates to its long term position and sand is returned offshore reducing entrance bar shoal depth.

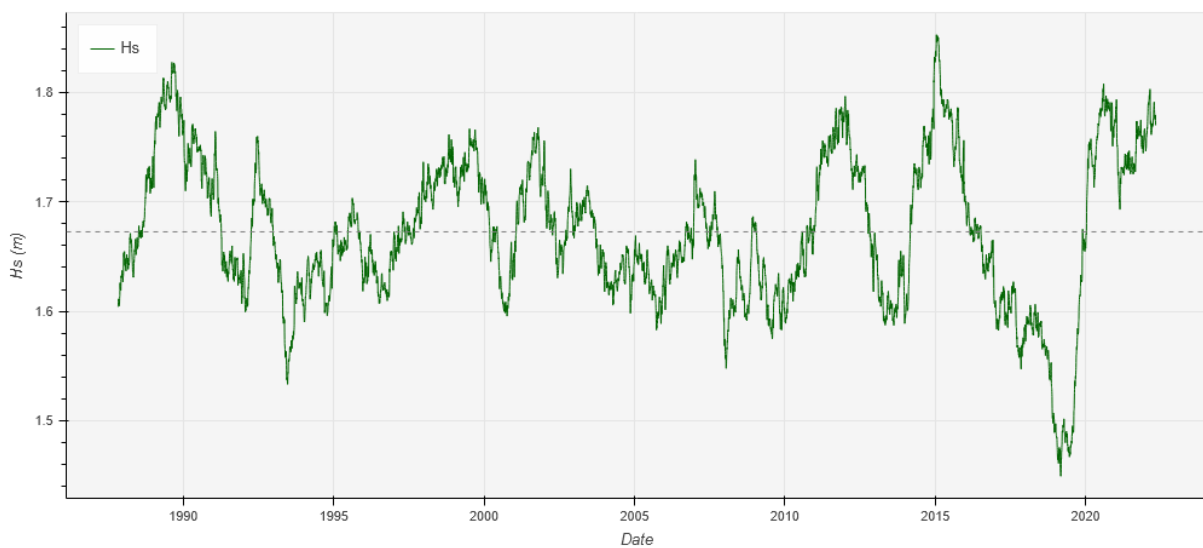
Figure 9 Eden wave buoy significant wave height (annual rolling average)

With erosion of the entrance bar sand spit first evident in the records from June 2019, the spit width reduced and remained stable in a mildly eroded state from September 2019 until the start of 2020. In the first 6 months of 2020, a series of large wave events further eroded the sand spit width to its smallest length on record. Recovering over the following 6 months, the sand spit returned to its long term average position by February 2021. Investigating the long term wave climate for the region, it was noted that the period from mid-2018 to mid-2019 recorded a prolonged period of the smallest average wave height on record with significant wave height 20cm less than its long term average (see Figure 9).

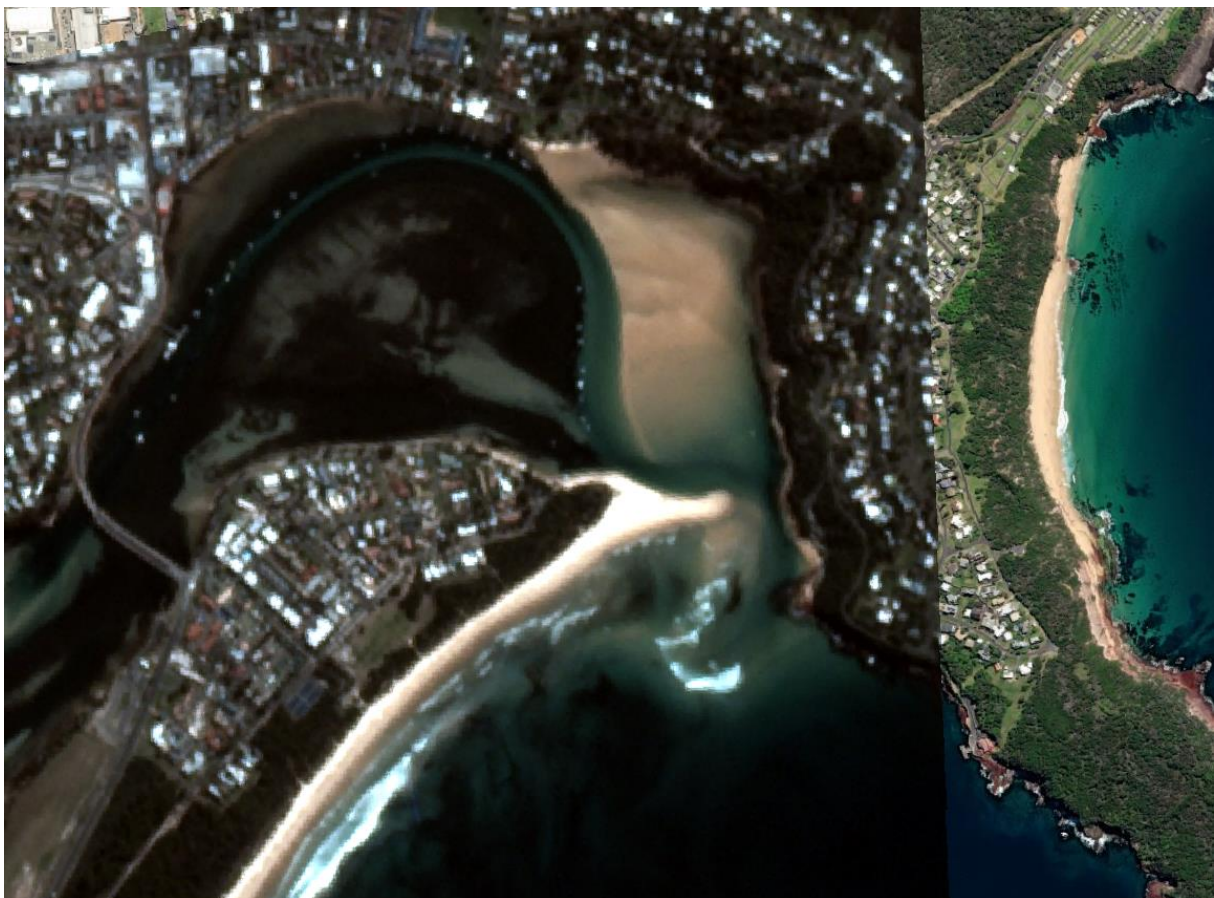
A-1 Merimbula Lake entrance bar conditions April 2019 (pre spit erosion)

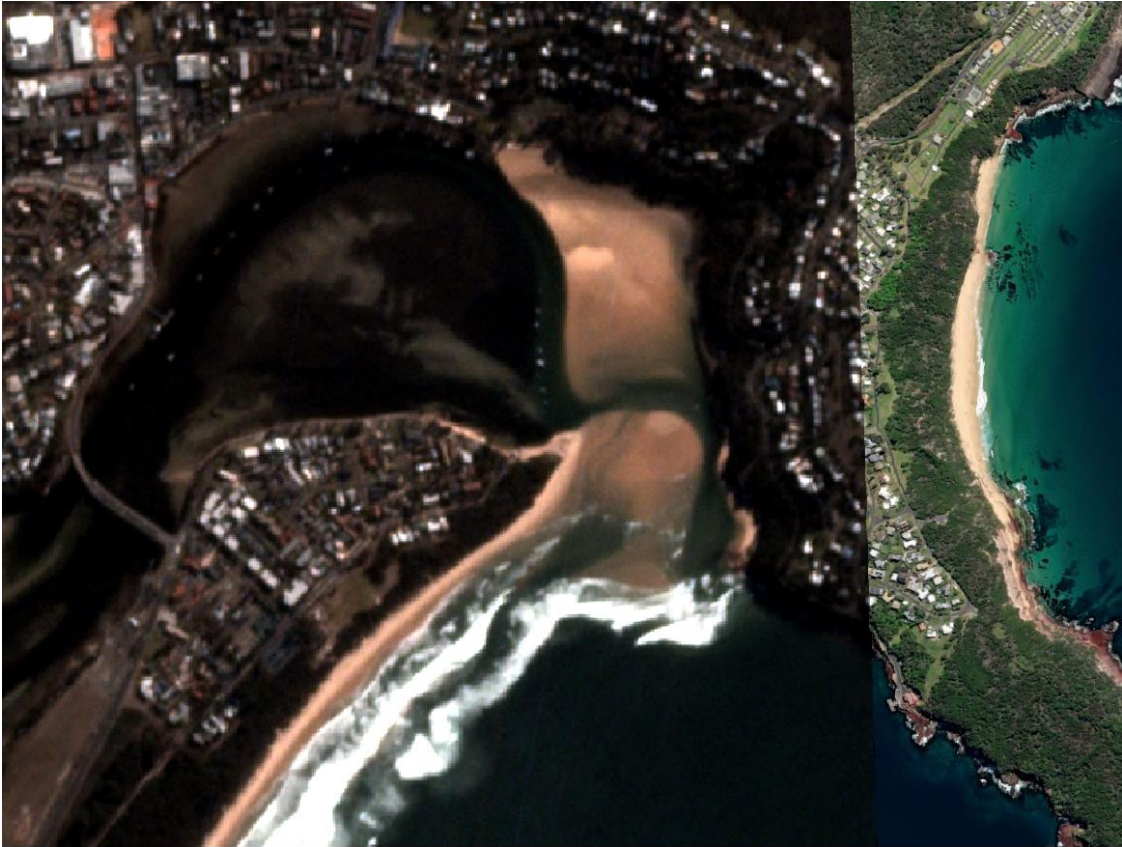
A-2 Merimbula Lake entrance bar conditions July 2020 (peak spit erosion)

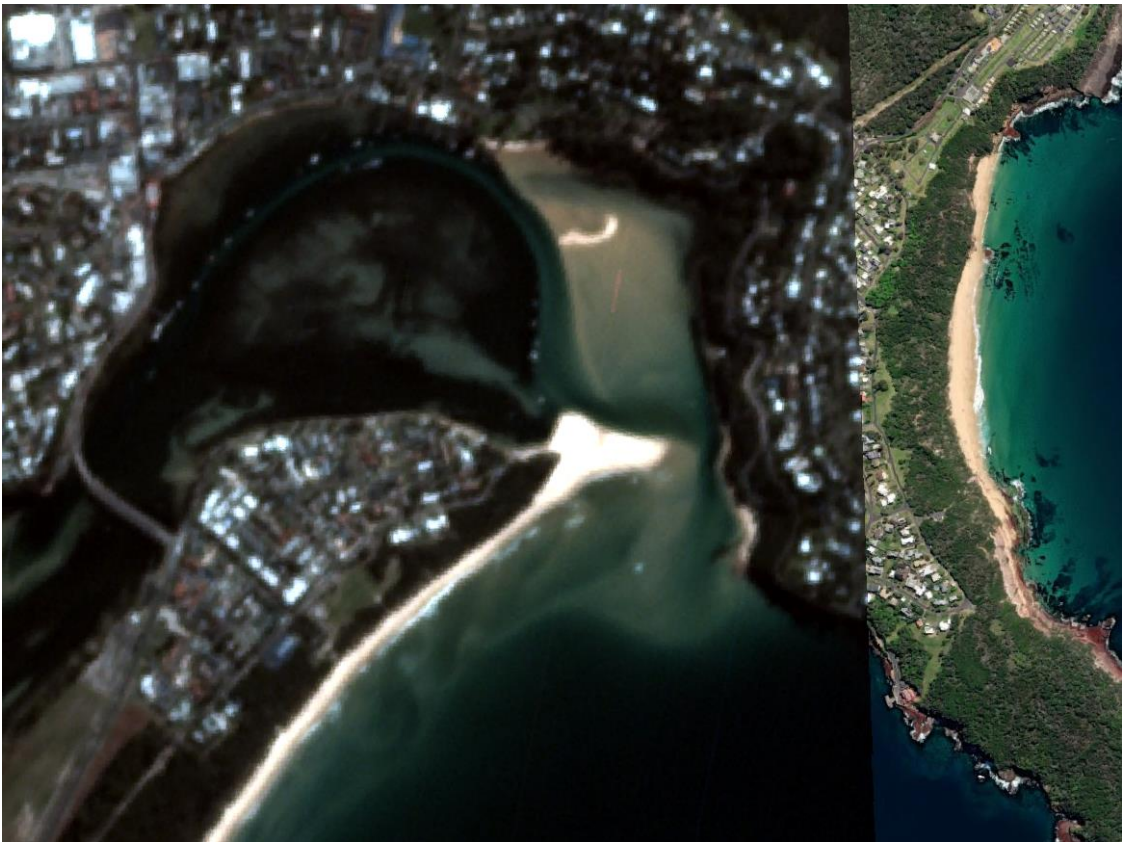
A-3 Merimbula Lake entrance bar conditions October 2021 (post spit recovery)

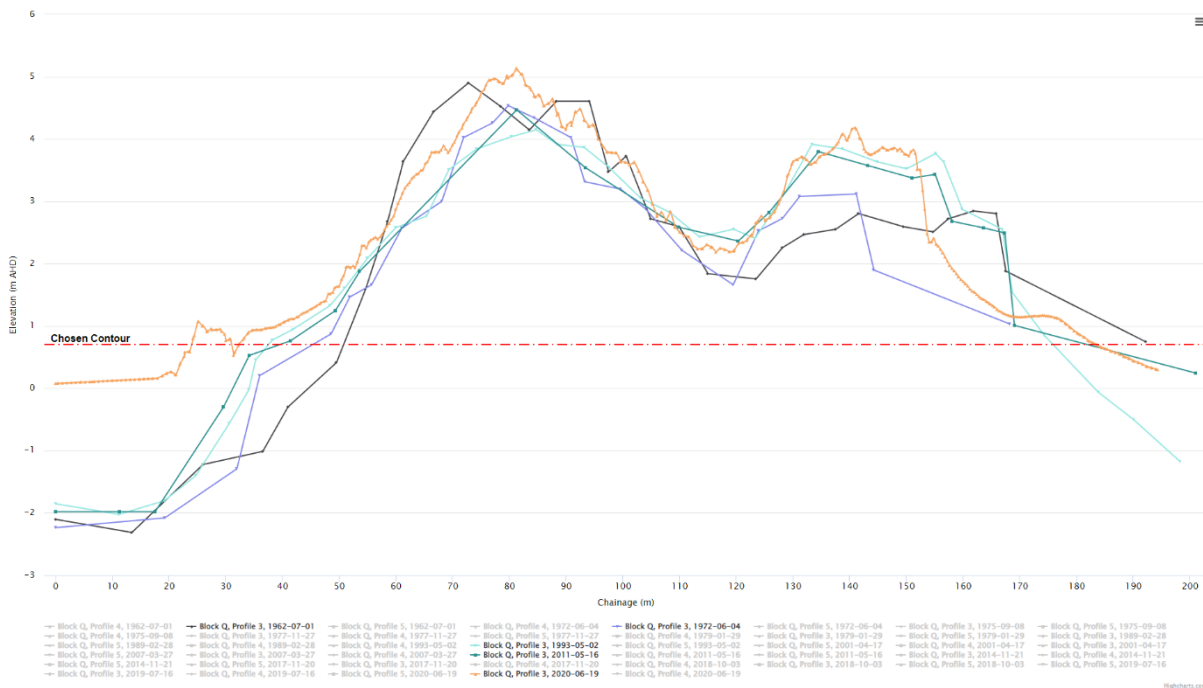
A-5 Block Q, Profile 3 – Historic eroded sand spit shoreline positions

Several images capturing the sand spit in an eroded state were observed in the historic data catalogue (1962, 1971 and 1979), and are consistent with the findings outlined above. These eroded states were short lived with the spit recovering by the following year.

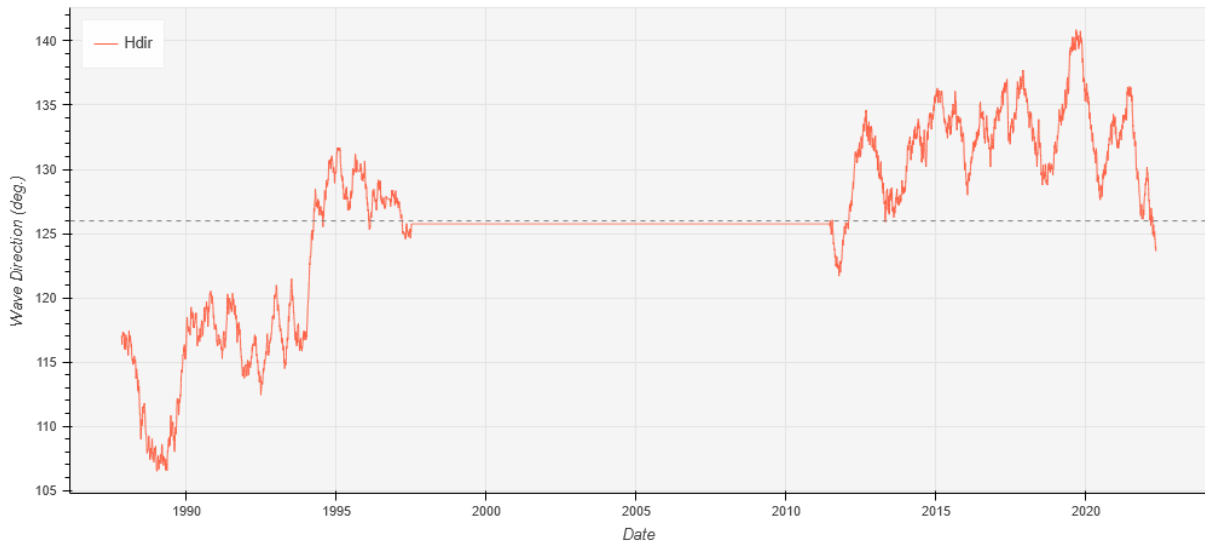
**A-12 Wave direction (annual rolling average) at Eden wave buoy timeseries
(Source: MHL, 2022)**

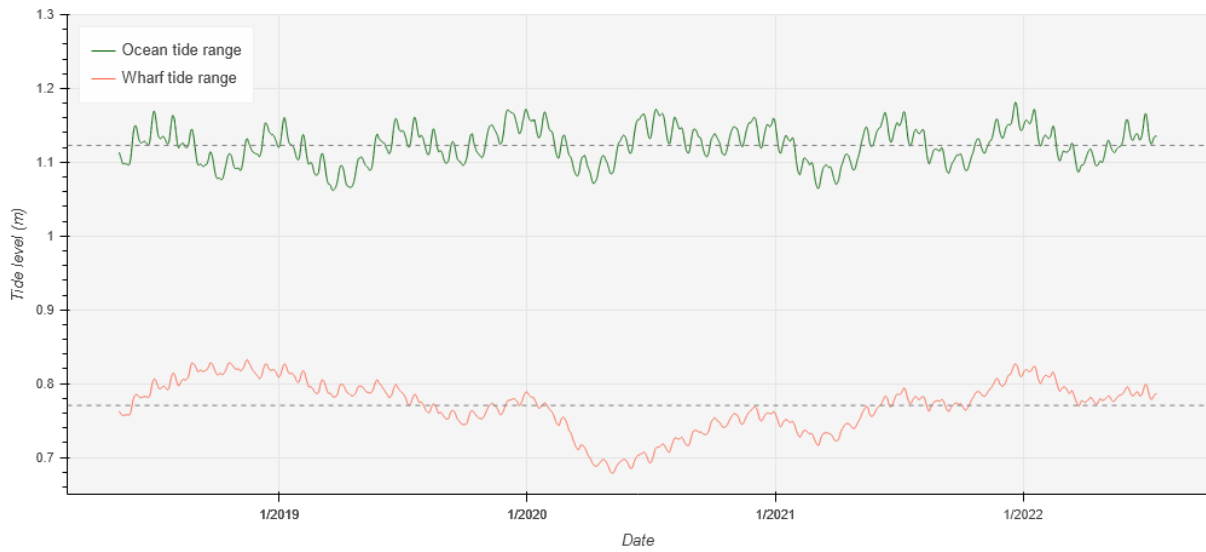
**A-17 Oceanic and Merimbula Lake tidal range timeseries (3 month rolling average)
(Source: MHL, 2022)**
