Review of Environmental Factors

Cuttagee Bridge Replacement

September 2021

Project Number: 21-143

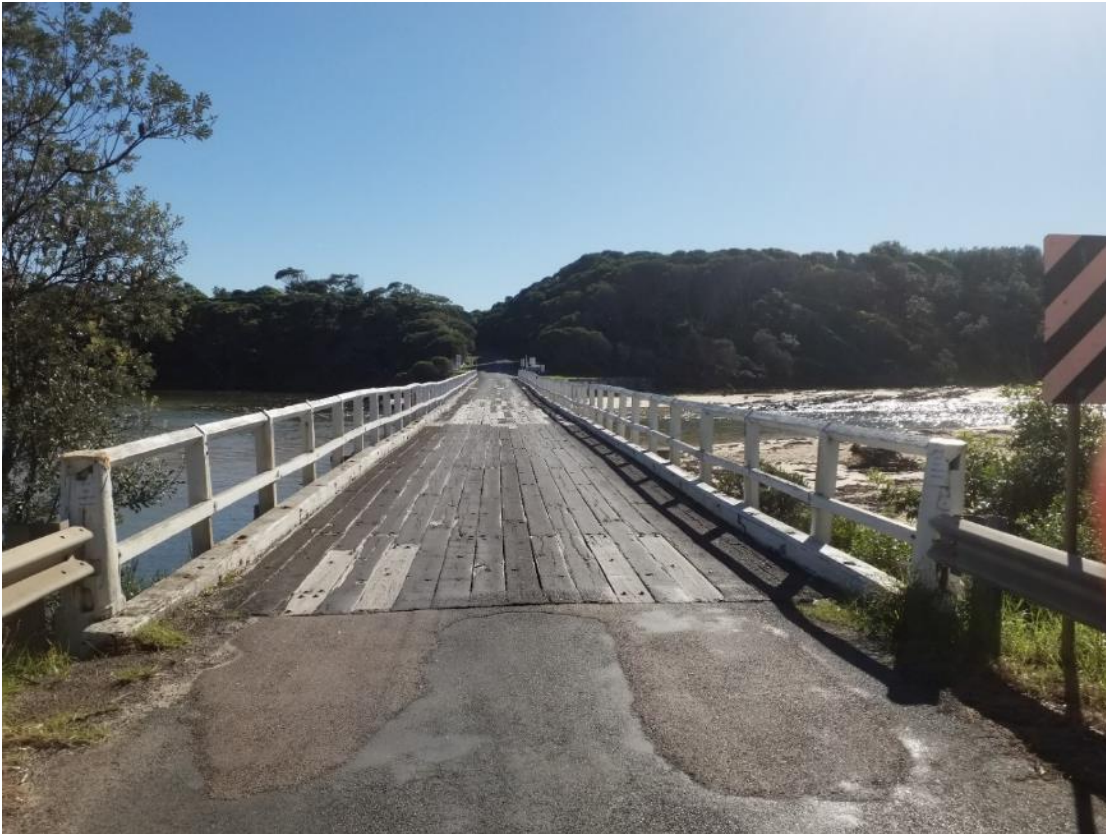
Figure 2-3 Cuttagee Creek Bridge (looking north)

Tathra-Bermagui Road at Cuttagee Bridge is single-lane and wooden-planked with a posted speed limit of 40km/hr. Either side of the bridge, the road is two lanes with a posted speed limit of 80km/h. Cuttagee Bridge is a ten one span timber bridge at the end of its functional life and in need of repair (refer Figure 2-3 and Figure 2-4). The bridge has a current weight restriction of 22.5T.

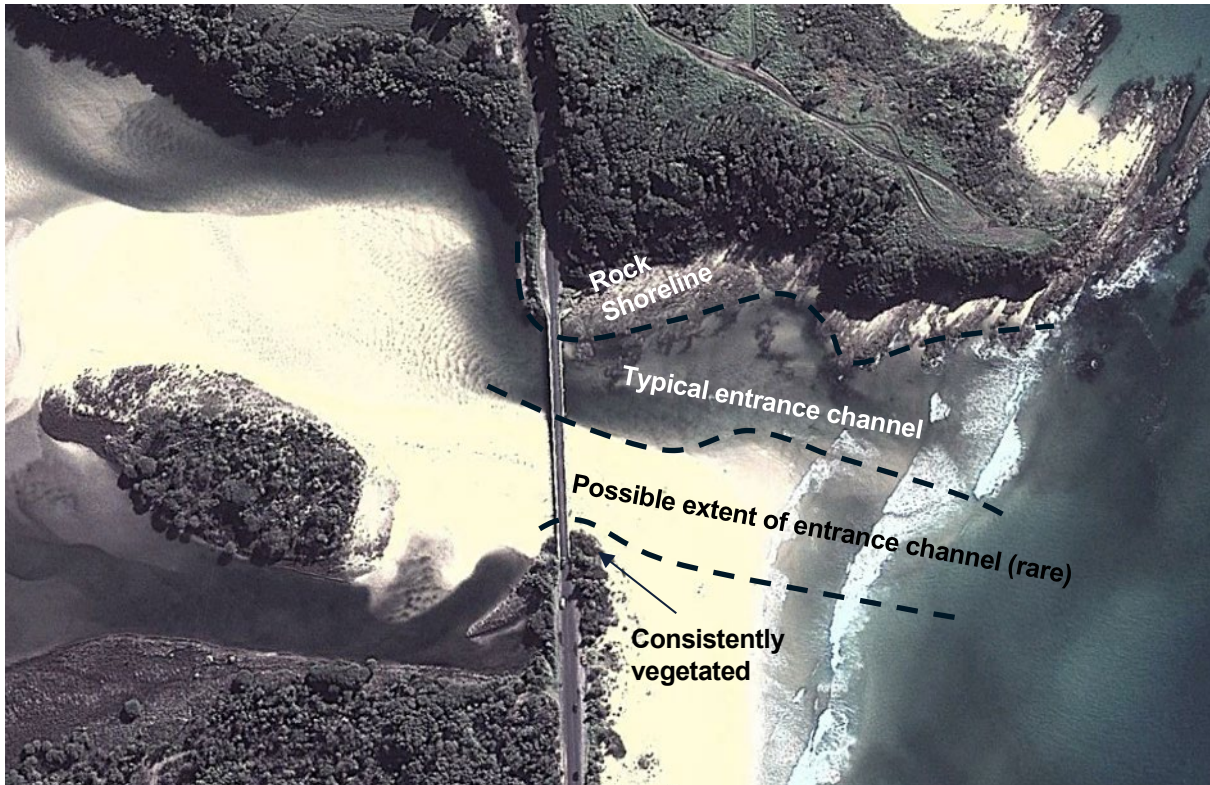
Figure 1: Summary of Cuttagee Lake Entrance Conditions

position during an extreme event. This analysis applied the InletTracker Python toolkit to satellite images from 1987 - 2021, using a novel least cost pathfinding method to determine the channel position, and a machine learning algorithm to ascertain if the lake was open or closed (Heimhuber et al, 2021). This analysis revealed that the sand shoals are dynamic and constantly shifting; however, the channel typically runs closer to the northern abutment of the bridge, as seen in Figure 1. The imagery also revealed that the dune at the southern extent of the bridge is consistently vegetated, in addition to the vegetated island to the west of the bridge. This suggests that these locations are rarely inundated or affected by scour and have been adopted as the southern limit of entrance erosion in this assessment.

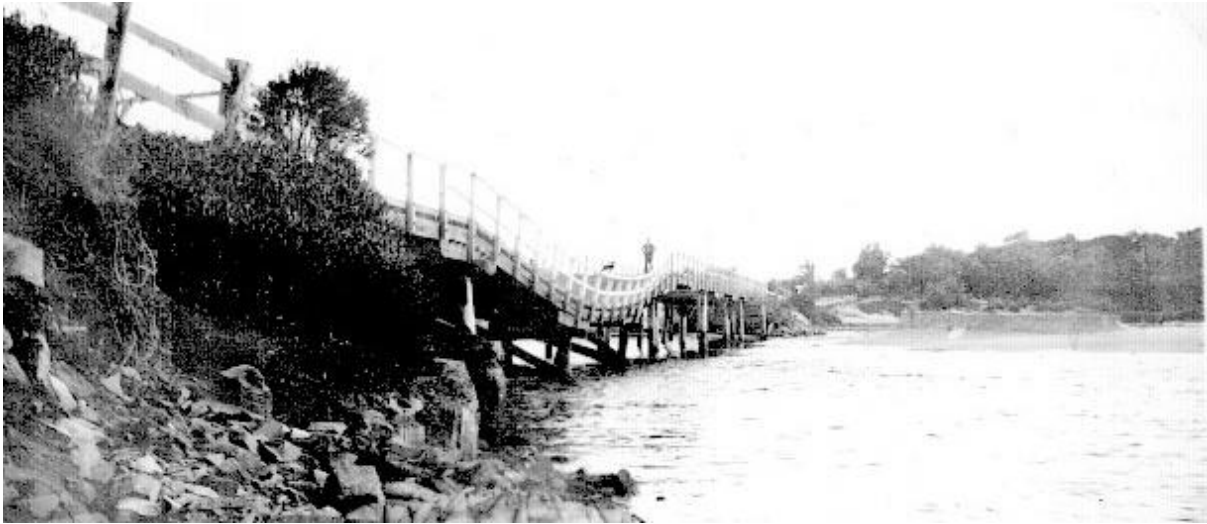
'The piles on the upstream of Cuttagee Bridge were undermined, tipping the bridge sideways so that it could be used only by light traffic using extreme caution'. Looking back: The floods of 1934, Bega District News 23 MARCH 2018.

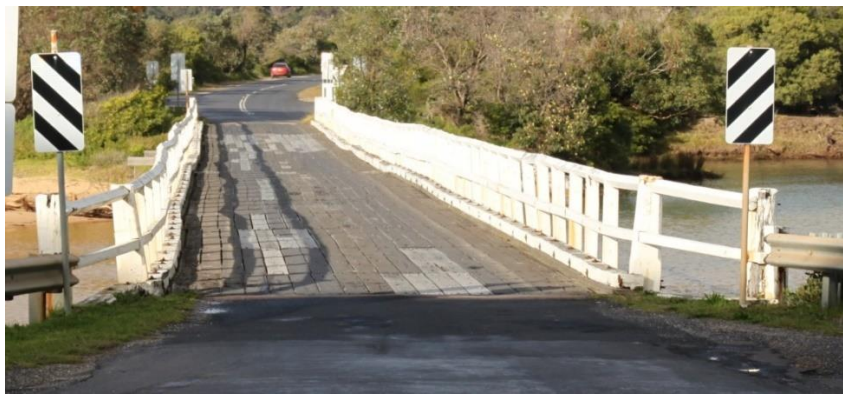
Cuttagee Bridge looking south. The many irregularities in the substructure are reflected in the 'wavy' lines of handrails, kerbing and the deck surface itself. Many timbers have decayed, and metal is rusting. June 2021

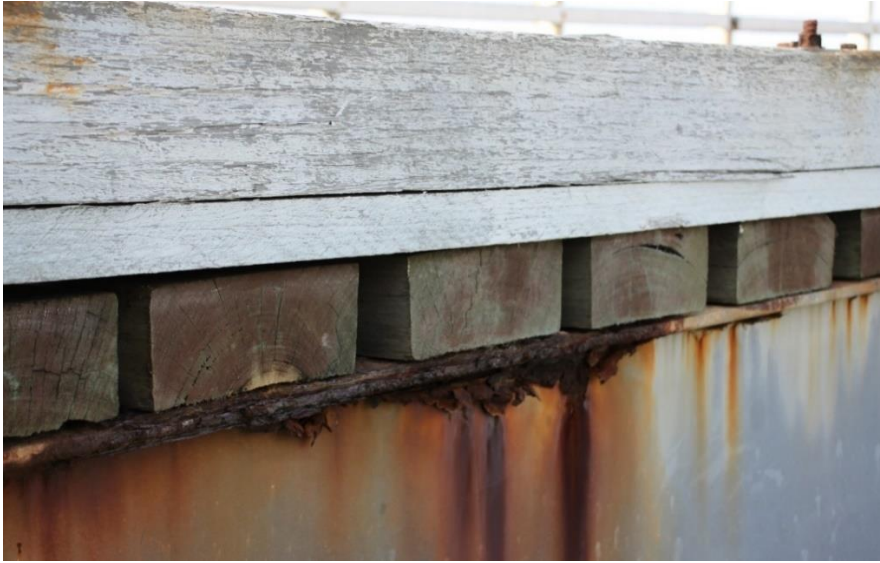
Rusting girders. June 2021

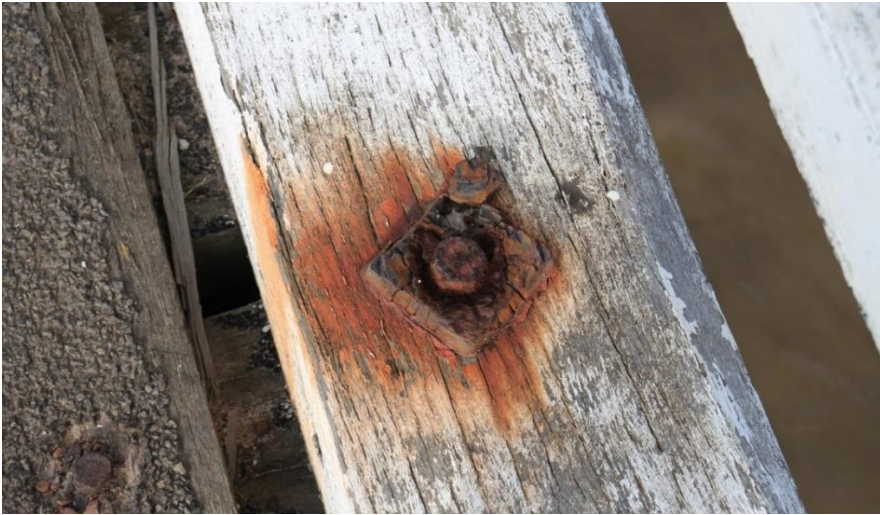
Rusting fixings holding down kerbs, June 2021

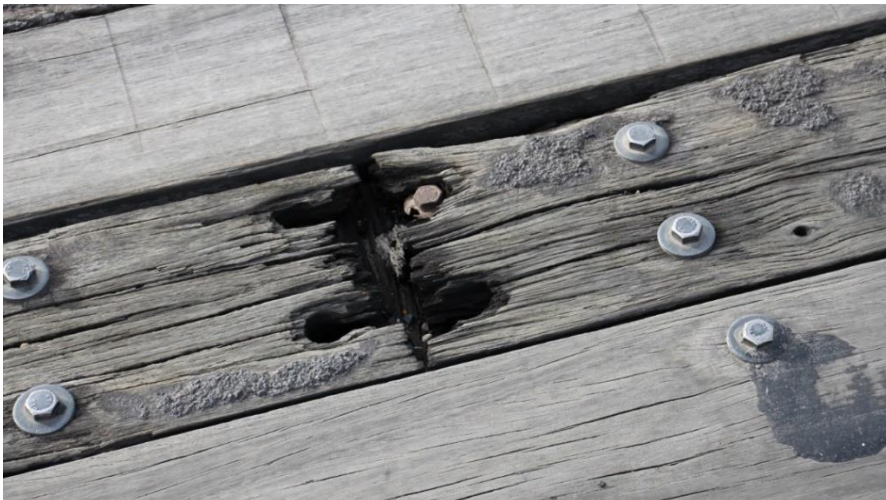
Failing deck timber. This common problem is caused by water entering the timber via the screw holes and causing decay. June 2021.

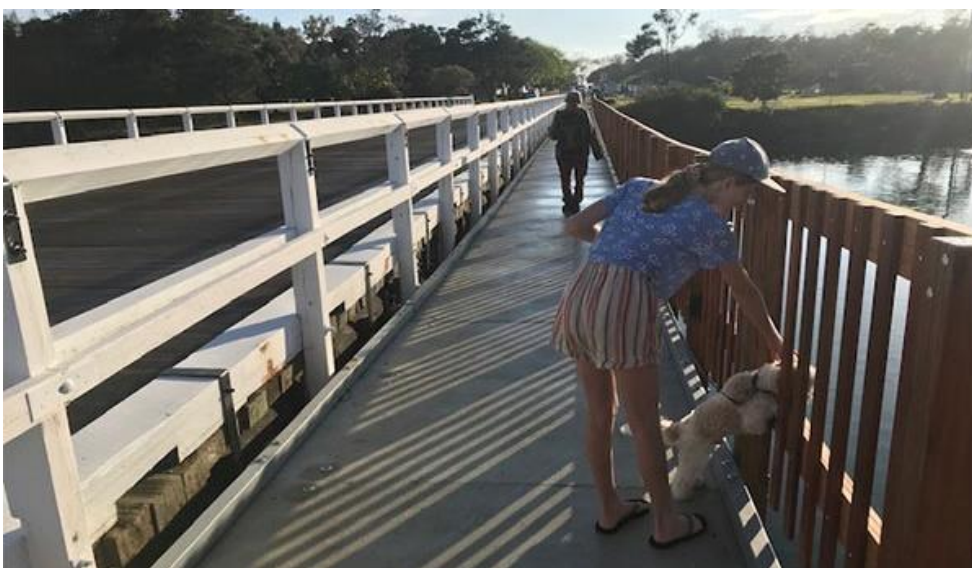
The historic timber railings on the vehicle bridge have been upgraded and painted. The balustrade on the pedestrian bridge has also been upgraded by changing from galvanised steel pipe to clear finished timber.

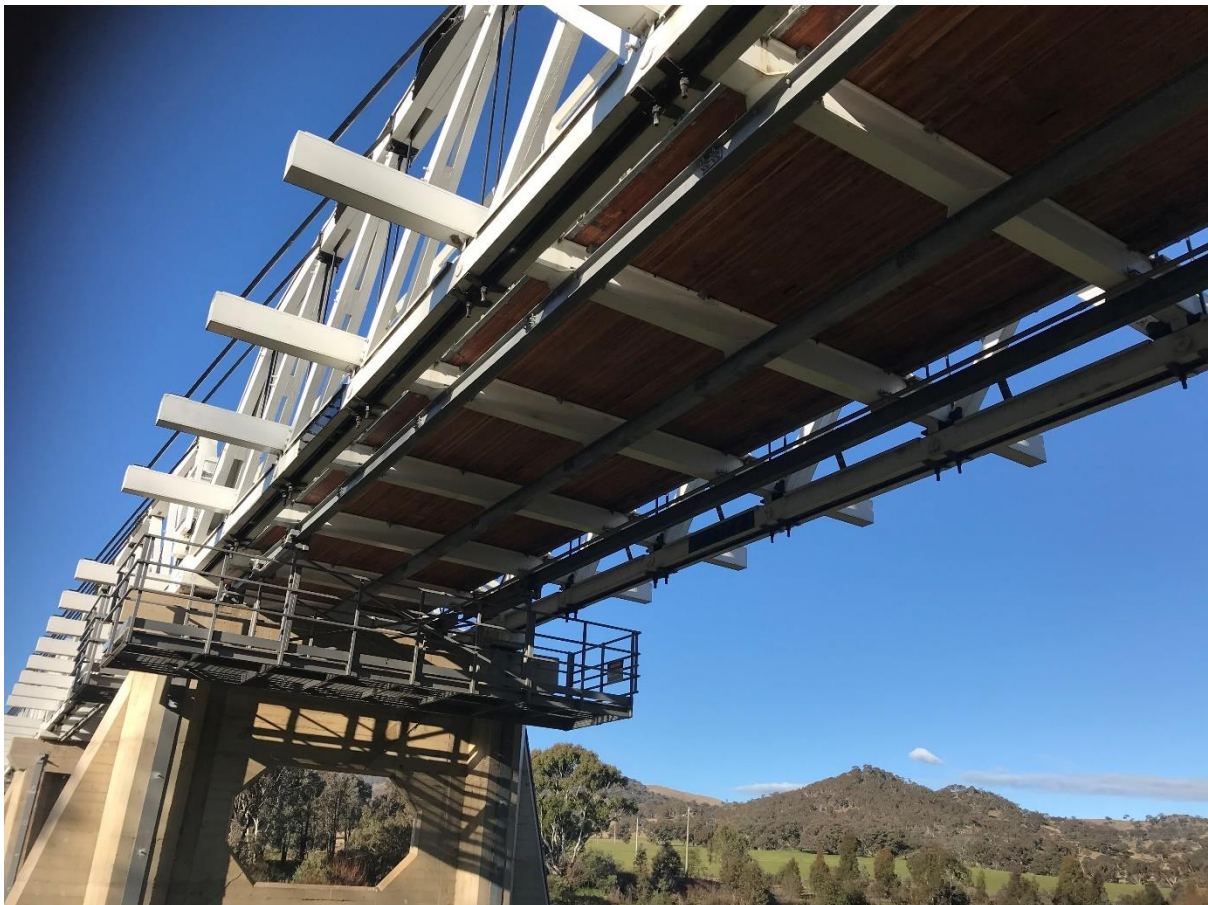
The welded steel cross-beams support the laminated timber deck. Photo July 2021.

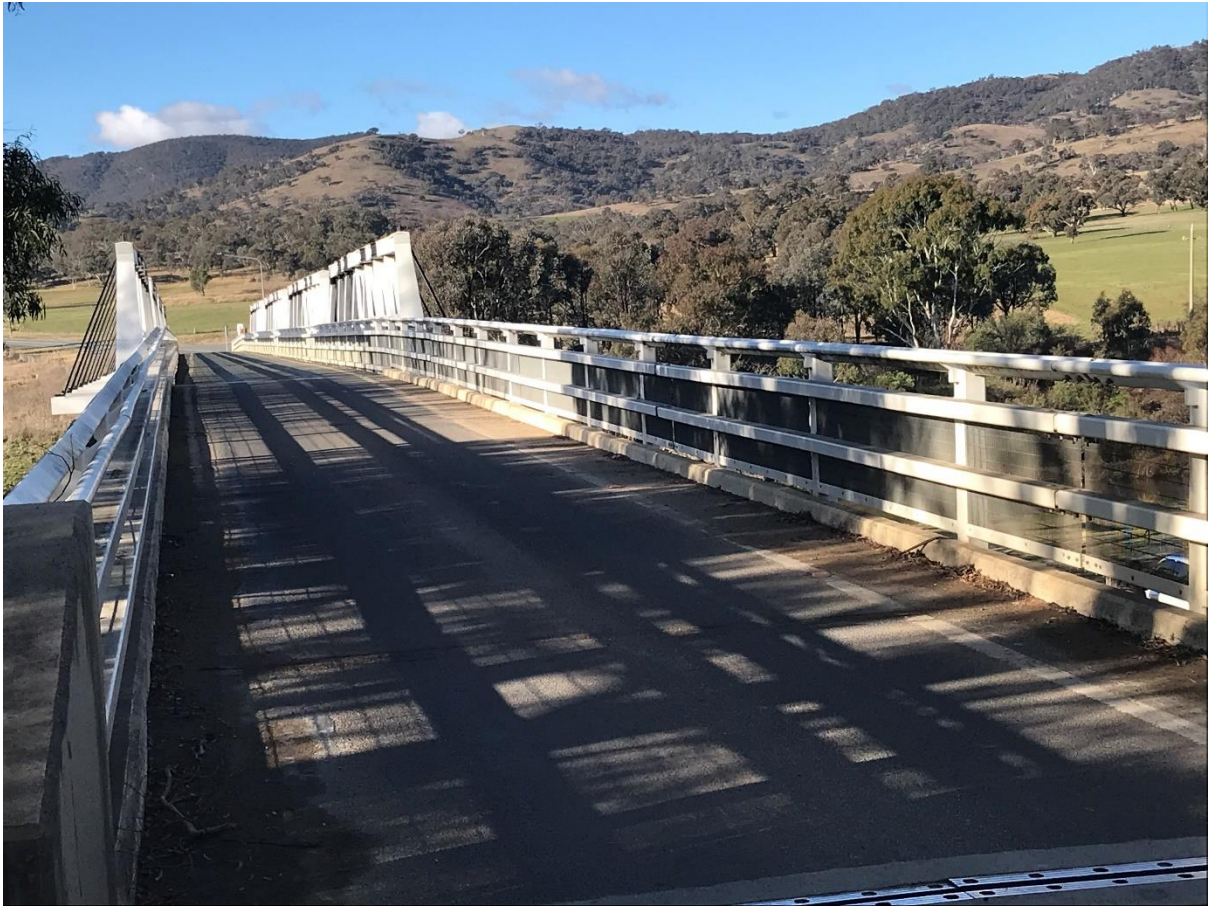
Tharwa bridge is one lane wide, with white painted steel rails closely modelled on traditional detail. Steel mesh is added to the rails to provide greater pedestrian security. The concrete deck on the approach spans has an asphalt surface which unifies the surface and visually ties the concrete approach spans and timber truss spans together.
