# Appendix A: Management Response Evaluation

# Appendix B: Management Action Profiles

**Management Action Title:** Investigation of Entrance Opening  
Trigger Level Sustainability

Wallaga Lake  
Coastal Management Program

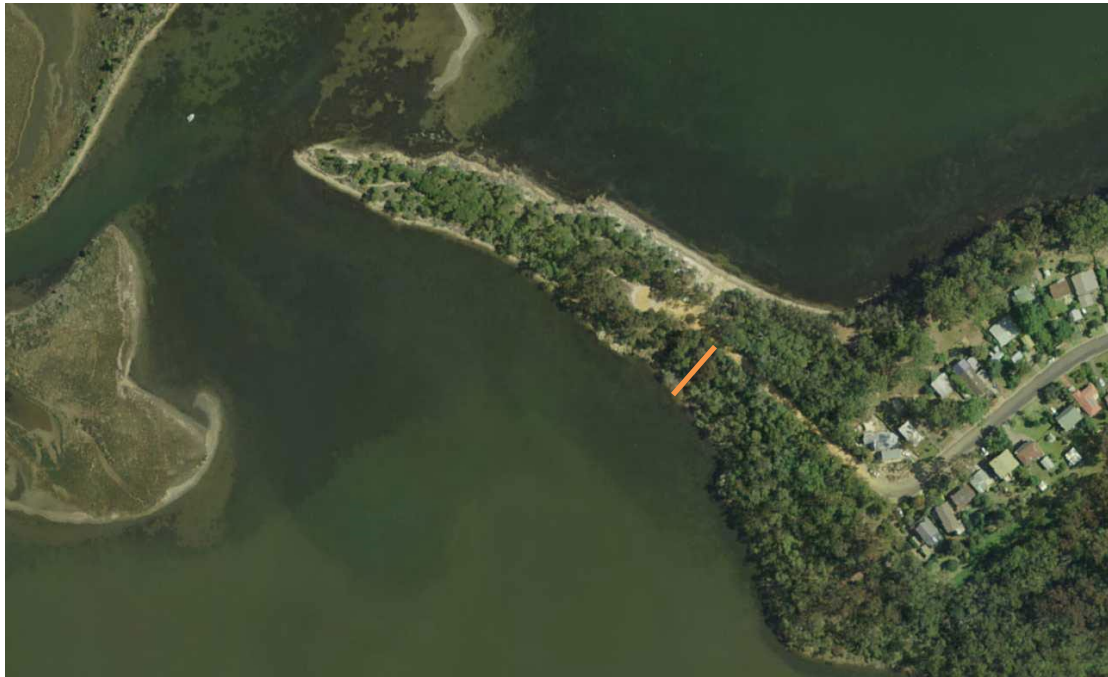
Figure 1: Location of cleared ad-hoc vehicle access to Meads Bay off Fairhaven Point Way

Collectively, and when combined with the informal vehicle access roads around the foreshore at Akolele and Beauty Point (discussed in R5.1), these issues are degrading the quality of the natural foreshore vegetation buffer around the developed section of the lake where it is most required.

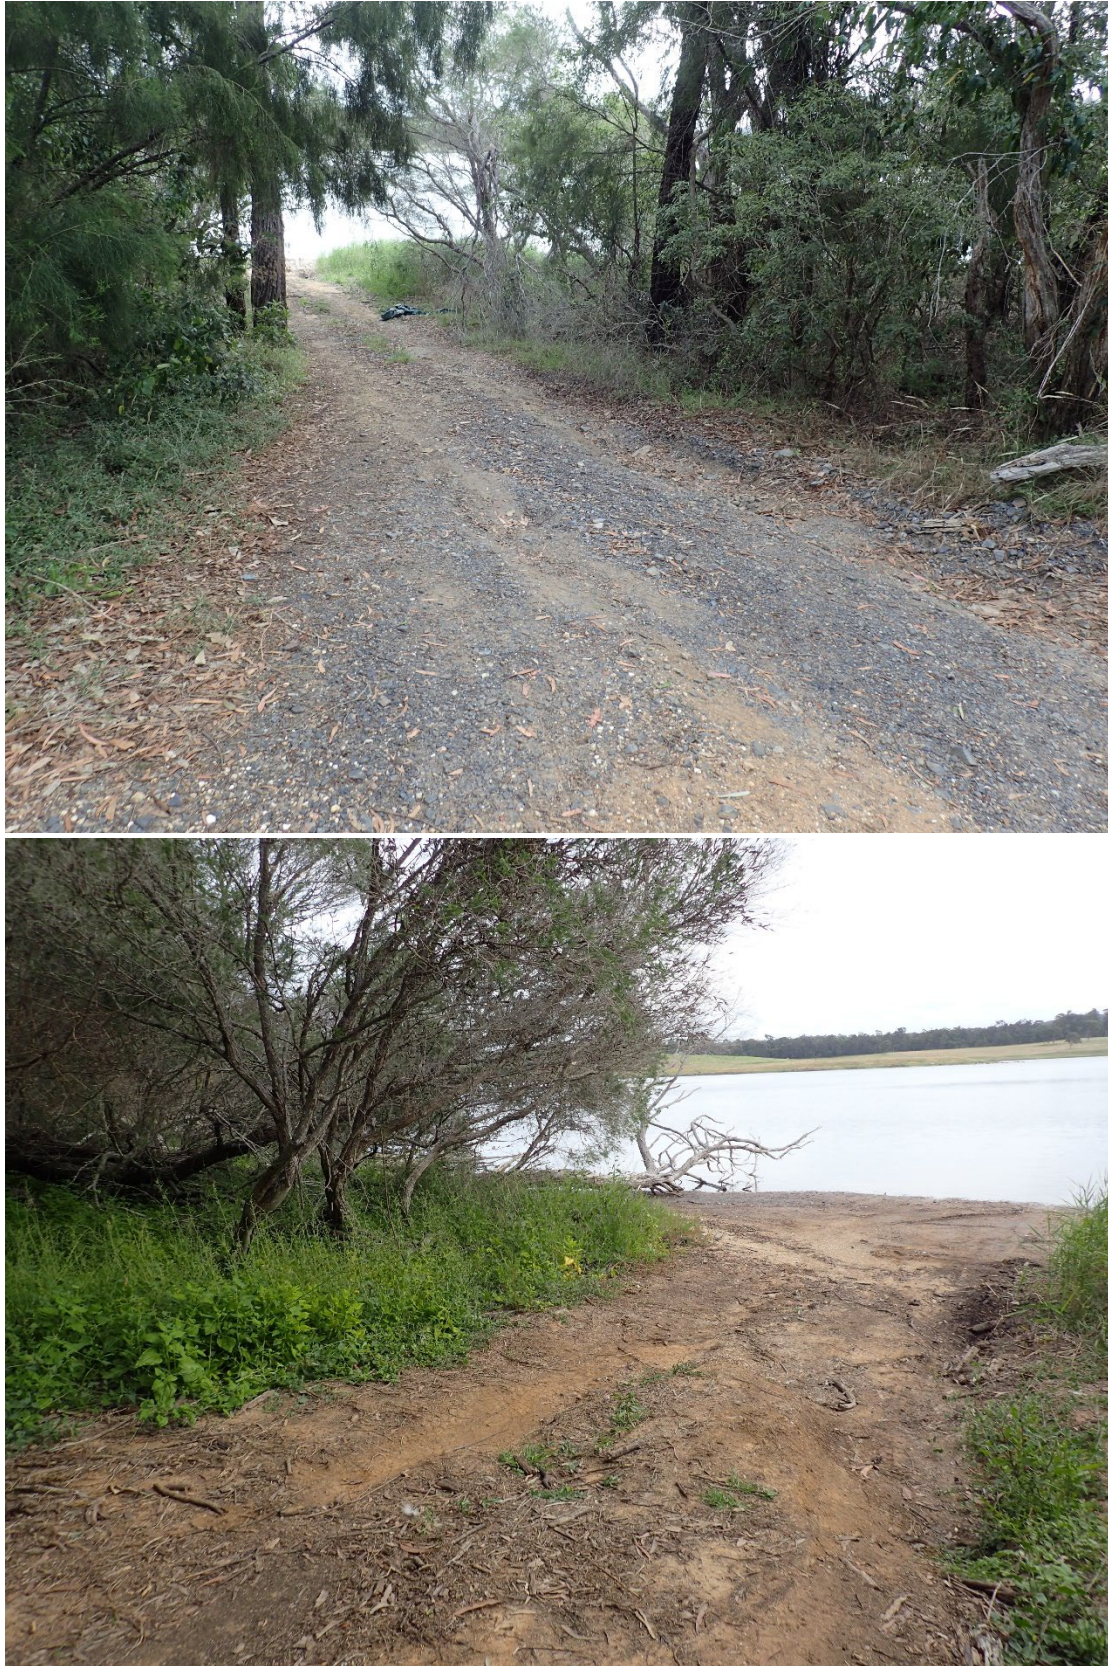
**Figure 2: Cleared ad-hoc vehicle access to Meads Bay**

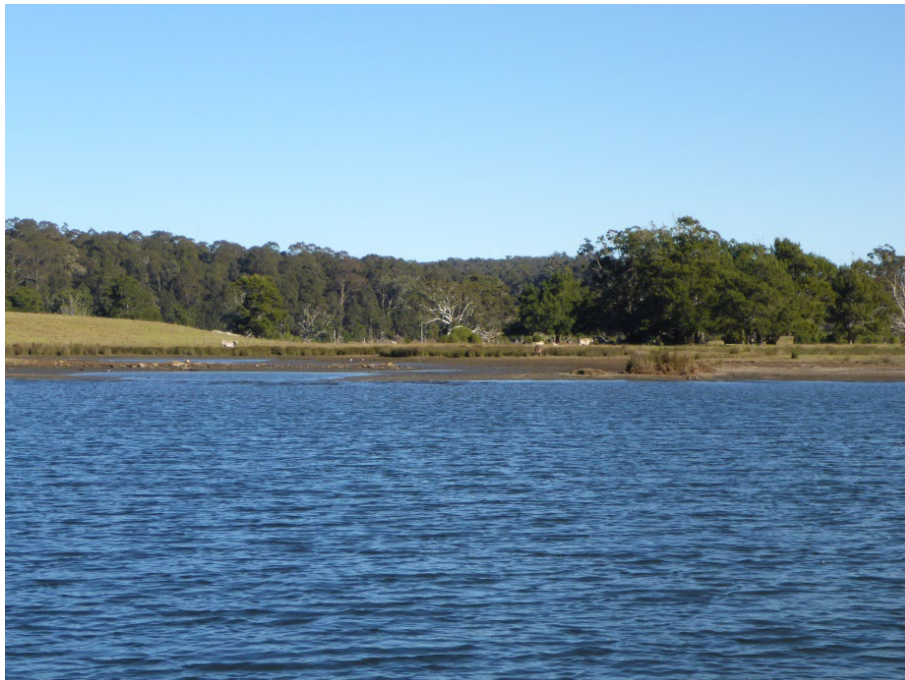
**Figure 1: Example of stock accessing wetland areas of Narira Creek**

Cattle grazing on these areas results in degradation of wetland vegetation communities and promotes erosion of estuary banks, with associated follow on impacts to areas of ecological significance including Meads Bay and Dignams Creek Sanctuary Zones of the Batemans Marine Park.

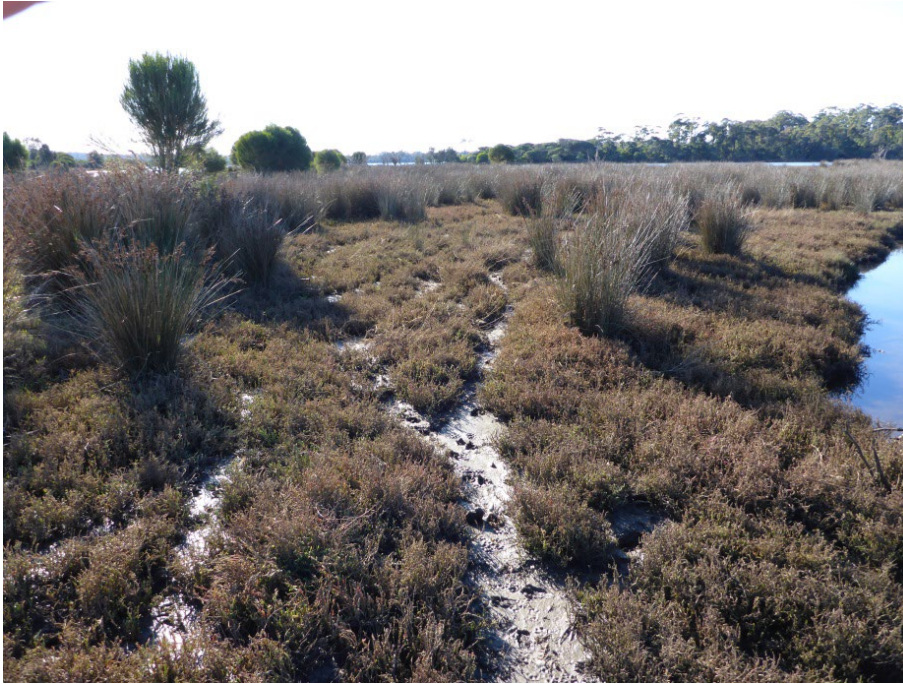
Figure 2: Example of cattle tracks in saltmarsh areas on Crown Land adjacent Meads Bay

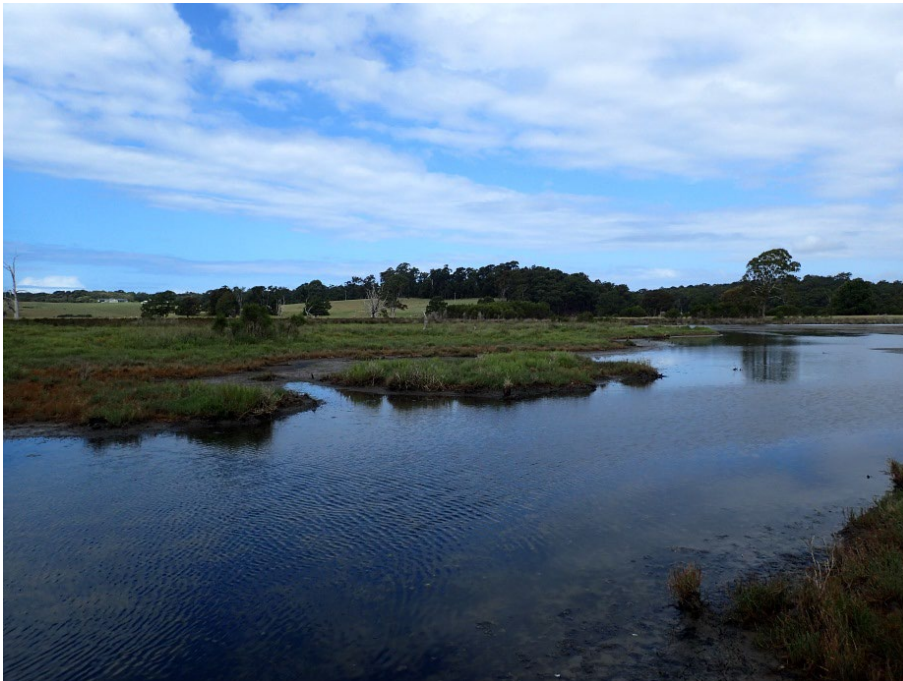
Figure 3: Example of cattle tracks around wetland areas on National Park land at Narira Creek

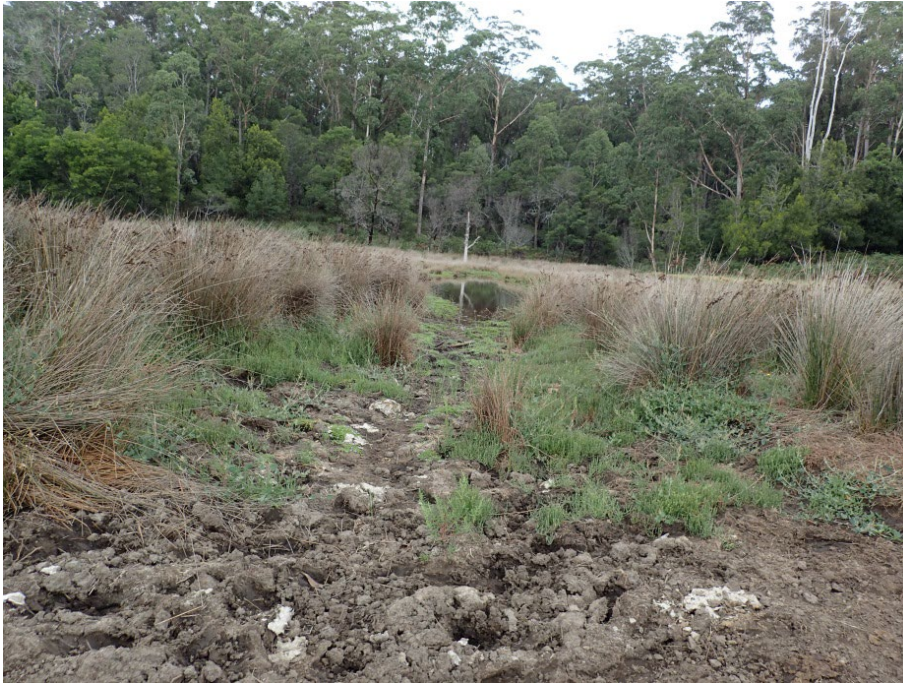
Figure 4: Example of cattle tracks around wetland areas on Private Property, Dignams Creek

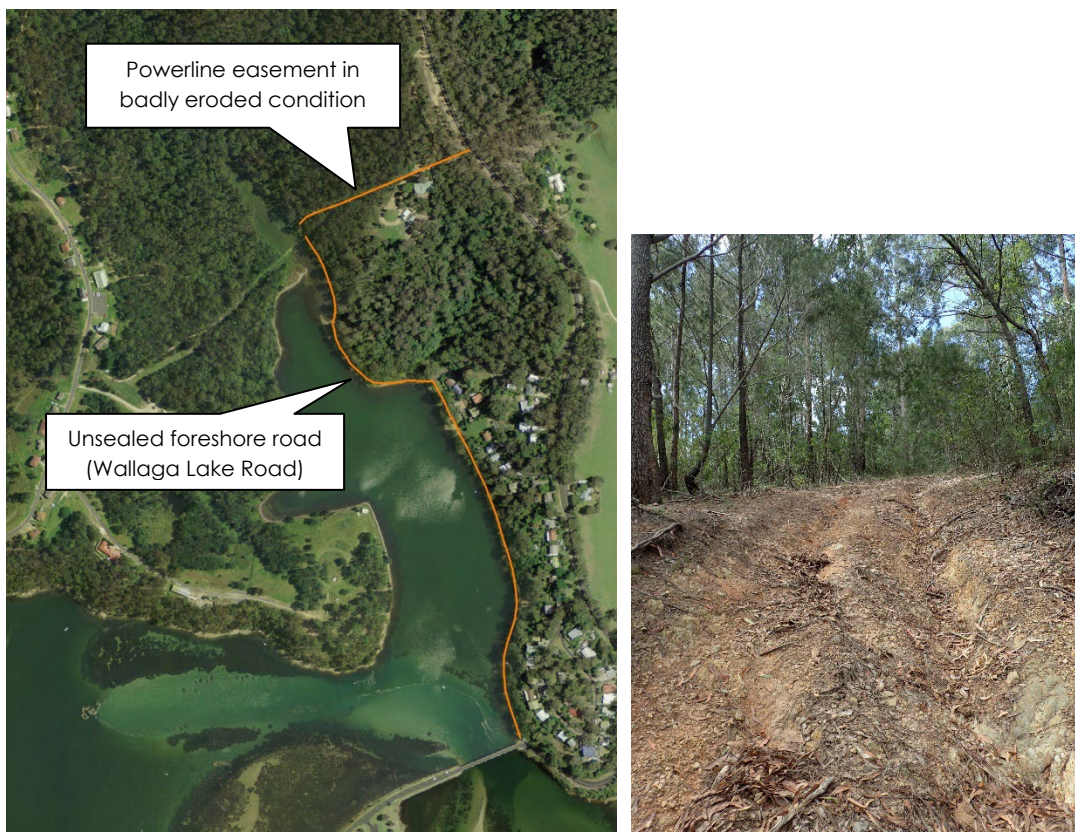
**Figure 1: Unsealed foreshore road and eroded powerline easement track at Akolele**

- The powerline easement access track at Akolele (Figure 1) is in an eroding condition and requires surface maintenance and installation of appropriate sediment controls.

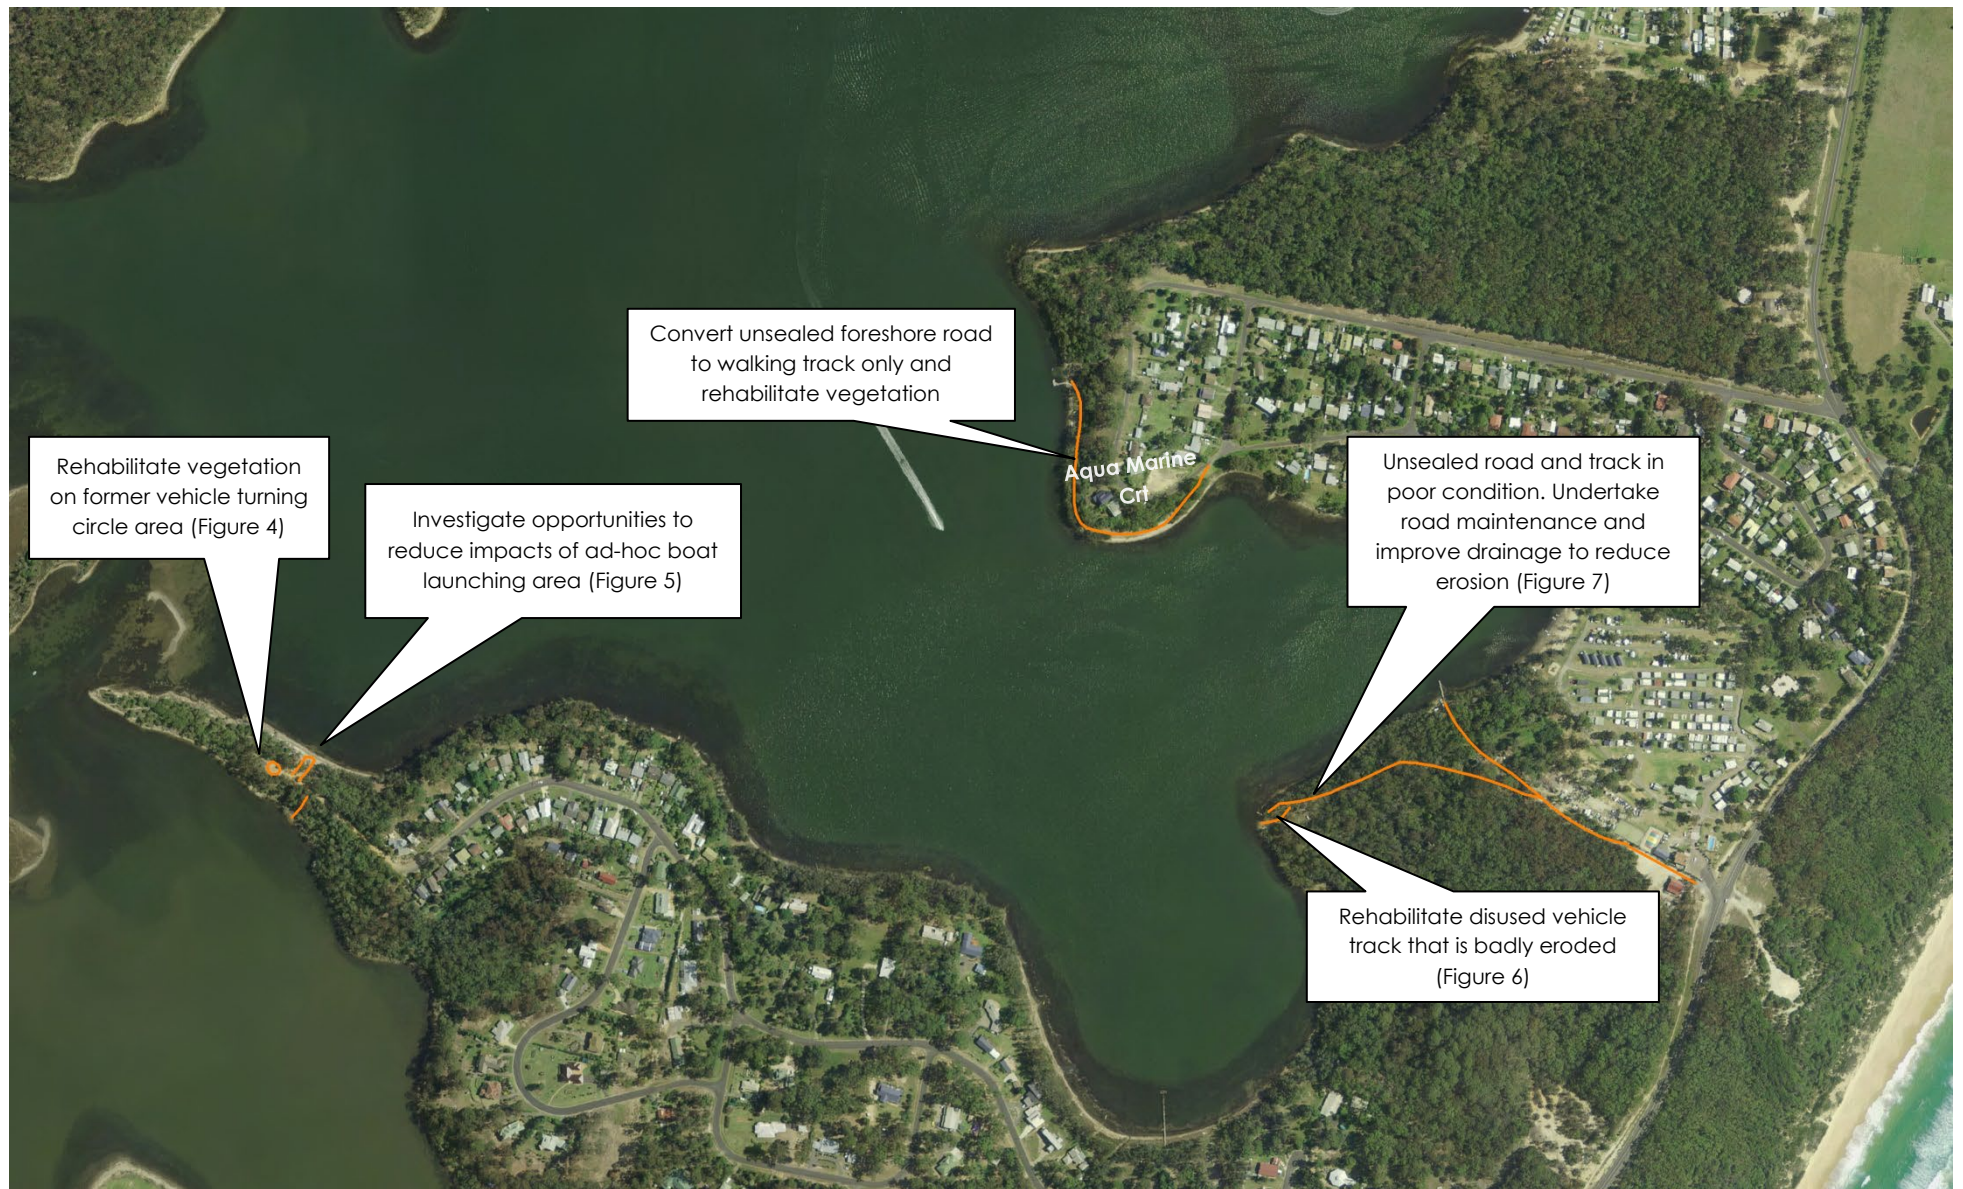
Figure 2: Unsealed roads and tracks in Beauty Point and Fairhaven

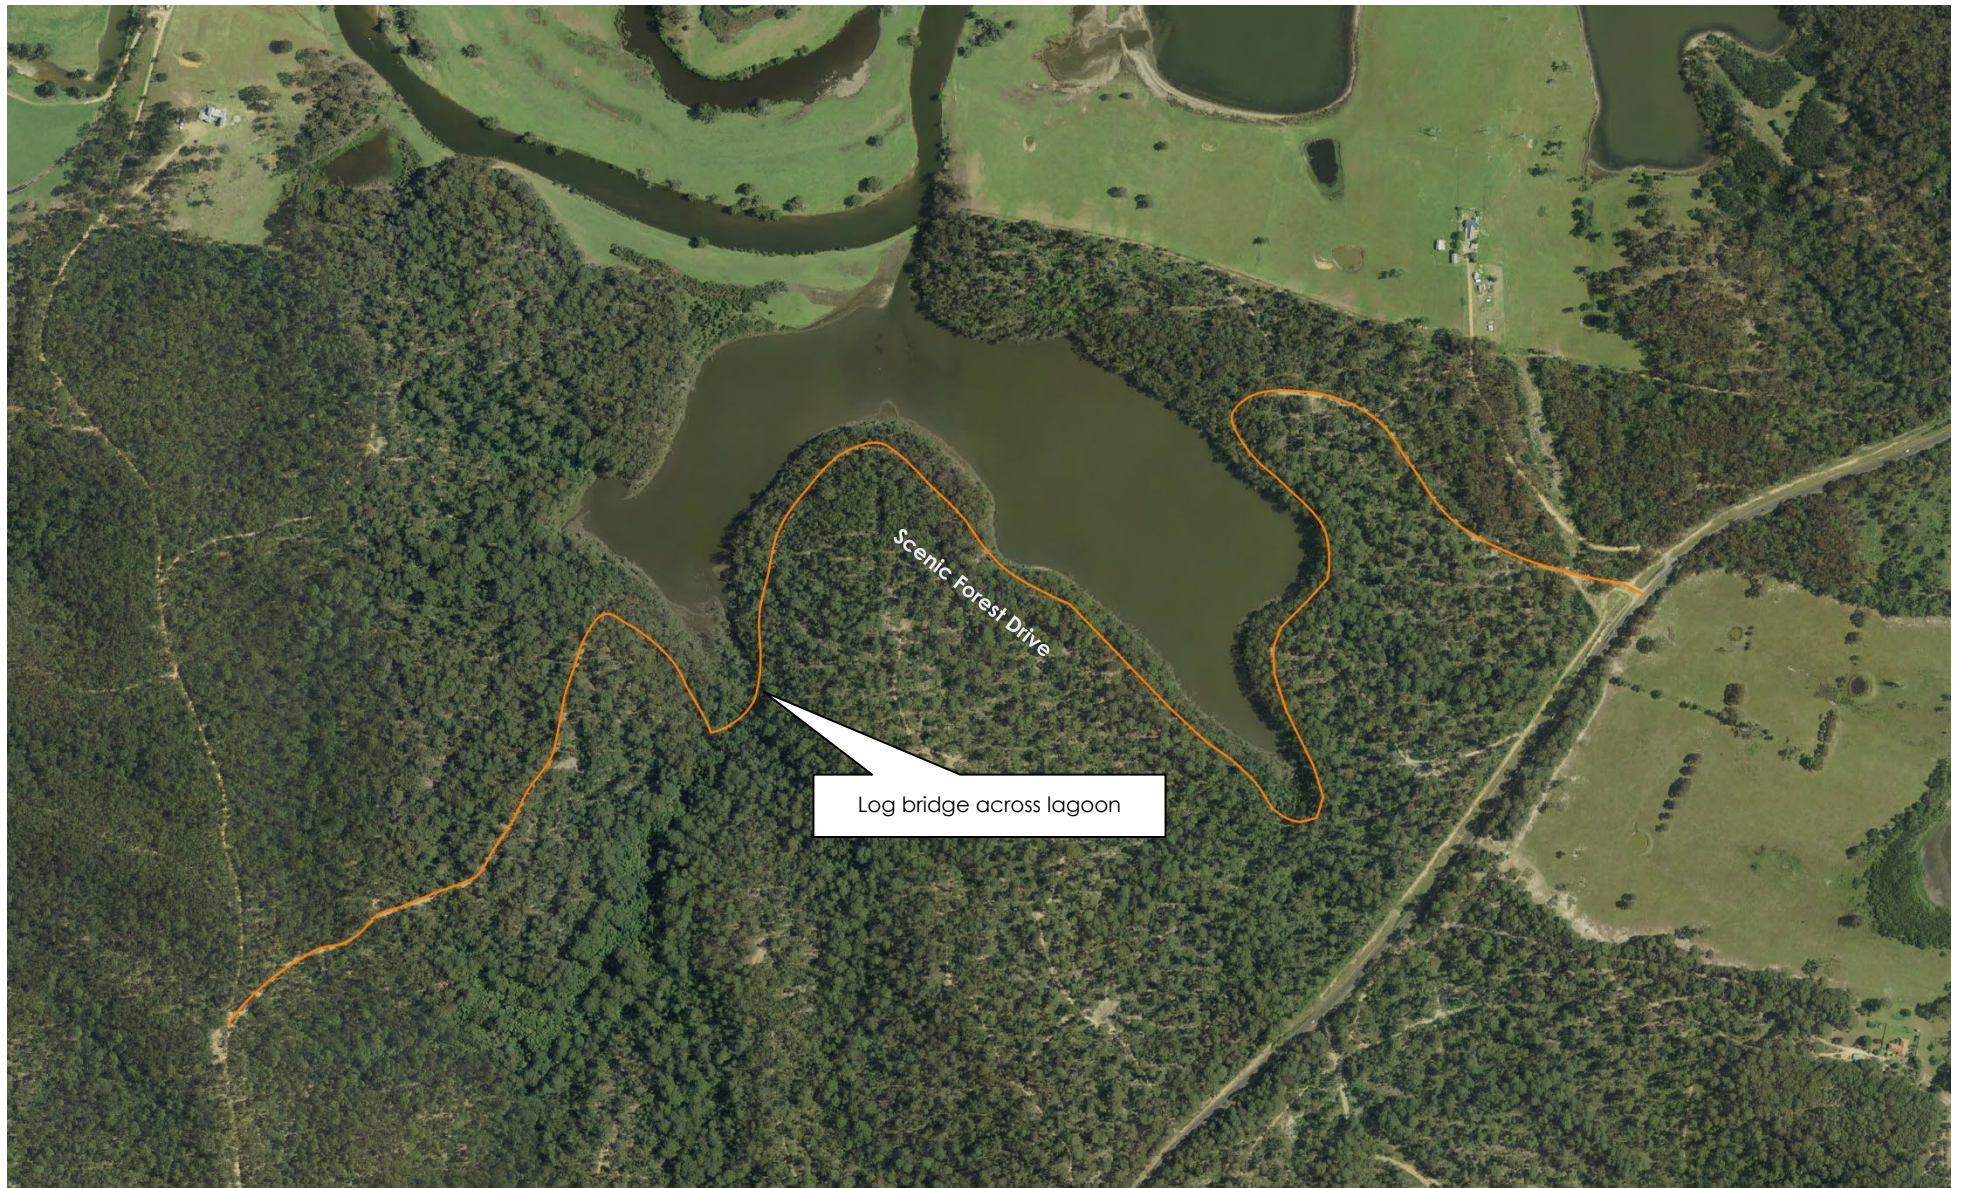
Figure 3: Unsealed roads and tracks in Beauty Point and Fairhaven

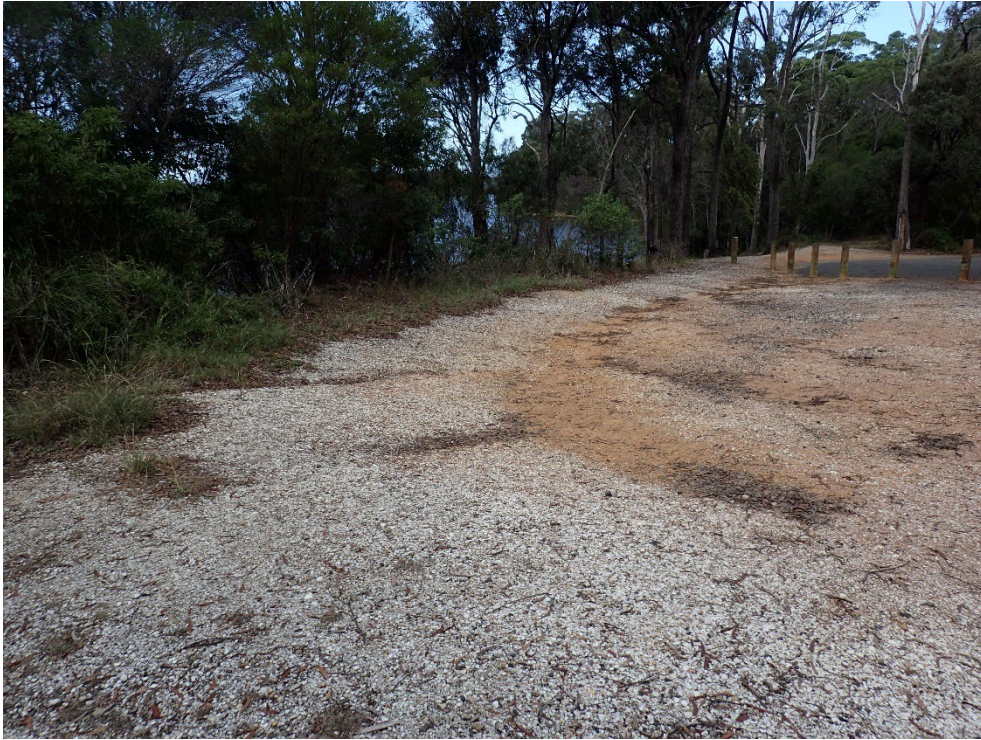
Figure 4: Eroding surface of former vehicle turning area, Fairhaven Point Way

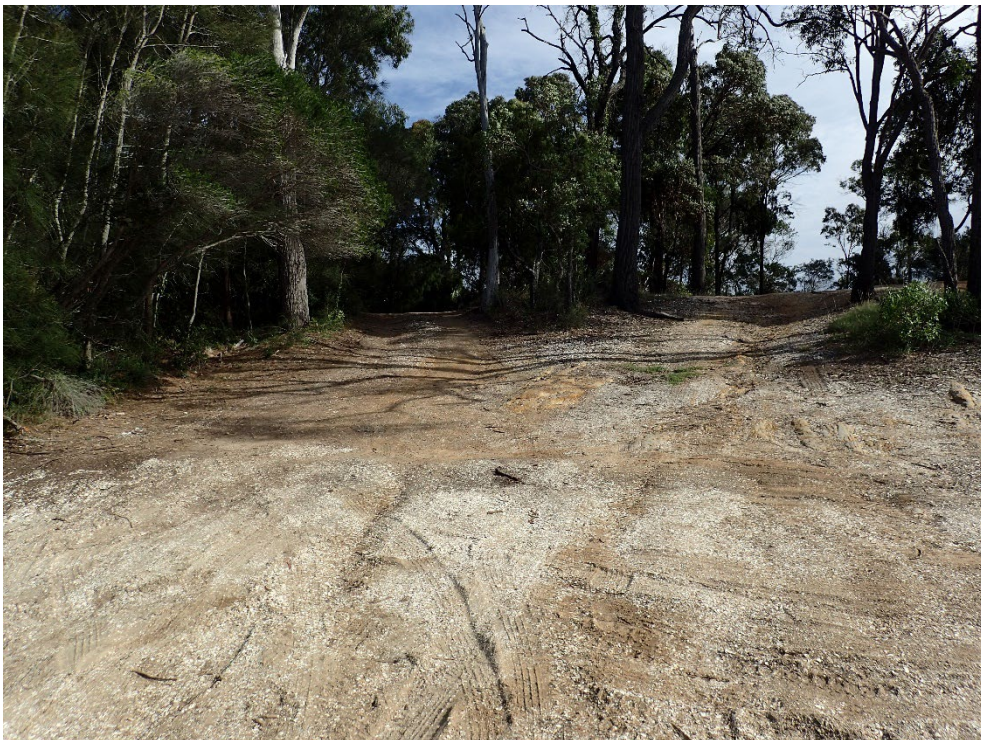
Figure 5: Eroding surface of former vehicle turning area, Fairhaven Point Way

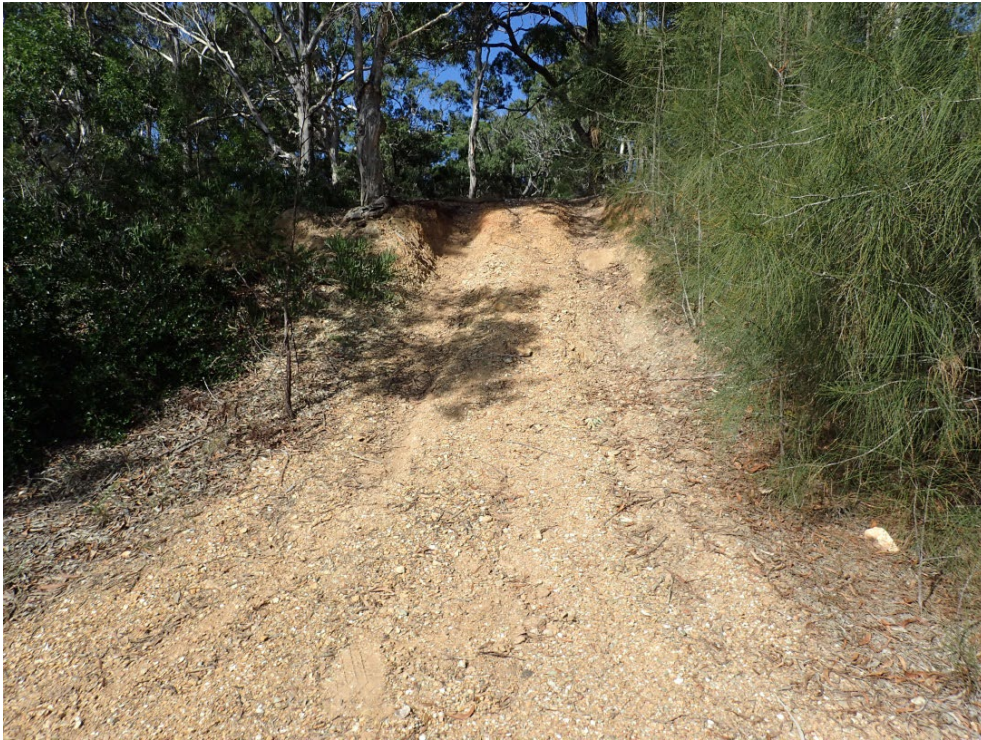
Figure 6: Eroding surface of former vehicle track

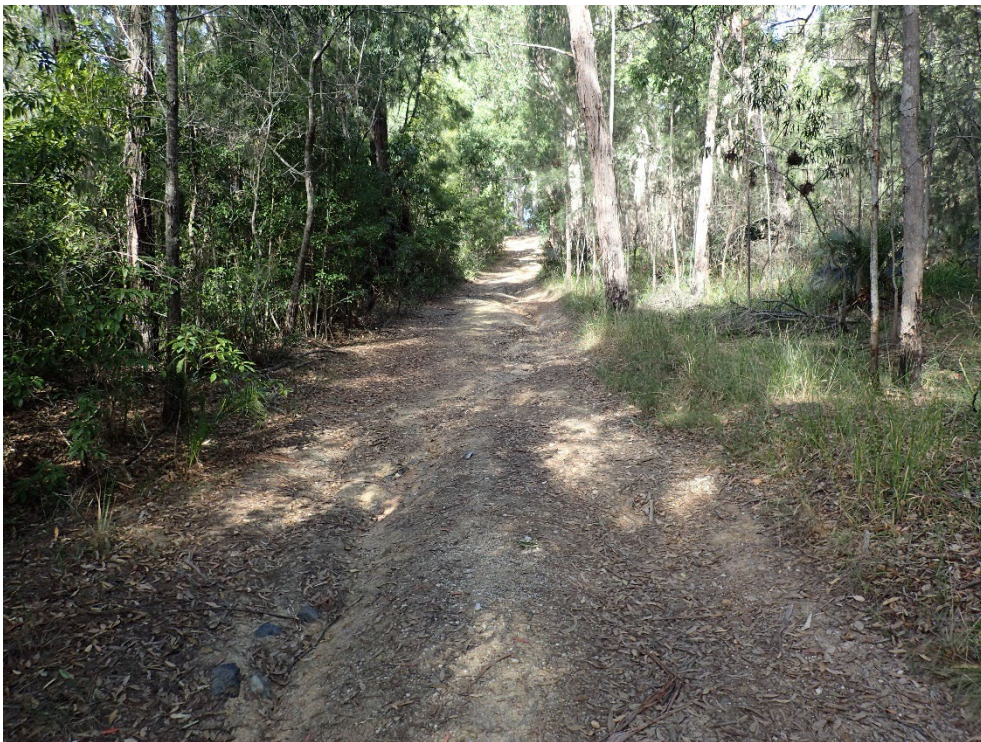
Figure 7: Poor condition unsealed track

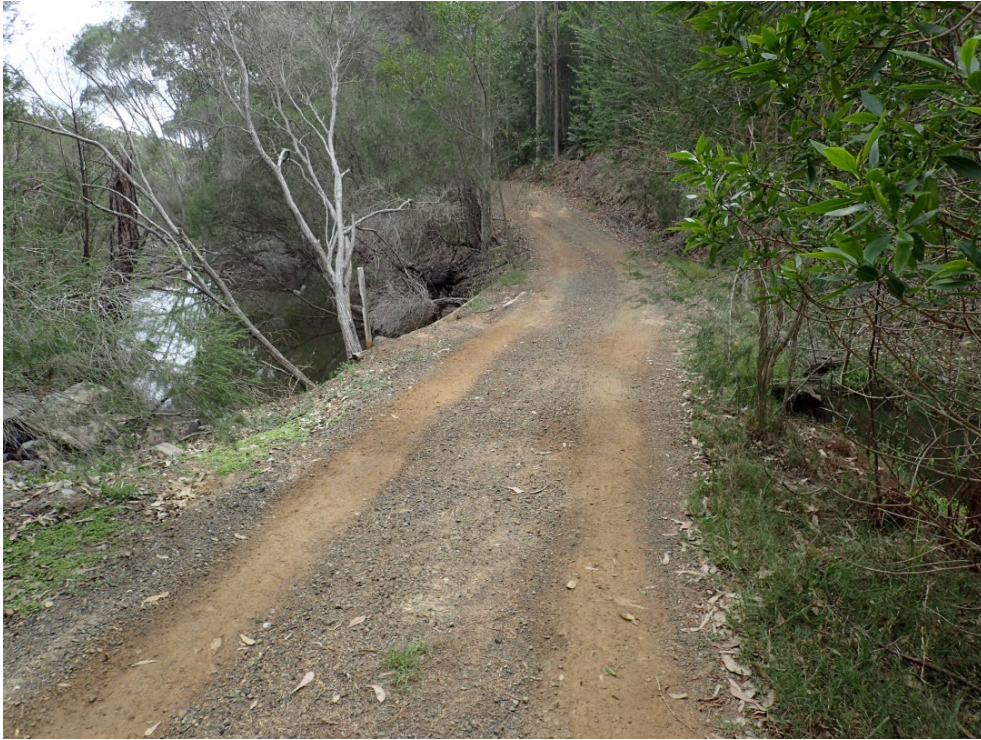
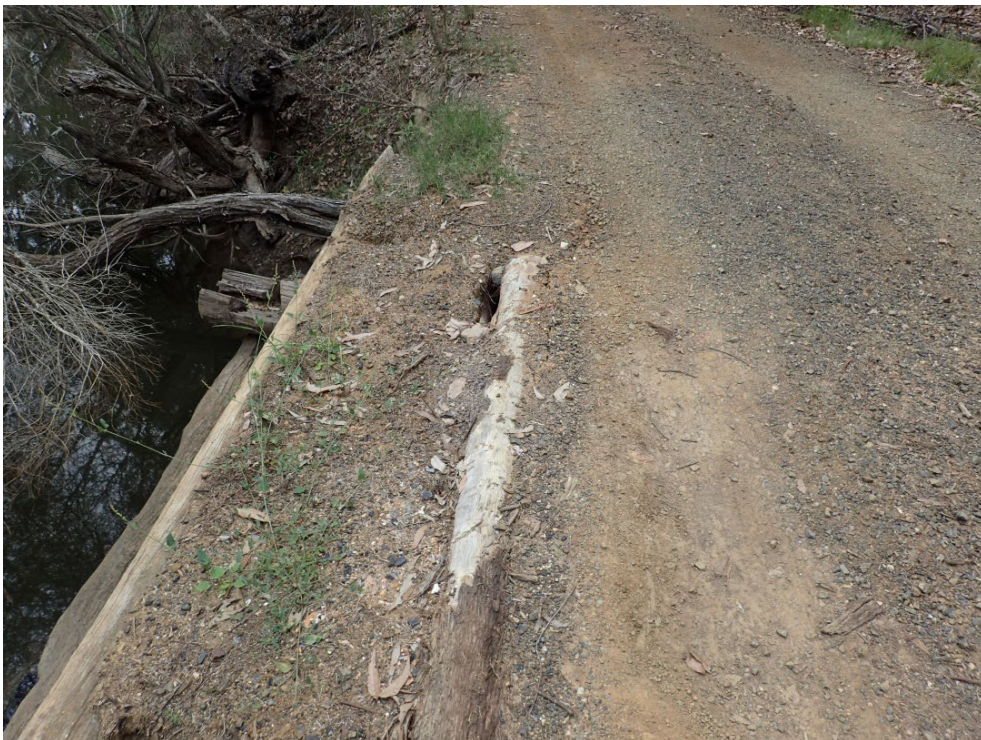
Figure 8: Log bridge on Scenic Forest Way, across Black Lagoon

- While Scenic Forest Way is a long stretch of unsealed road that eventually drains to Black Lagoon, sealing of the road is likely inconsistent with the character and unnecessary while ever the road surface is maintained in good condition and with appropriate sediment controls. However, there is one log bridge over a gully of the lagoon where road base and sediment are readily contributed to the lagoon (Figures 3 and 7). Consideration should be given to replacing the bridge with box culverts and sealing of this low-lying section of the road.

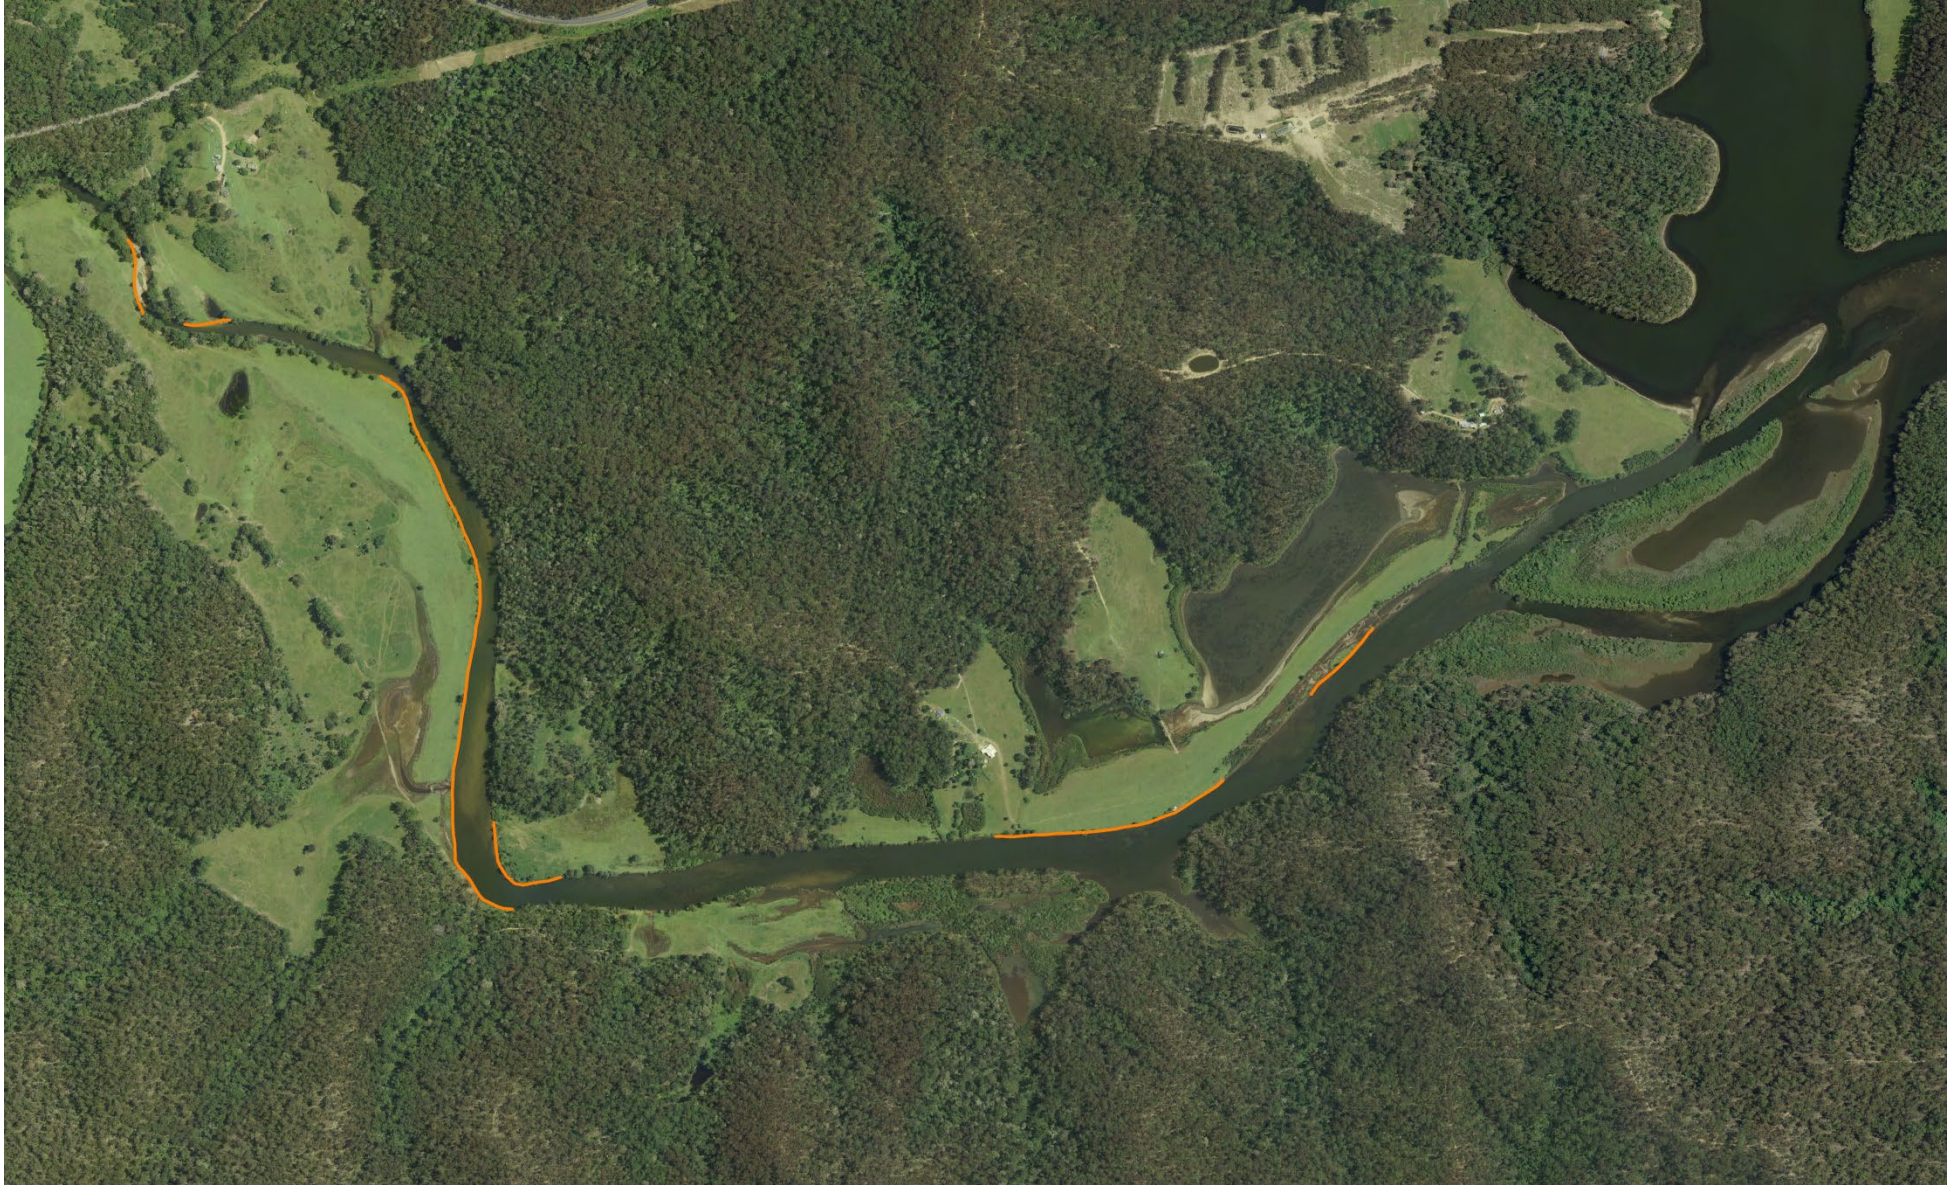
Figure 1: Zones of Bank Erosion/Slumping, Dignams Creek Estuary Branch

Extensive areas of riparian foreshore are (or have previously been) grazed to the water's edge by cattle, resulting in degraded banks and increased sediment loads to rivers/lake at some locations, while at other sites it has simply prevented the establishment of native fringing vegetation communities (including both terrestrial and intertidal/high stand wetland species). This has been recorded during site inspections along banks of Meads Bay, Narira and Dignams Creeks, and the areas where these creeks join the main body of the lake.

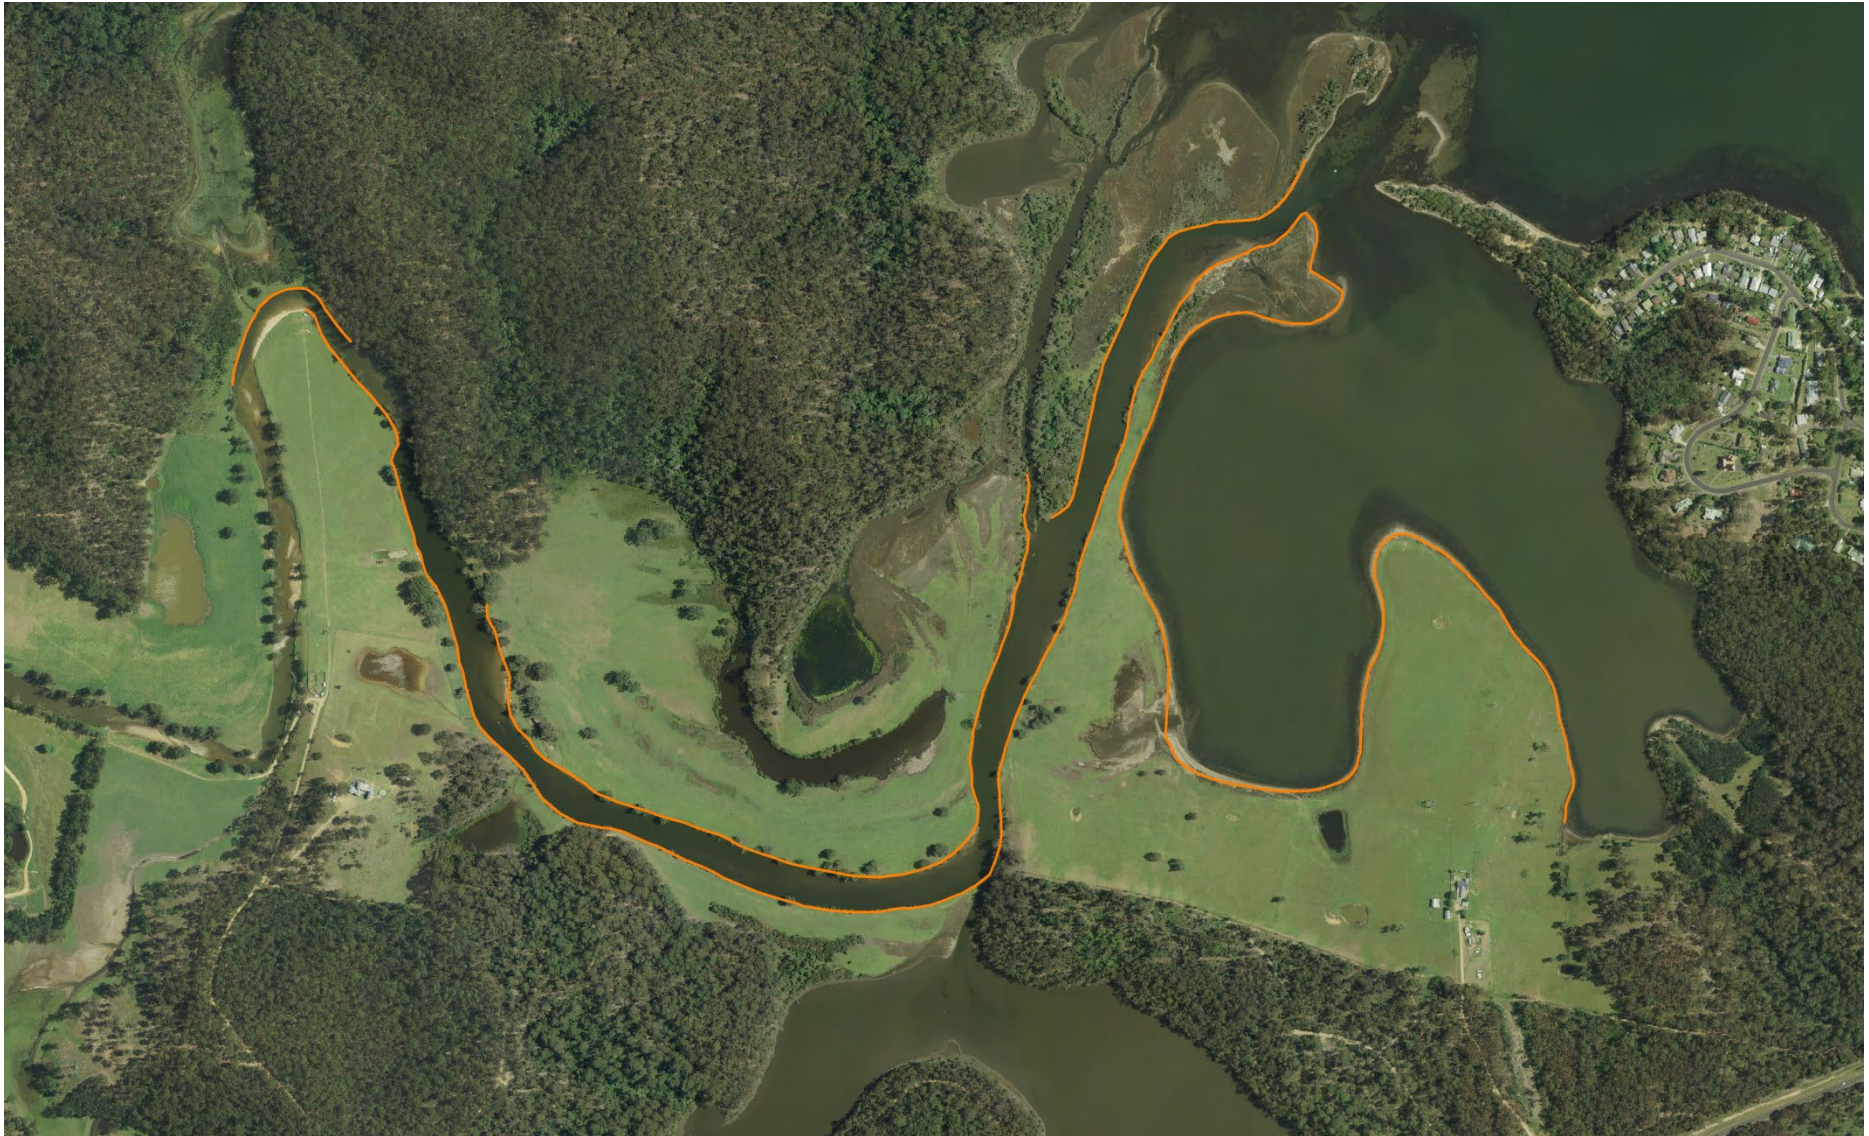
Figure 2: Zones of Bank Erosion/Slumping, Narira Creek Estuary Branch

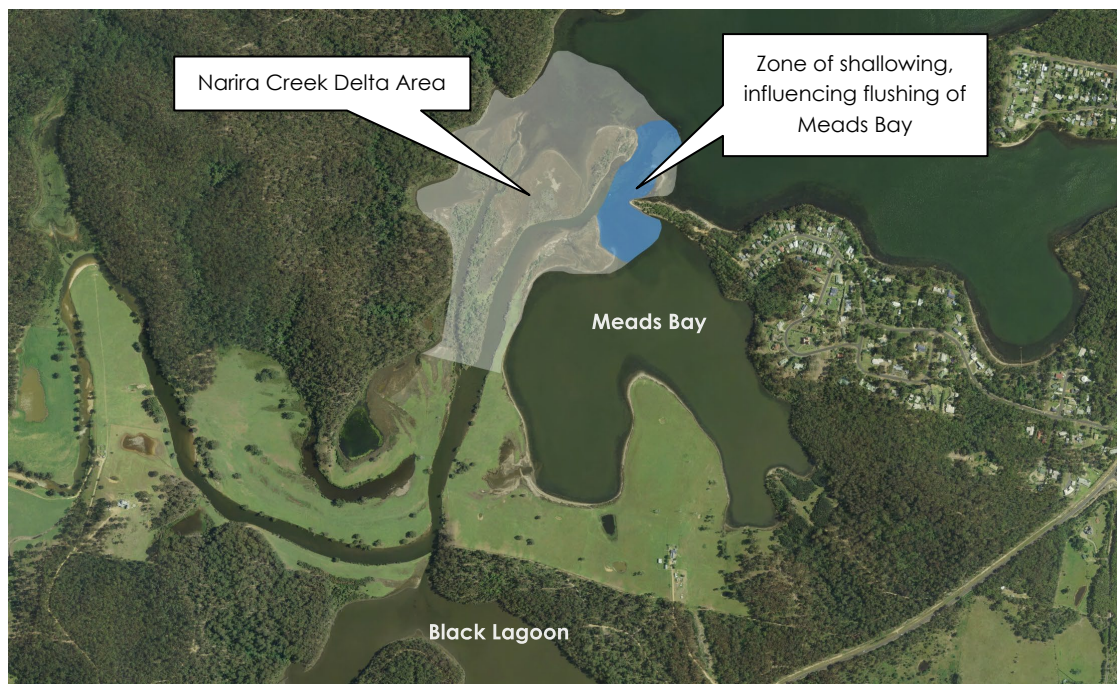
**Figure 1: Location of Narira Creek delta, Meads Bay and Black Lagoon**

The Narira Creek fluvial delta at the entrance to Mead's Bay has anecdotally been accreting at an accelerated rate. This zone of the lake is a depositional point for catchment derived sediment that moves down the catchment during floods. Due to the layout of the lake, the growth of this fluvial delta both in planform area and localized shallowing of the lake depth has the potential to significantly alter the hydraulic function and hydrodynamics of both Meads Bay and Black Lagoon. This issue was previously identified in the Wallaga Lake Estuary Management Plan (2000), and remains a relevant concern, as raised by stakeholders during the preparation of this CMP.
