# Cuttagee Lake Rapid Catchment Assessment

## Catchment Management Plan

**Bega Valley Shire Council**

*15 July 2016*

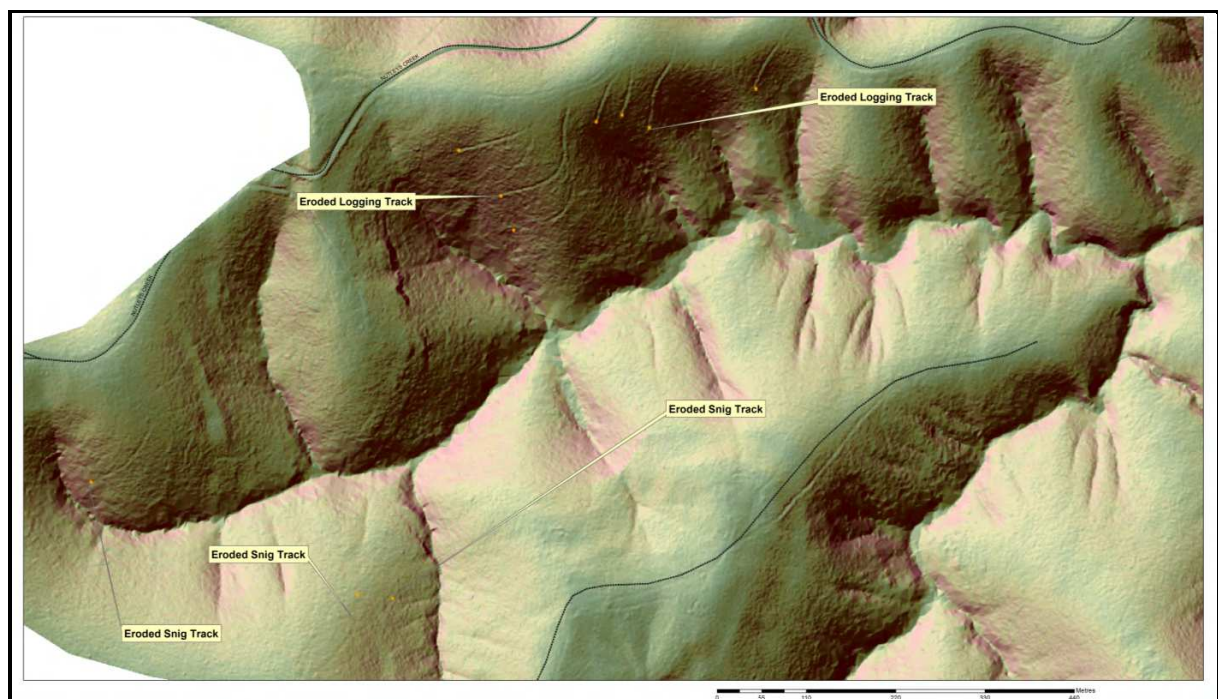
**Figure 12.** Example of forestry logging roads and snig tracks identified on the enhanced DEM and slope analysis.

The potential erosion assessment identified the many logging roads and snig tracks constructed in the catchment from historical forestry operations, particularly in the upper catchment with example image shown in **Figure 12**. Soils in the Cuttagee catchment are classified as erosional soil landscapes (DLWC 1999). This means that soils are extremely sensitive to disturbance and are particularly prone to erosion when they are disturbed. Constructed logging roads, tracks, and snig tracks are vulnerable to erosion, especially when runoff concentrates in these depressions, and without appropriately functioning runoff controls, begin to behave like first order drainage lines. Sediments may be mobilised from the surfaces of unsealed roads in even low to moderate rainfall events. These areas are likely to continue to erode until they reach the underlying bedrock or dense clays.

Erosion of logging roads and snig tracks may be a dominant source of sediment supply to the estuary. Certainly there is evidence of excessive and recent sediment deposition on the fluvial delta of Cuttagee Creek, which may be from identified potential erosion sites in the upper catchment. However, further assessment would need to be undertaken to estimate the amount of sediment sourced from the upper catchment that is supplied to the estuary.

Most of the potential erosion sites identified in the upper catchment would be difficult to access and it may not be practical to implement remediation actions. It is important however, to have an overview of the distribution of potential erosion sites and where possible, inspect sites to assess erosion significance. Also, major unsealed roads and trails may need to be regularly maintained and inspected by the relevant authority, particular adjacent watercourse crossings.

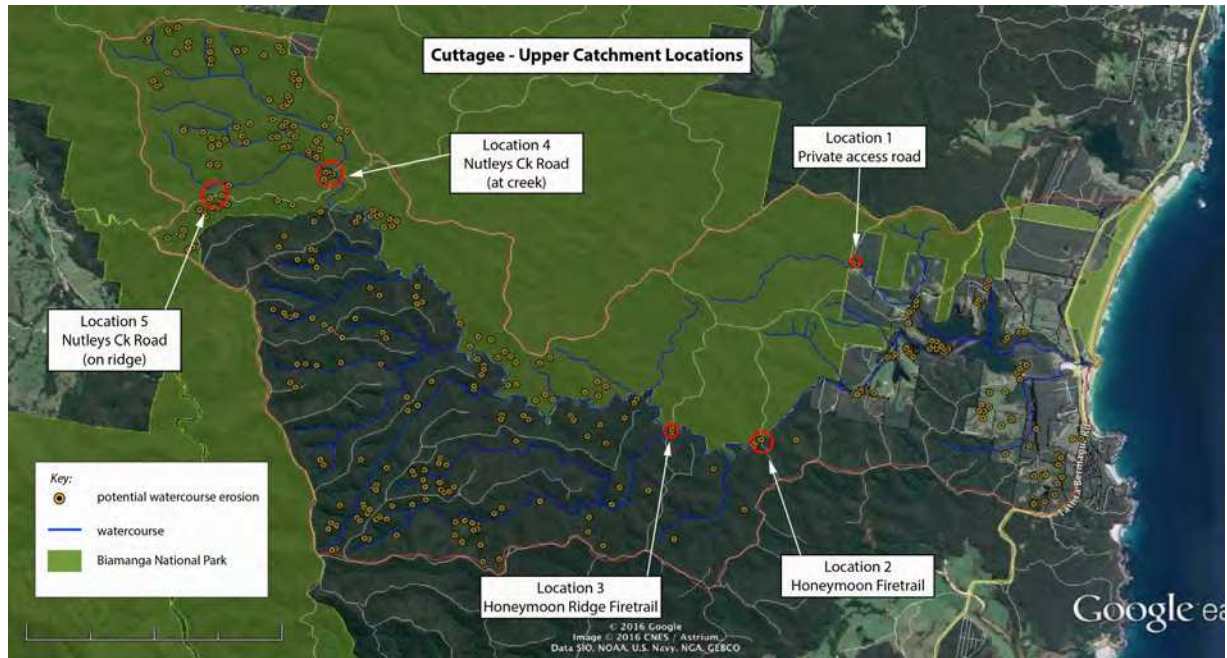
**Figure 13.** Upper Catchment locations and unsealed road areas inspected for erosion issues.

The network of unsealed roads in the upper catchment crosses Cuttagee Creek at four locations as shown in **Figure 13**. Potential erosion issues were identified at these locations during desktop analysis of LiDAR aerial imagery. A total of five locations of the unsealed road network in the upper catchment were inspected to assess potential erosion issues including the four creek crossings and a location on the Nutleys Ck Road ridge.

and exit points of a single culvert. The culvert has <30% capacity before it is full of sediment and fails. This issue is located in Biamanga National Park and is responsibility for NPWS.

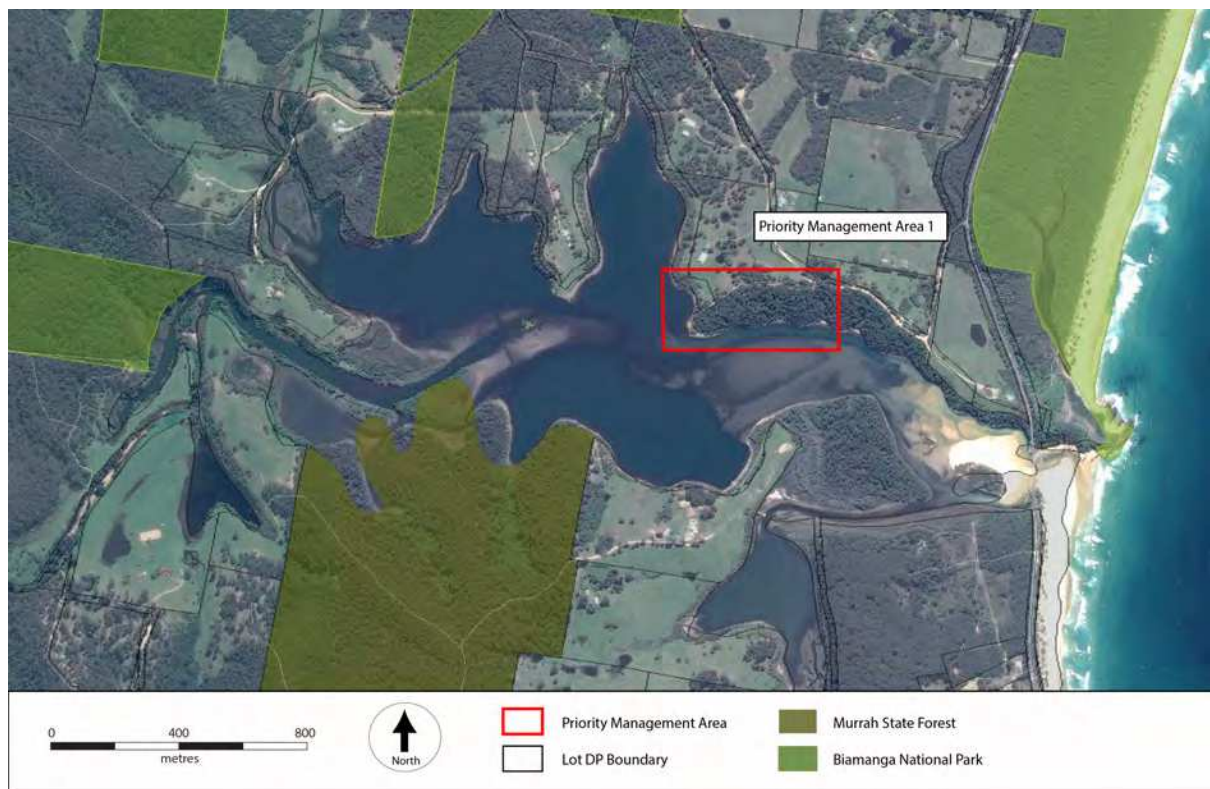
**Figure B1** Location of priority management area 1.

This area includes an unsealed crown road off Geall Road that descends a moderate slope and provides access to the northern foreshore of Cuttagee Lake. The road is in poor condition with serious erosion, deep rutting and is not useable during wet conditions. The erosion of the road is also contributing sediment to the estuary during rainfall events.

The road is important as it represents the only public access point to the estuary foreshore for launching small vessels. Primarily both commercial and recreational fishermen utilise the road and commercial fisherman have no other access point to the lake and would like road access improved and maintained. Vehicle access to the foreshore is currently uncontrolled with low-level impacts to riparian vegetation. The boat launching area may also be a potential cultural heritage site of local significance.

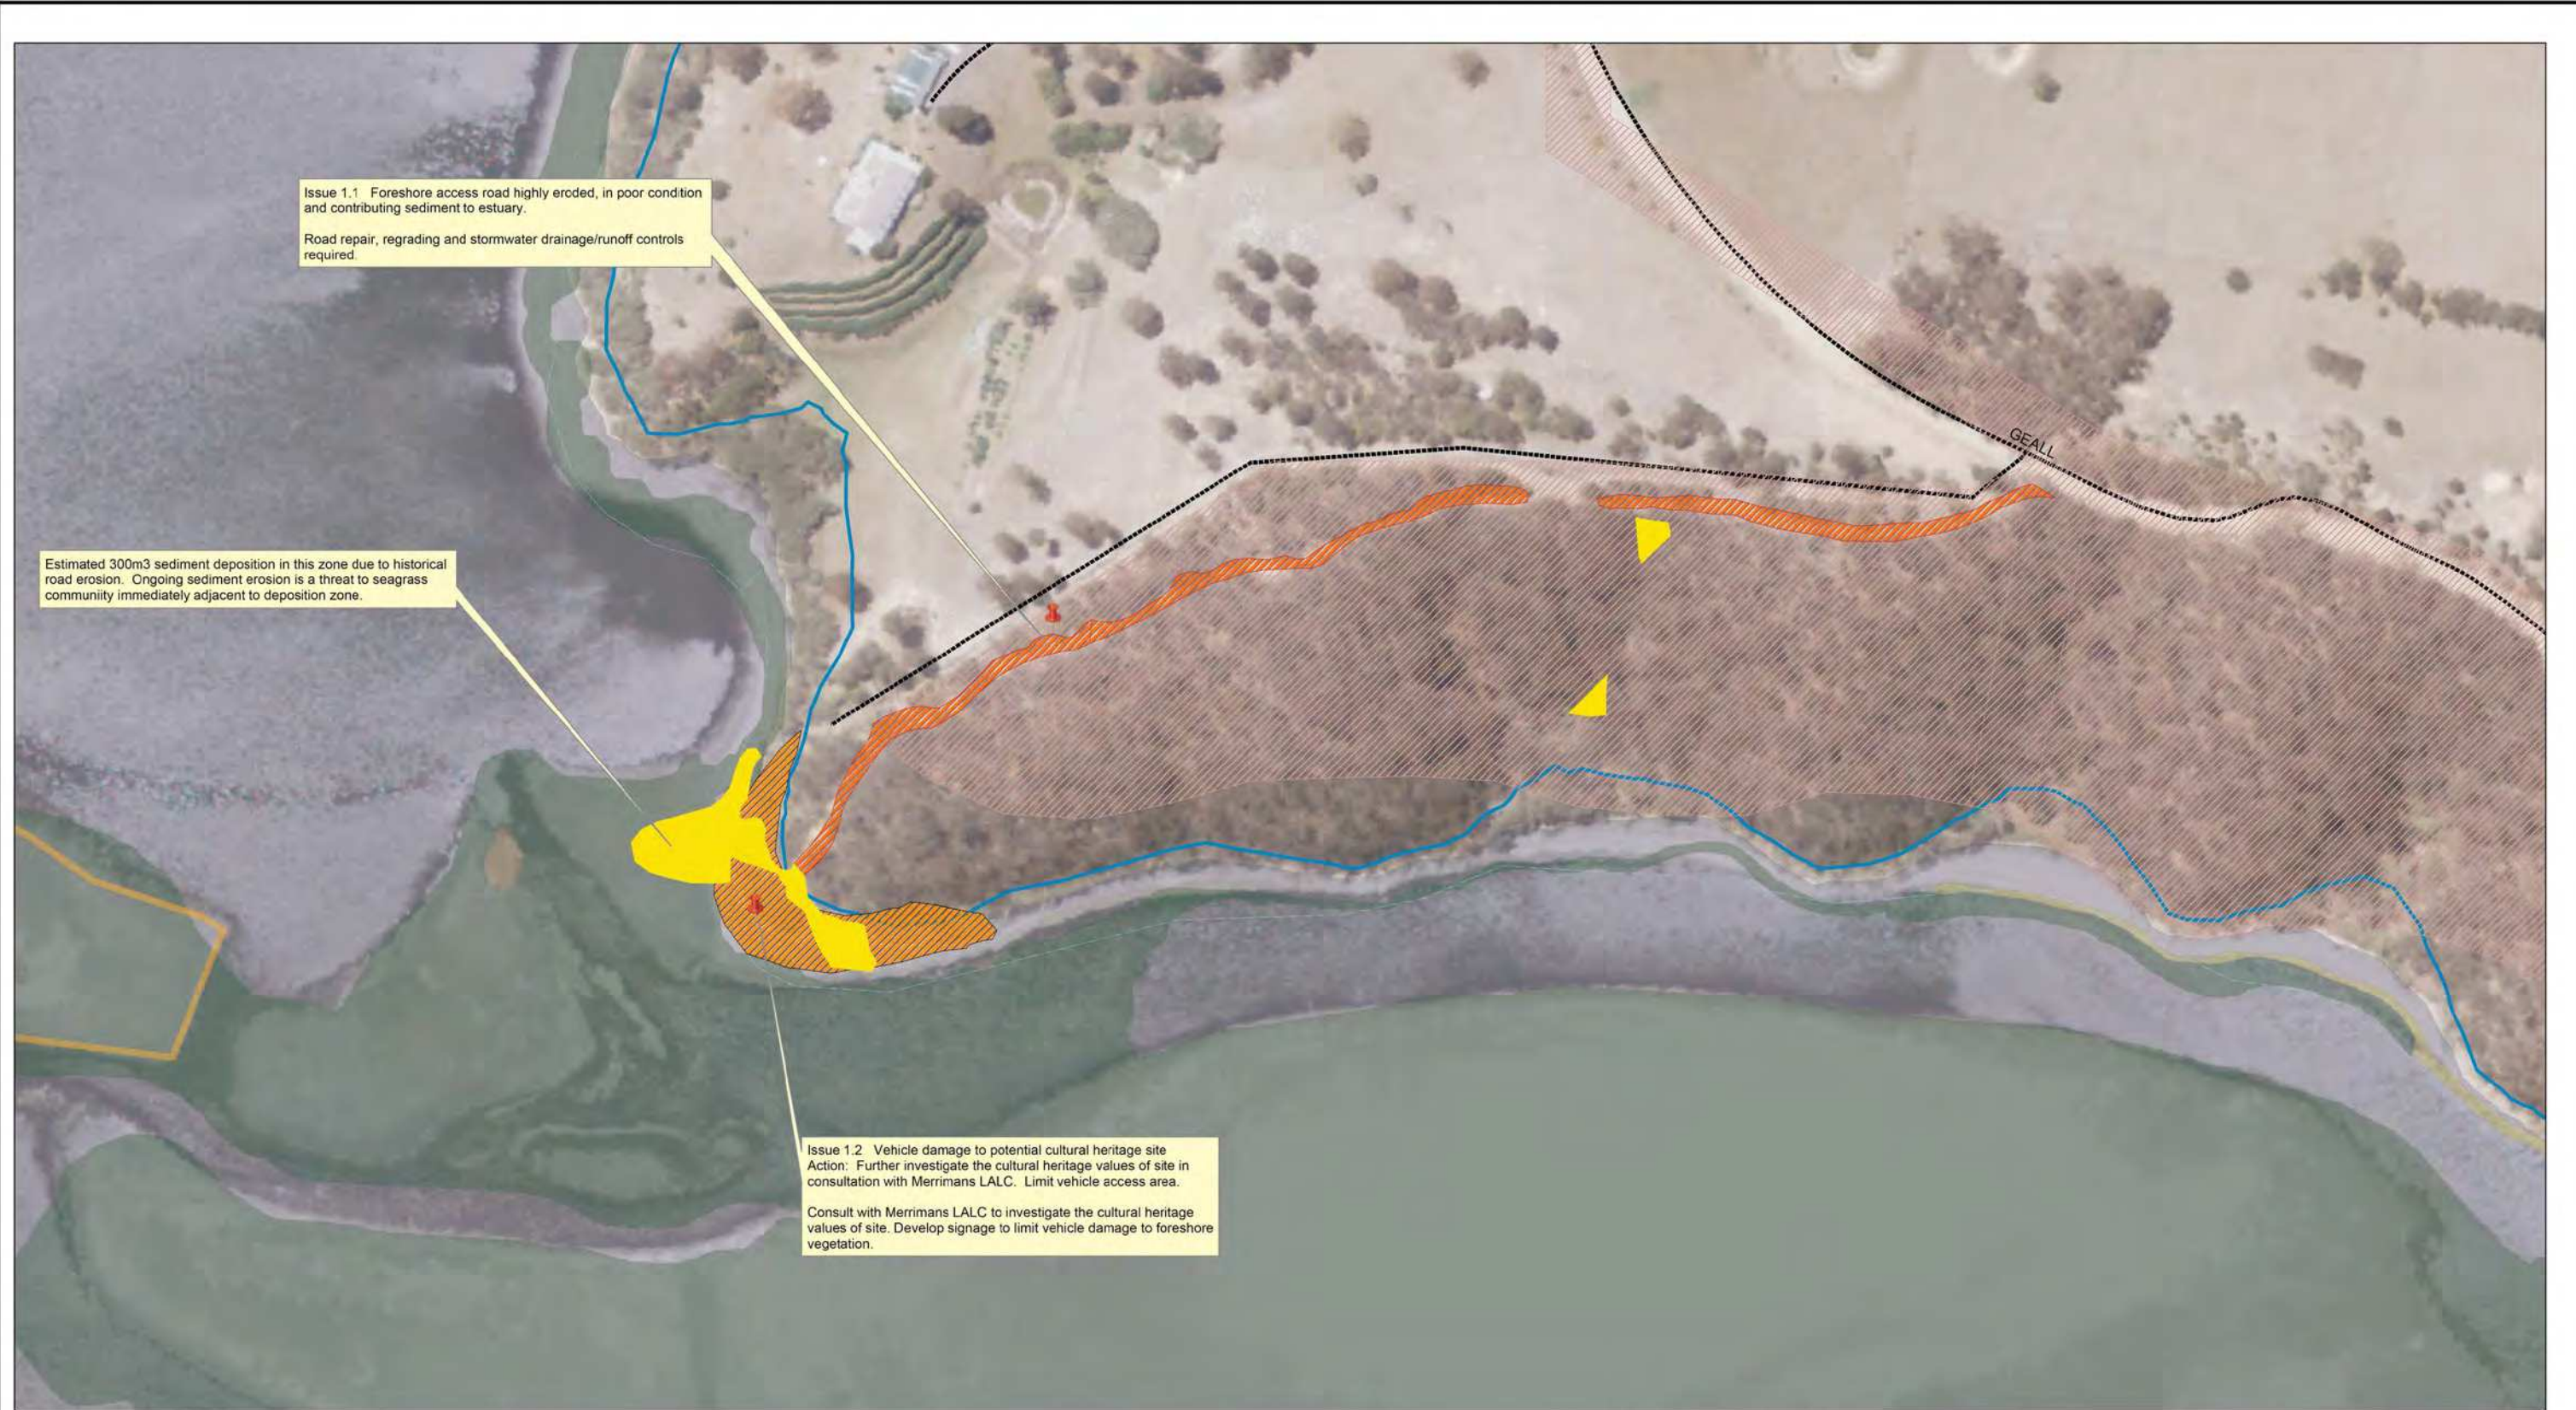
Issue 1.1 Foreshore access road highly eroded, in poor condition and contributing sediment to estuary.  
Road repair, regrading and stormwater drainage/runoff controls required.

Estimated 300m<sup>3</sup> sediment deposition in this zone due to historical road erosion. Ongoing sediment erosion is a threat to seagrass community immediately adjacent to deposition zone.

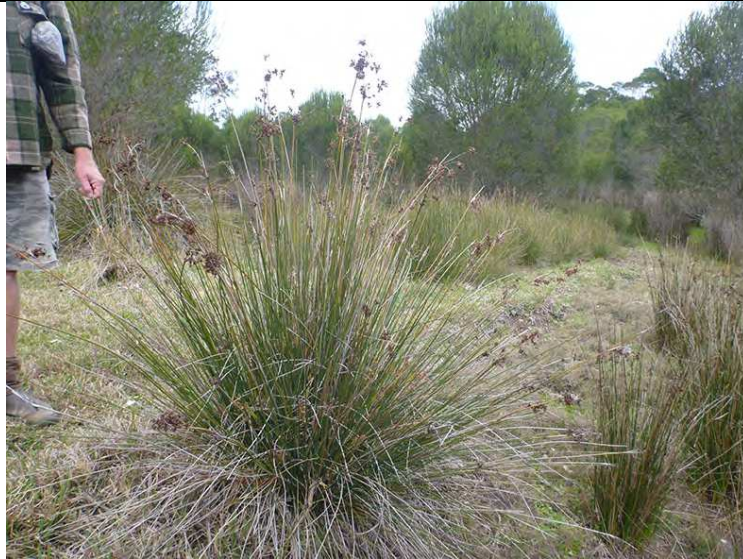
**Issue Description:** A small incursion of highly invasive Spiny Rush (*Juncus acutus*) has established along a section of the creek with an estimated population of <20-30 individuals. Spiny rush is a serious environmental weed that co-occurs with and can be confused with native sedge *Juncus kraussii*. Left uncontrolled, infestations of spiny rush are a threat to coastal saltmarsh. Large seed bank reserves in the soil mean control and eradication may take more than 3 years. Further information regarding spiny rush can be found at <http://www.weeds.org.au/>.

**Figure B7** Example of Spiny Rush individual with large terminal seed heads

- Work with landholder to eradicate population and follow-up with subsequent monitoring of the creek line.
- Notify other landholders to keep a look-out for this weed.
- Work with landholder to establish new plantings of native sedges *Juncus* spp. along the creek line. Refer to recommended plant species list (**Appendix D**) for upper estuary zone.

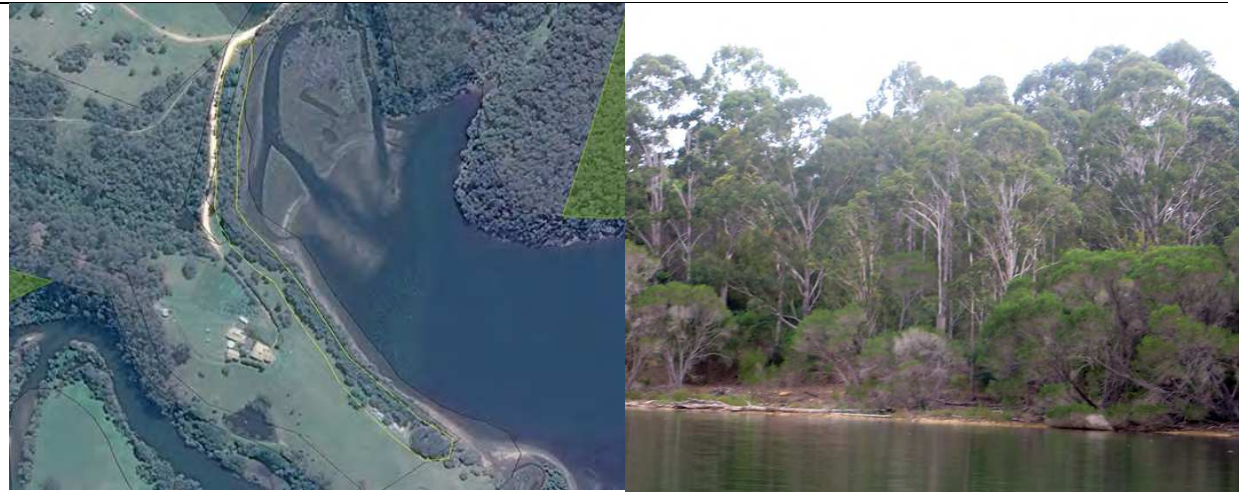
**Issue Description:** The western foreshore of estuary is missing canopy vegetation and habitat trees such as *Eucalyptus* spp. that would have previously be present but have been historically cleared. The foreshore vegetation in this area is in a transitional stage of regrowth and senescence with black wattle (*Acacia mearnsii*) currently the dominant canopy forming species. An improved foreshore aesthetic where habitat trees are re-established along this foreshore could be achieved over shorter time frame by employing a strategy of assisted natural regeneration.

**Figure B11** Area of western foreshore (outlined in yellow) proposed for re-establishing habitat trees and canopy vegetation strata (*left image*). Example of northern foreshore where natural regeneration of canopy trees has been encouraged (*right image – courtesy of S. Cameron*)

- Work with stakeholder and landholder to implement a program of assisted natural regeneration along the western foreshore. The action would involve mulching areas and establishing nodal plantings of canopy forming tree species. Over time the tree species would be expected to naturally regenerate the gaps between planted nodes. Refer to recommended plant species list for upper estuary zone (**Appendix D**).

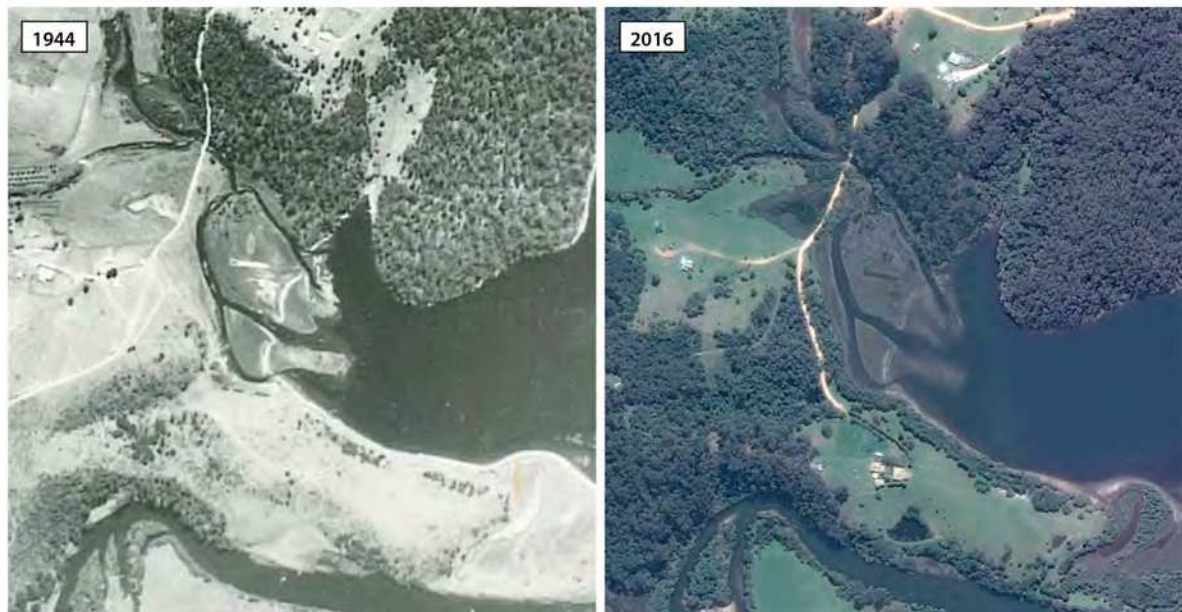
**Figure B12b** Comparison of aerial imagery showing the fluvial delta at the western margin of Cuttagee Lake from years 1944 (*left image courtesy of OEH*) and 2016 (*right image – Google Earth*). It is

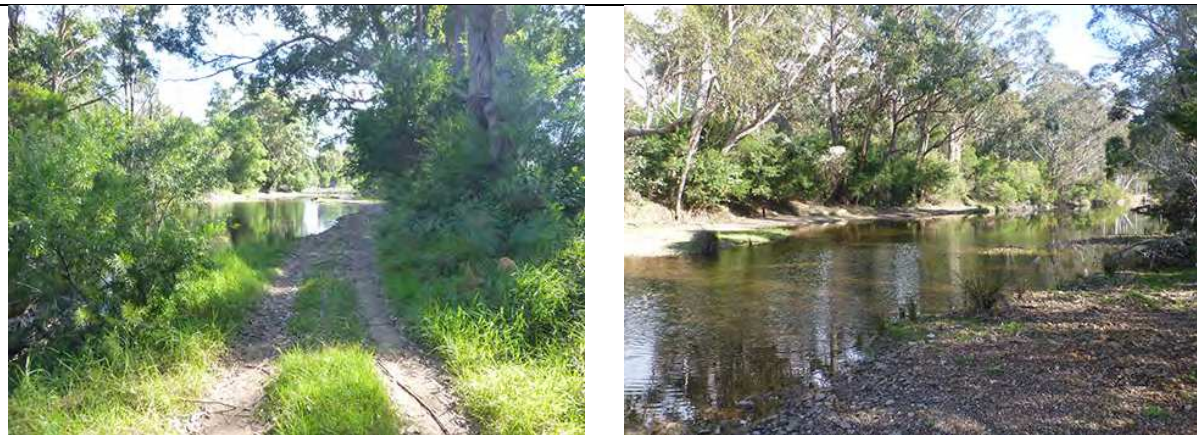
**Figure B18** Approach to Cuttagee Creek crossing from eastern bank (*left image*), the creek crossing during low tide conditions when the estuary was open to the ocean (*right image*).

- Recommend landholder investigate alternative access to the property when water levels in the estuary exceed 1.2m AHD and during flood events.
- The creek-bed is the responsibility of DPI Fisheries and they would need to be consulted in addition to Council should the landholder wish to apply for planning approval to construct an appropriately engineered crossing that would permit continued access during high water stands.

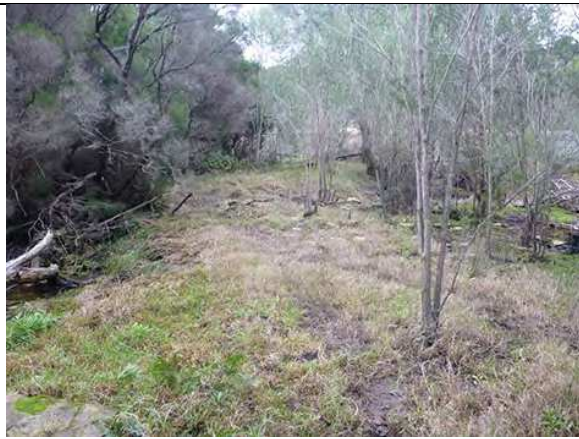
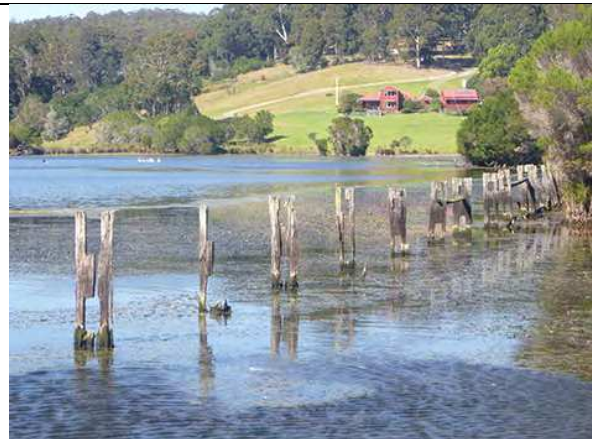
**Figure B19** Cattle crossing constructed over watercourse (*left image*), view over the freshwater wetland from near cattle crossing (*right image*).

- No intervention to the cattle crossing is currently recommended. The wetland is a freshwater refuge in an otherwise saline environment and may meet the EEC requirements

for *Freshwater wetlands on Coastal Floodplains*. The value of removing the weir structure would result in the partial drainage of the wetland and would have to be considered in context of likely short-term impacts such as increased turbidity, potential for altered vegetation community and potential risk of disturbing and exposing acid sulphate soils associated with its removal.

- Undertake further assessment of wetland flora to determine if the wetland community meets the EEC requirements for *Freshwater wetlands on Coastal Floodplains*
- Work with landholder to implement alternative stock management routes between grazing areas.
- Work with landholder to eradicate exotic weed species to reduce risk to nearby EEC Swamp sclerophyll forest.

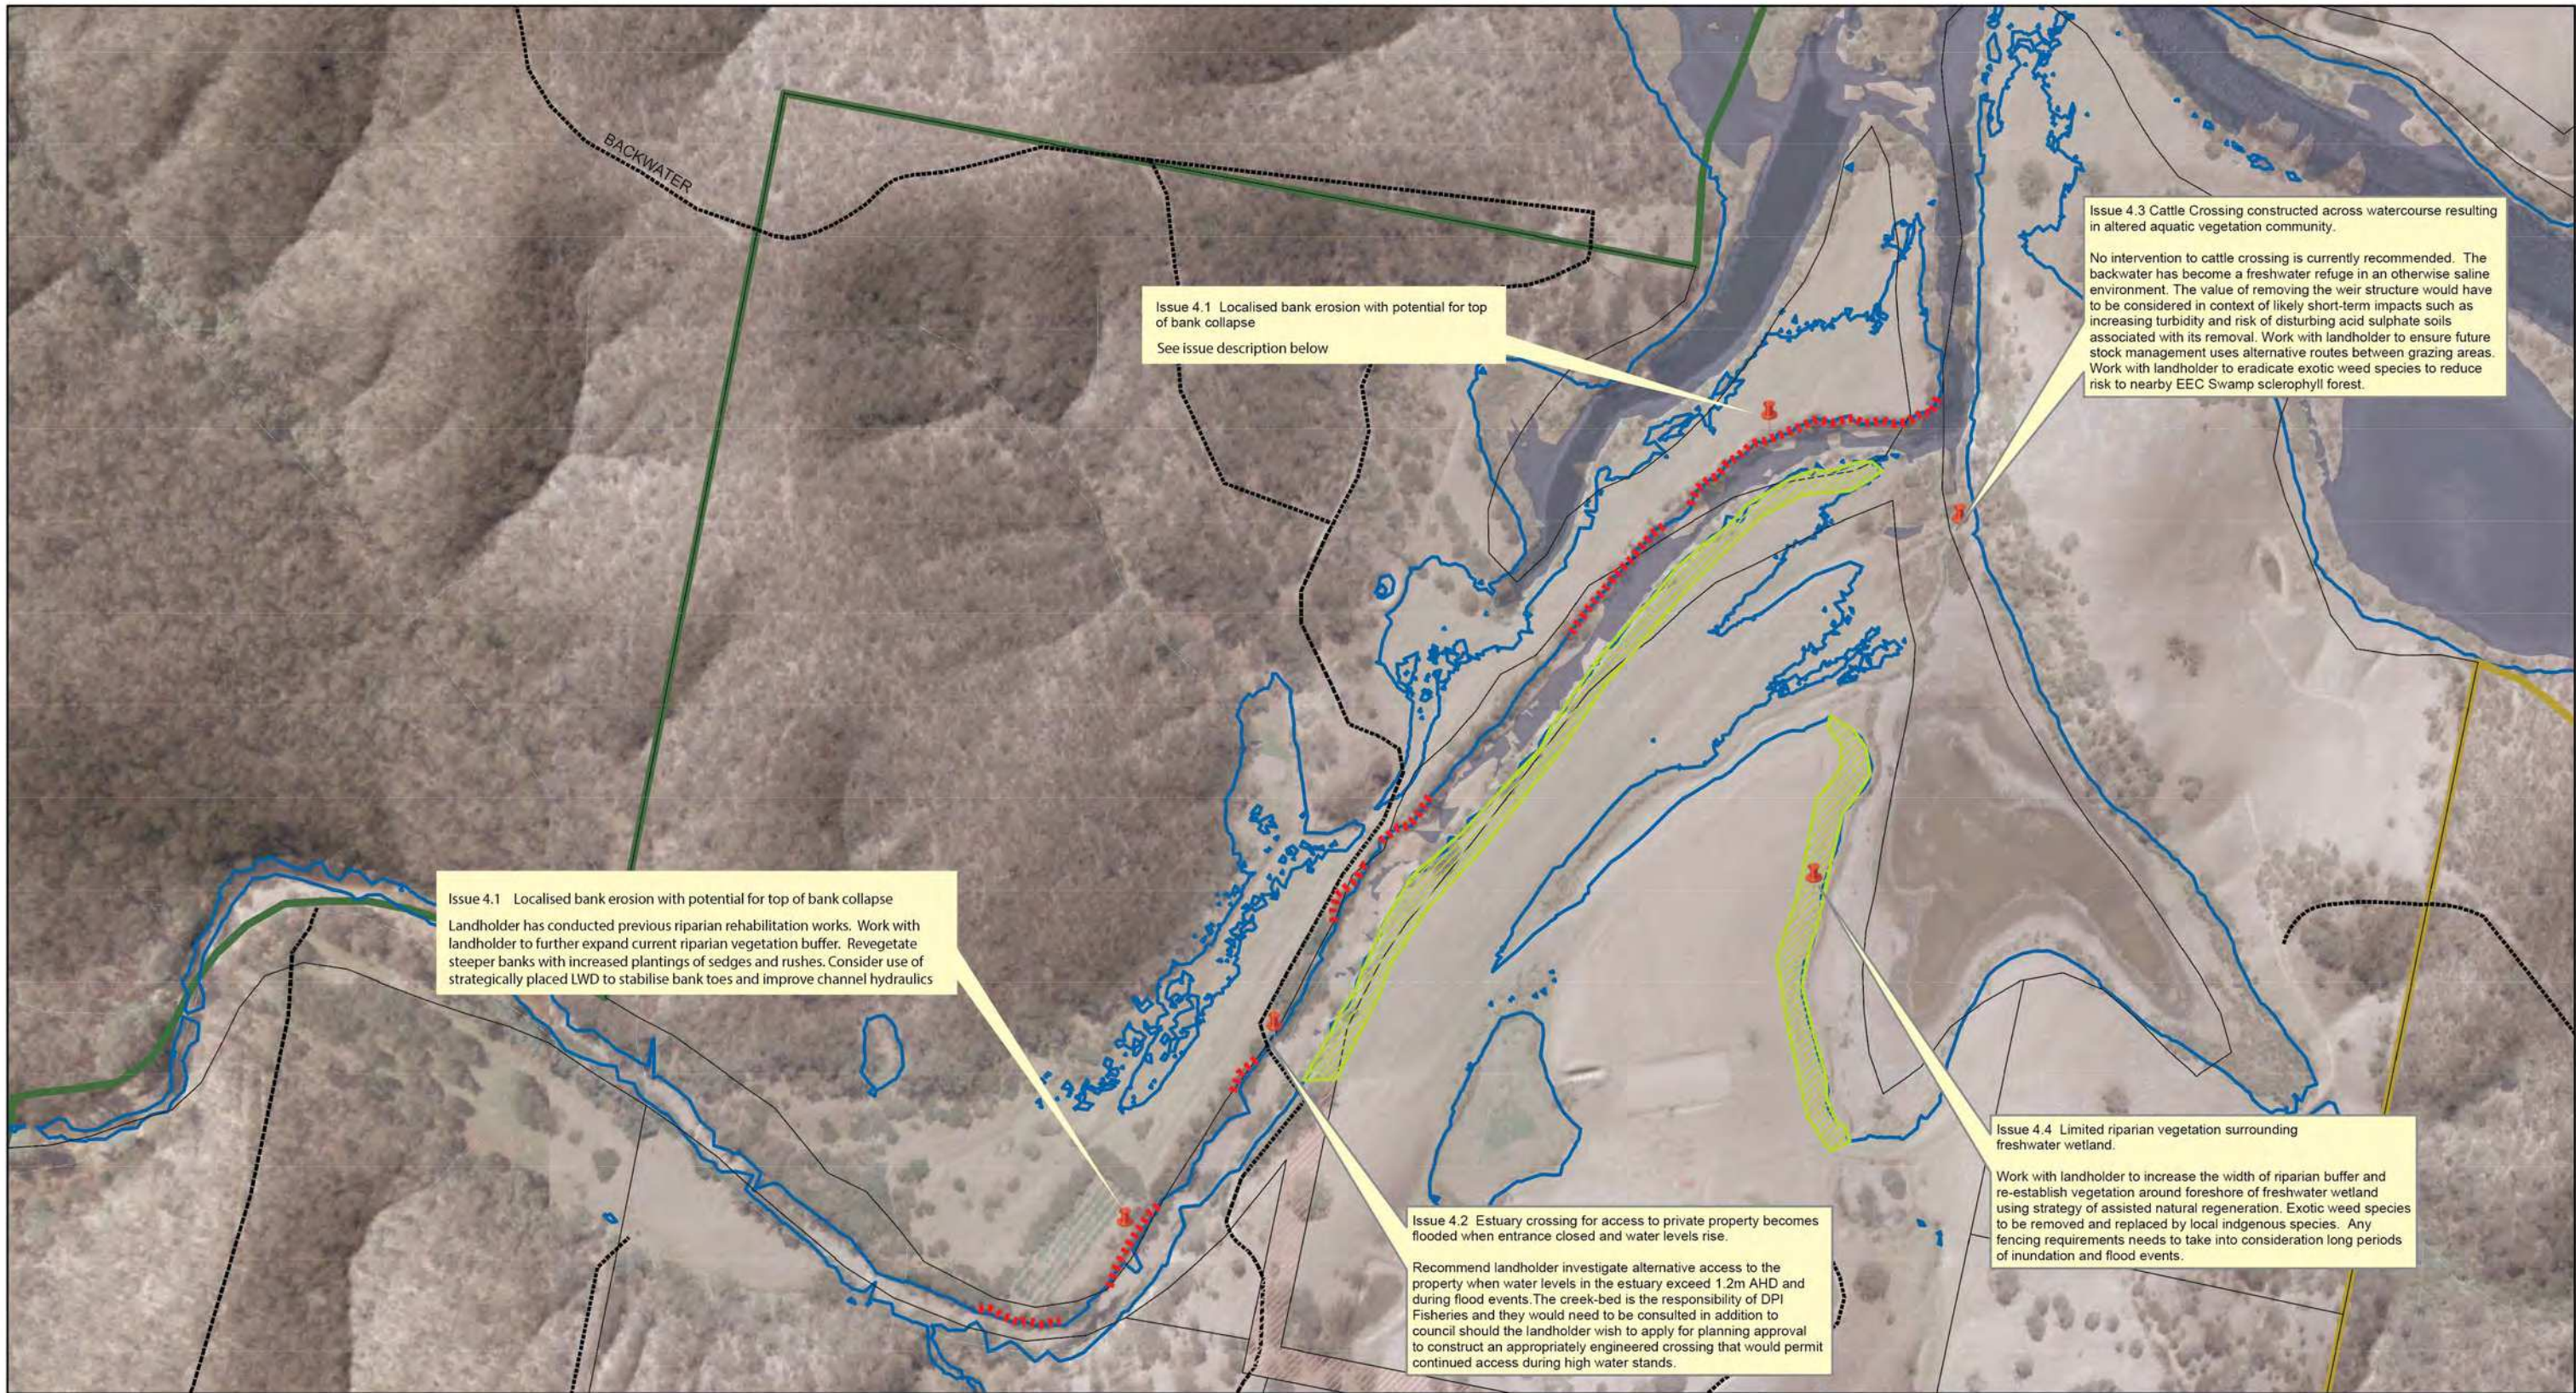
Issue 4.1 Localised bank erosion with potential for top of bank collapse  
See issue description below

Issue 4.3 Cattle Crossing constructed across watercourse resulting in altered aquatic vegetation community.  
No intervention to cattle crossing is currently recommended. The backwater has become a freshwater refuge in an otherwise saline environment. The value of removing the weir structure would have to be considered in context of likely short-term impacts such as increasing turbidity and risk of disturbing acid sulphate soils associated with its removal. Work with landholder to ensure future stock management uses alternative routes between grazing areas. Work with landholder to eradicate exotic weed species to reduce risk to nearby EEC Swamp sclerophyll forest.

Issue 4.2 Estuary crossing for access to private property becomes flooded when entrance closed and water levels rise.  
Recommend landholder investigate alternative access to the property when water levels in the estuary exceed 1.2m AHD and during flood events. The creek-bed is the responsibility of DPI Fisheries and they would need to be consulted in addition to council should the landholder wish to apply for planning approval to construct an appropriately engineered crossing that would permit continued access during high water stands.

Issue 4.4 Limited riparian vegetation surrounding freshwater wetland.  
Work with landholder to increase the width of riparian buffer and re-establish vegetation around foreshore of freshwater wetland using strategy of assisted natural regeneration. Exotic weed species to be removed and replaced by local indigenous species. Any fencing requirements needs to take into consideration long periods of inundation and flood events.

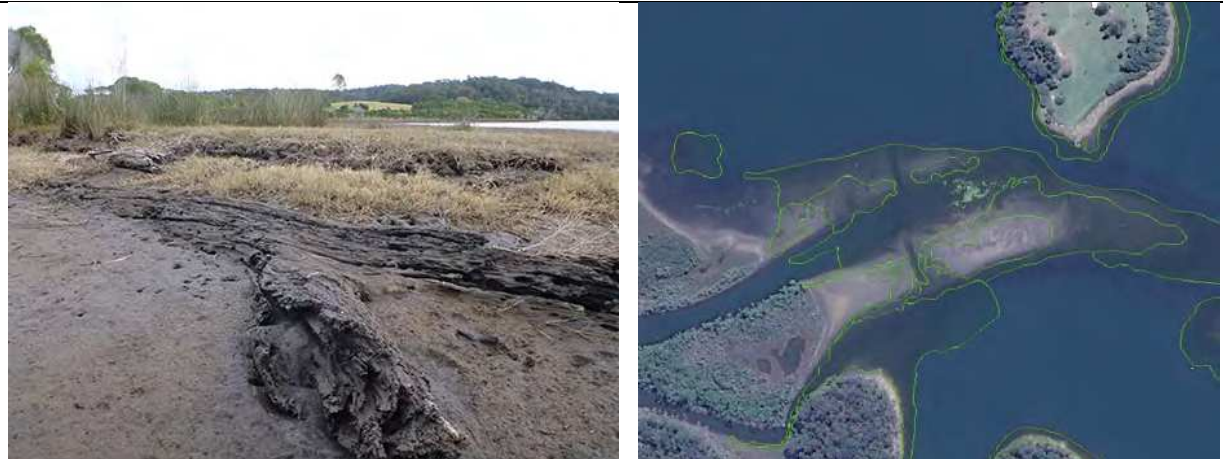
hydraulic conditions. Anecdotal landholder reports suggest large volumes of sediment deposited in this area in 2010 following two significant flood events resulting in burial of seagrass in this area (*pers. obs.* S. Cameron). Subsequent seagrass recovery was observed over the following 3-year period to 2013 (Elgin 2014).

**Figure B22** Example of naturally deposited LWD at the mouth of Cuttagee creek assisting the formation of levee banks of the propagating delta (*left image*). Area of mapped *Zostera* and *Halophila* seagrass community (outlined in green) in vicinity of the fluvial delta (*right image*).

- Consider the use of strategically placed LWD to enhance sediment deposition areas, improve channel morphology, protect seagrass community from being buried and indirectly create fish habitat opportunities.
- Update seagrass mapping and implement program to monitor condition of seagrass community. This recommendation may also consider monitoring sediment deposition rates.

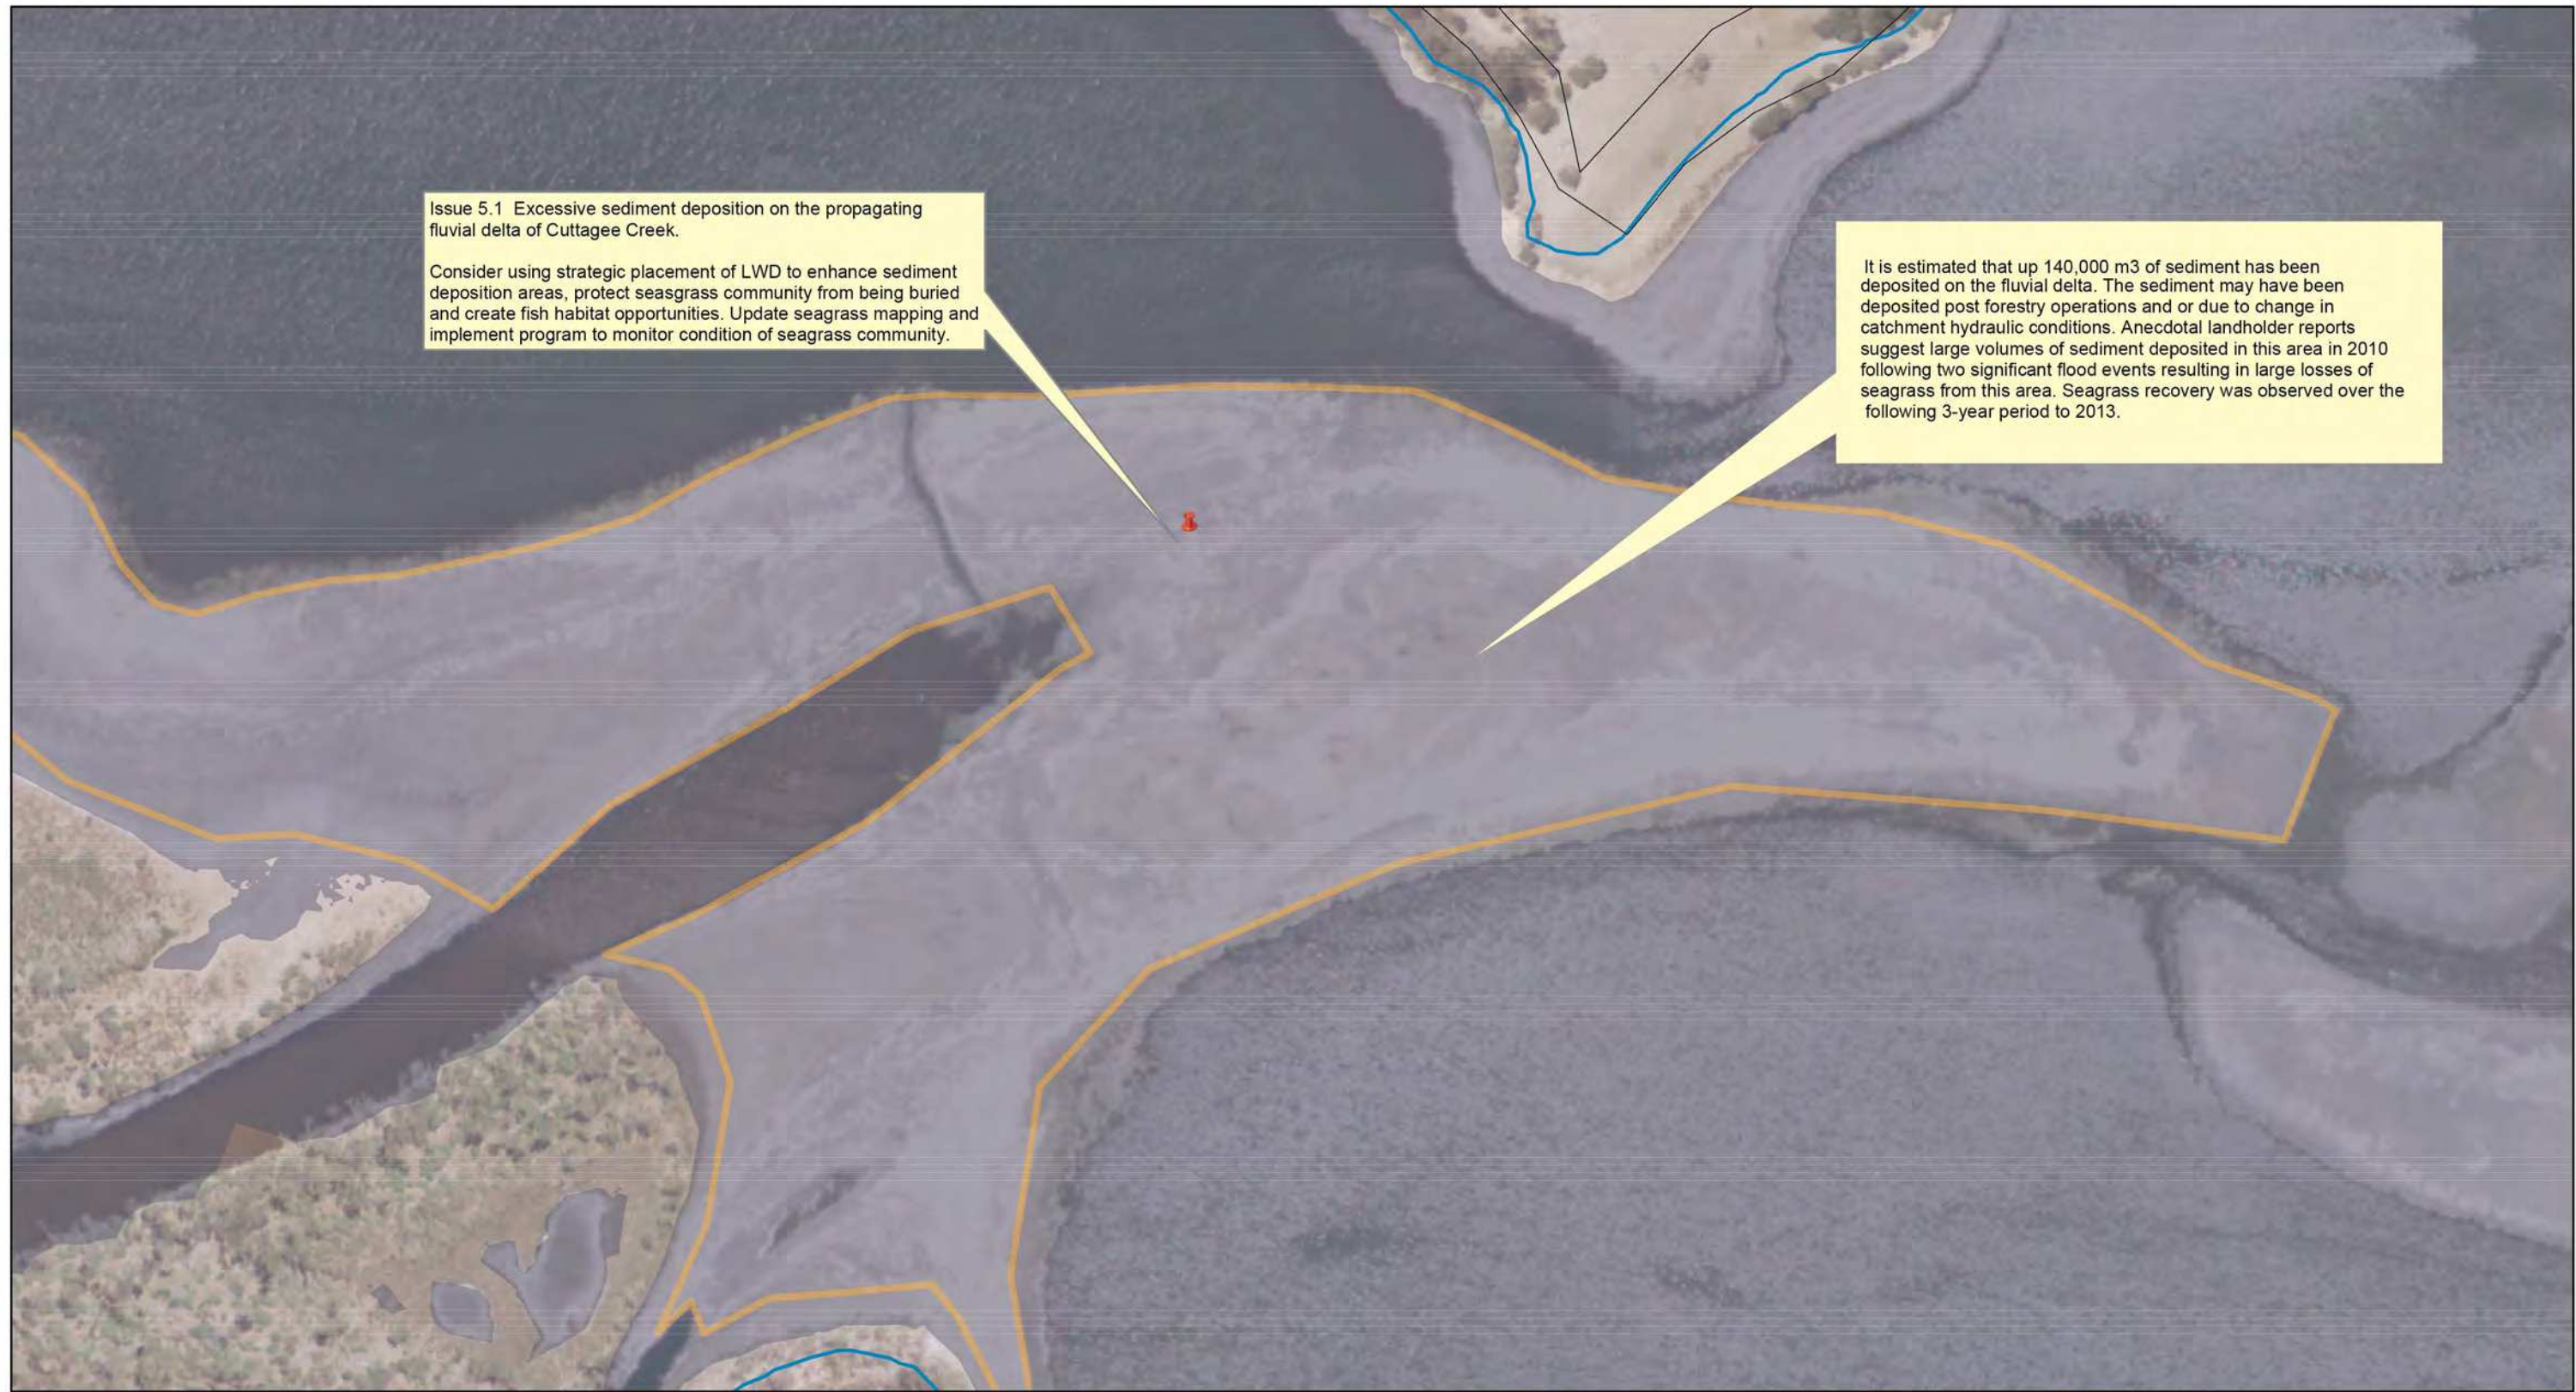
**Issue 5.1 Excessive sediment deposition on the propagating fluvial delta of Cuttagee Creek.**

It is estimated that up 140,000 m<sup>3</sup> of sediment has been deposited on the fluvial delta. The sediment may have been deposited post forestry operations and or due to change in catchment hydraulic conditions. Anecdotal landholder reports suggest large volumes of sediment deposited in this area in 2010 following two significant flood events resulting in large losses of seagrass from this area. Seagrass recovery was observed over the following 3-year period to 2013.

Consider using strategic placement of LWD to enhance sediment deposition areas, protect seagrass community from being buried and create fish habitat opportunities. Update seagrass mapping and implement program to monitor condition of seagrass community.
