# Cuttagee Lake Rapid Catchment Assessment

## Catchment Management Plan

**Bega Valley Shire Council**

*15 July 2016*

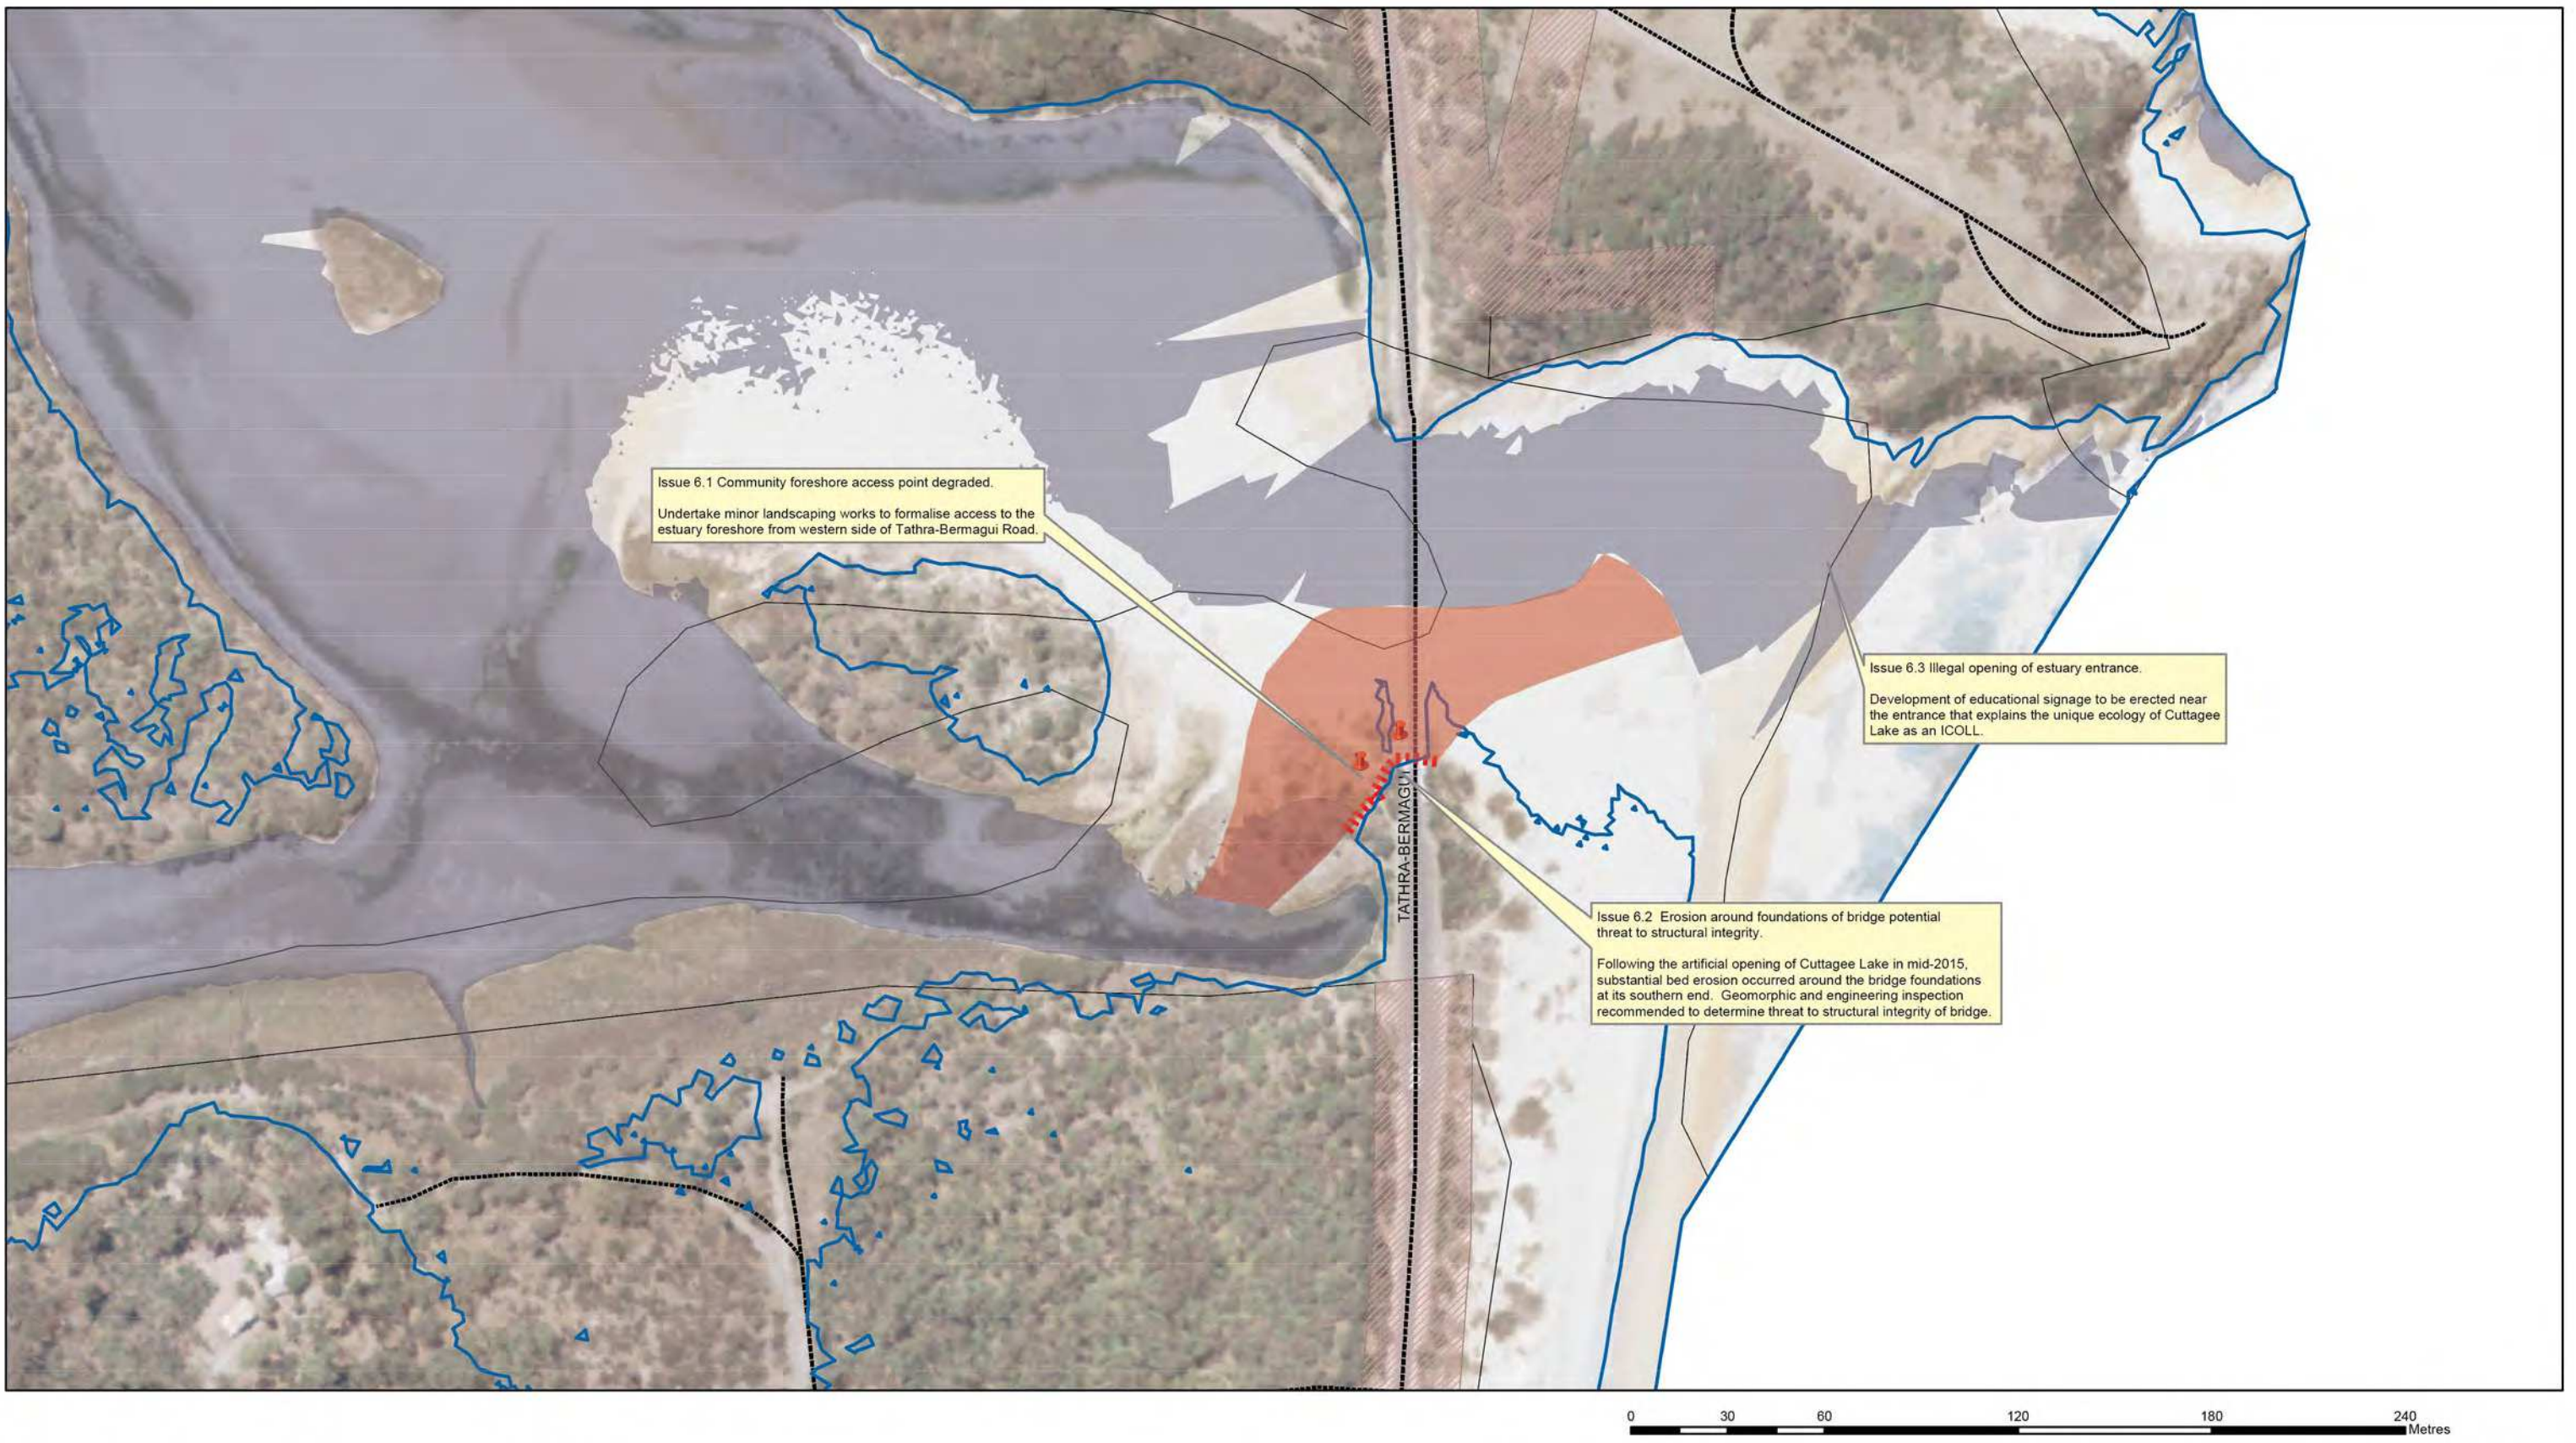
Issue 6.1 Community foreshore access point degraded.  
Undertake minor landscaping works to formalise access to the estuary foreshore from western side of Tathra-Bermagui Road.

Issue 6.3 Illegal opening of estuary entrance.  
Development of educational signage to be erected near the entrance that explains the unique ecology of Cuttagee Lake as an ICOLL.

Issue 6.2 Erosion around foundations of bridge potential threat to structural integrity.  
Following the artificial opening of Cuttagee Lake in mid-2015, substantial bed erosion occurred around the bridge foundations at its southern end. Geomorphic and engineering inspection recommended to determine threat to structural integrity of bridge.

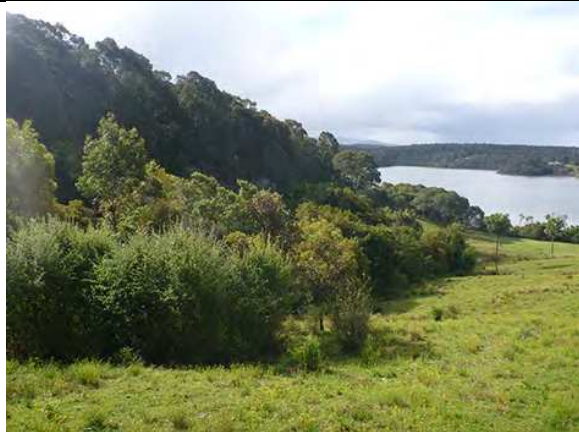
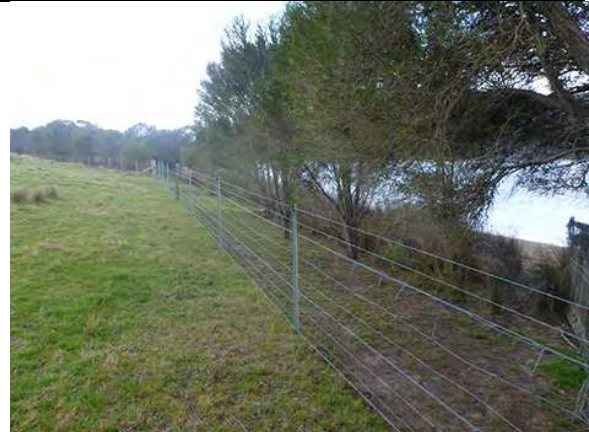
**Figure B27** Example of *South East Warm Temperate Rainforest* that has naturally regenerated in a gully adjacent to Murrah State forest (left image). Much of the foreshore has been fenced-off with a thin riparian buffer dominated by *Melaleuca* spp. (right image).

- Work with landholders to expand riparian vegetation buffer where current vegetation exists, and assist natural regeneration of foreshore areas where there is little riparian vegetation.

Exotic weed species to be removed and replaced by local indigenous species. Refer to recommended species list (Appendix D).
