Structure 228 - Structural Assessment Report

MR272 & MR320 Structures
Assessment

Prepared for
Bega Valley Shire Council

6 December 2021

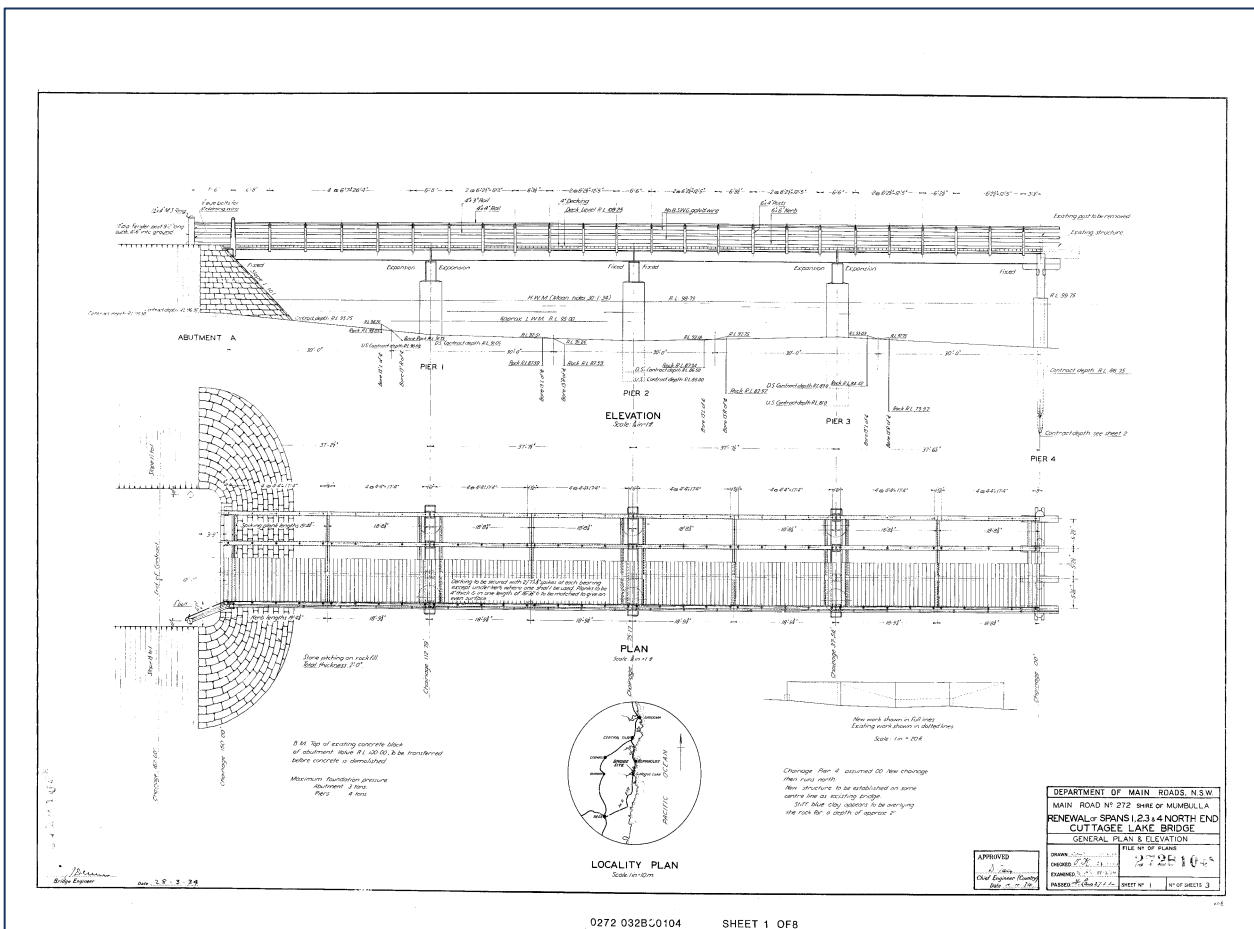
Figure 1: Original Design drawing provided for structure

As per the design drawings provided from the client, the structure was renewed in 1934 suggesting that the bridge structure was designed and constructed prior to 1934. Refer Figure 1 for the design information shown in the design drawings.

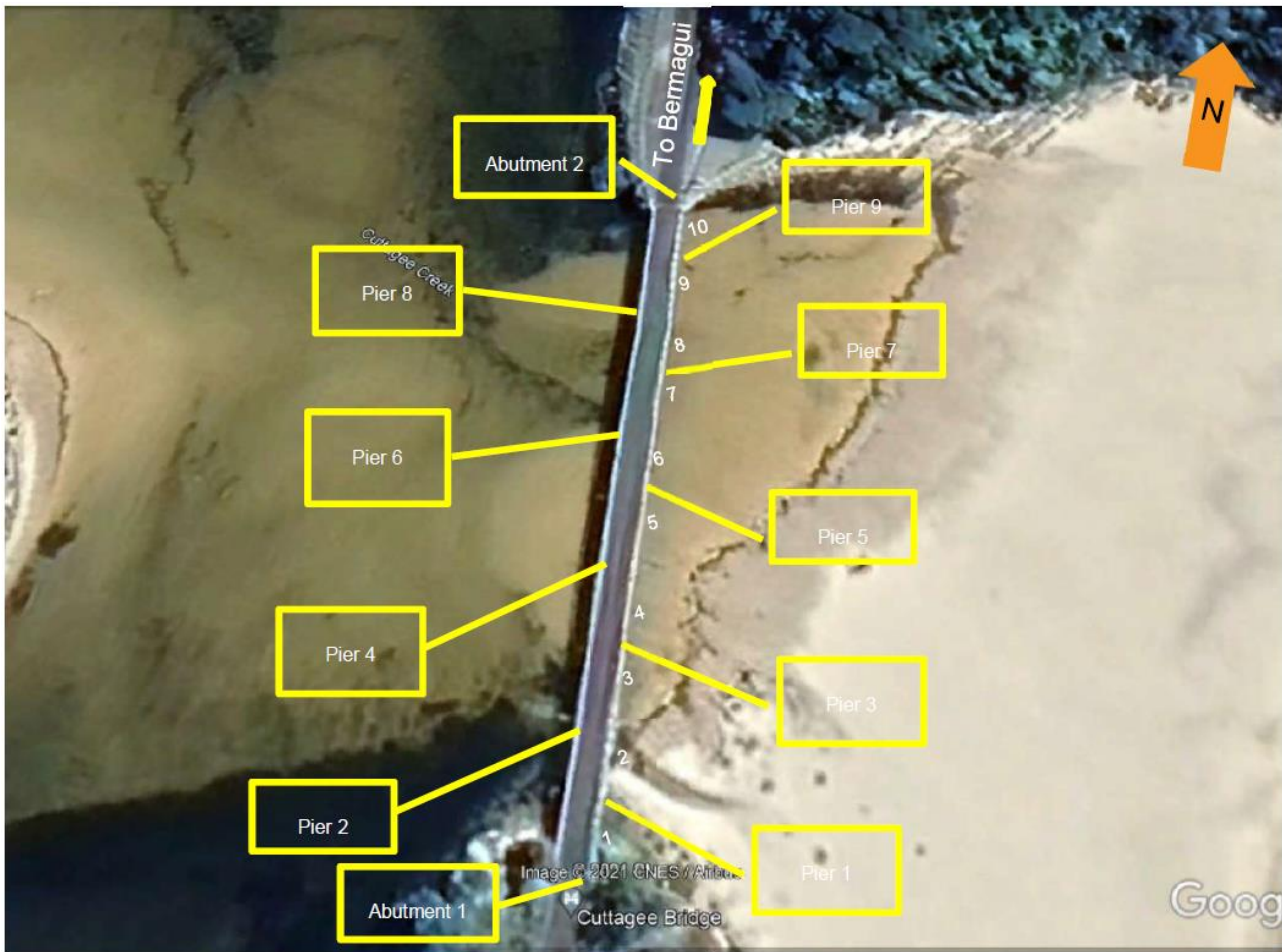
Figure 2: Labelling Sequence of the Structure for Inspection

The inspection team was able to inspect all the structural elements above the lake bed level. Waders were used to get into the water and inspect each span and its components. Due to the inspection timing, water was observed under all spans of the bridge. For inspection purposes, the span towards Tathra side was considered as Span 1 and that towards Bermagui as Span 10. Refer to Figure 2 for labelling of the structure.

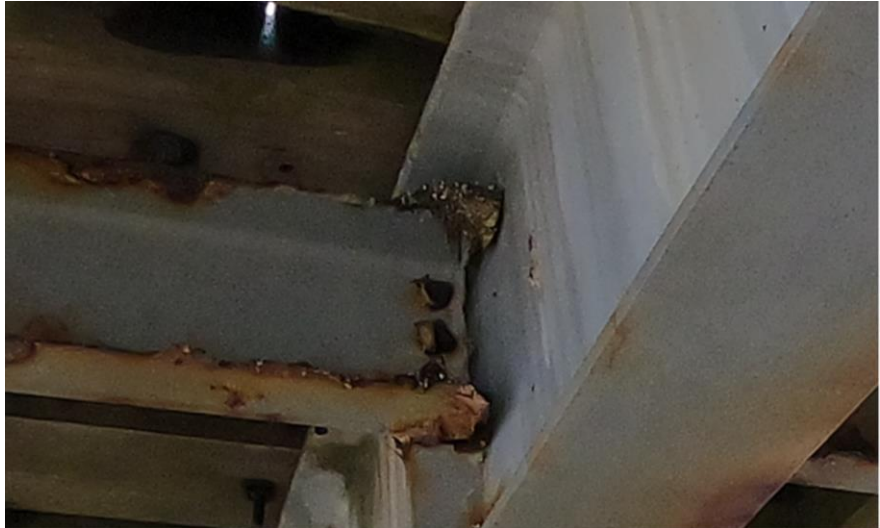
Span 7 to 9. Issues similar to Span 1 but more severe. Loss of section capacity anticipated to be min 25%.

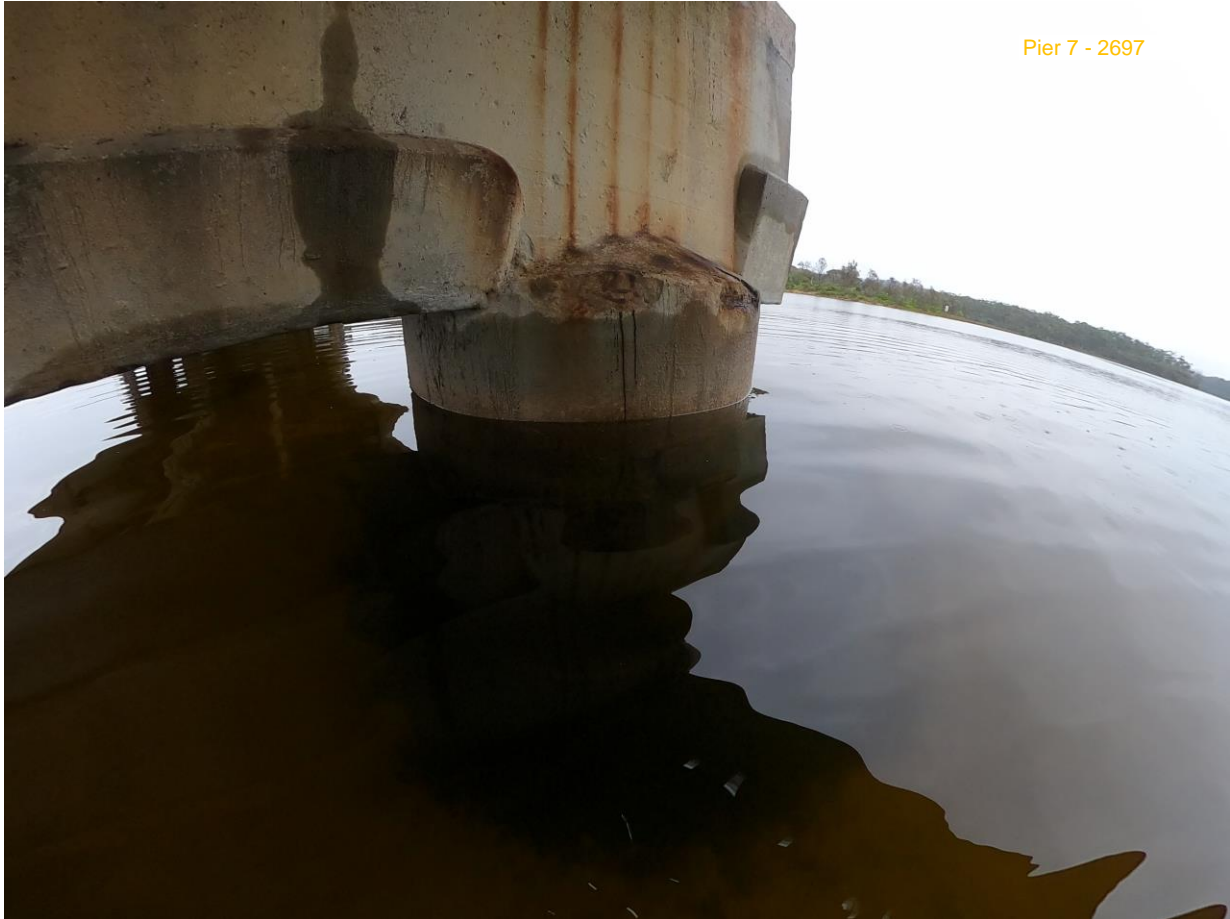
Pier 7 - 2697

Pier Column 7		22 C	Each			100		Similar to Pier 2	2696 to 2701				
Pier Structure 6		22 S / T	Each			60	40	Initial wooden frame support structure which appeared to be severely damaged and has been strengthened by means of a steel frame at some point in time. The steel structure was found to be corroded as well due to the humid environment.	2714;2716;2718;2719
