Catchment Management Plan

REPORT

Bega Valley Shire Council

PROJECT REFERENCE: JN15115

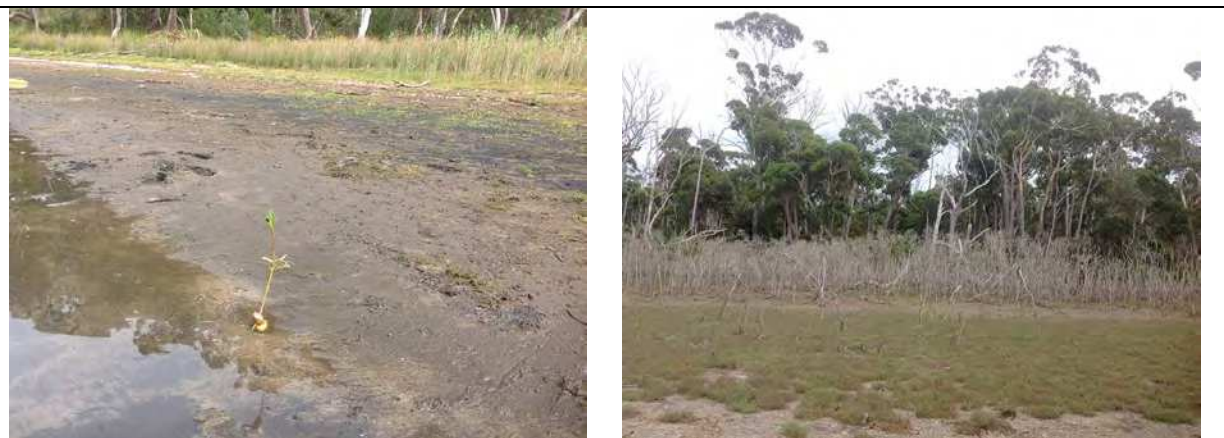
Contemporary management of Middle Lagoon is the combined responsibility of NPWS, DPI Fisheries, DPI Lands and BVSC whose management policy regarding the lagoon entrance is that of – ‘no artificial intervention’. In more recent times (at least past decade), Middle Lagoon has been allowed to open to the ocean naturally with estuary water levels remaining higher for naturally longer periods – typically up to 12 months and longer. As a result of water levels resuming a more natural pattern and high water stands becoming more prolonged at higher elevations, many of the tree, shrub and graminoid species that had colonised the low-lying foreshore areas are now dead or dying. This vegetation response extends well up into the lower reaches of Sandy and Booths Creek. The species primarily affected include *Melaleuca ericifolia*, and *Eucalyptus* trees such as *Eucalyptus bosistoana* (grey box), *E. longifolia* (woolbutt) and *E. botryoides* (bangalay), where these have been growing at low levels near the shores. There is also evidence of graminoids *Juncus kraussii* (sea rush) and *Bolboschoenus* sp. having been drowned in places, unable to tolerate the duration, depth and perhaps salinity of the recent high stands.

Figure 7. Ecological implications for the intermittent nature of Middle Lagoon. Grey mangrove (*Avicennia marina*) seedling that has opportunistically colonised the western foreshore of the lagoon during an entrance open phase (*left image*). An example of a dead stand of *Melaleuca ericifolia* on the southern foreshore of Middle Lagoon.

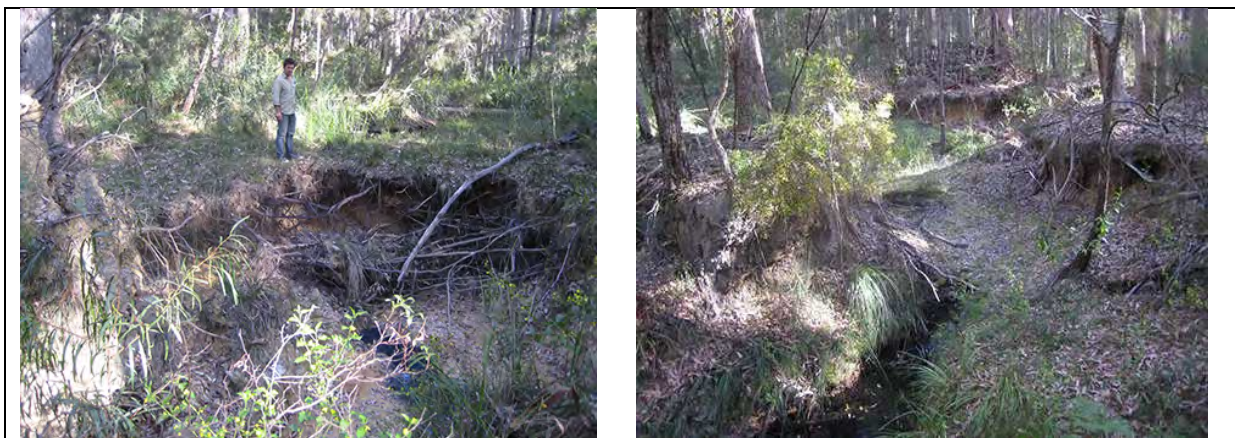
Figure 18. Example of active head cut in forested setting of Sandy Creek sub-catchment.

Active head-cut on second order stream in forested setting (*left image*). Gully formation due to migration of the head-cut up the drainage line. A natural process in areas with highly erodible soils such as Sandy Creek sub-catchment (*right image*).

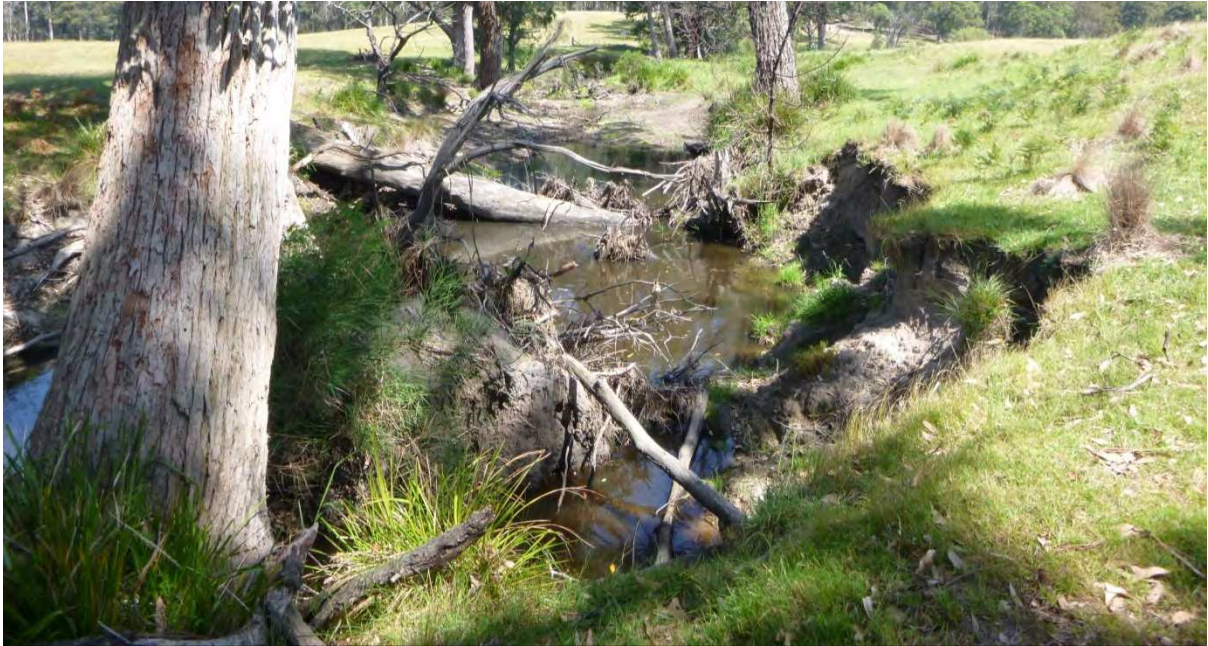
Figure 20. Natural process of tree collapse occurring along lower Sandy Creek supplying large woody debris (LWD) to creek and estuary.

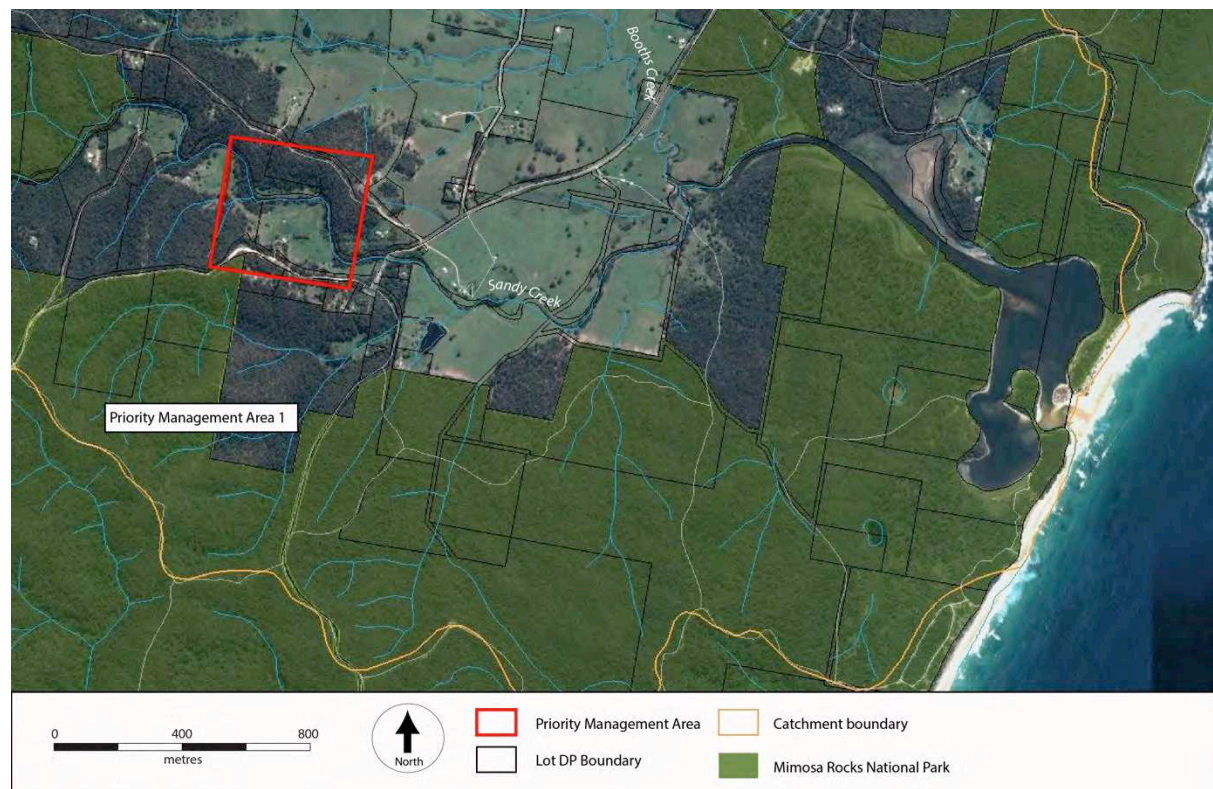
Figure B1 Location of priority management area 1.

The management area includes lower Sandy Creek bounded by the slopes of Worlands Road to the north and the slopes of Dr George Mountain Road to the south. Sandy Creek is surrounded by private lands and the riparian zone along reaches within this area are generally well vegetated. The management issue in this area is to address ongoing erosion of the unsealed Dr George Mountain Road and the roadside embankments. A proportion of sediment fines from Dr George Mountain Road are transported in surface runoff during each high rainfall event with some sediments captured in mitre drains but some also transported further downslope to Tathra-Bermagui Road where it poses a direct threat to sedimentation of Sandy Creek.

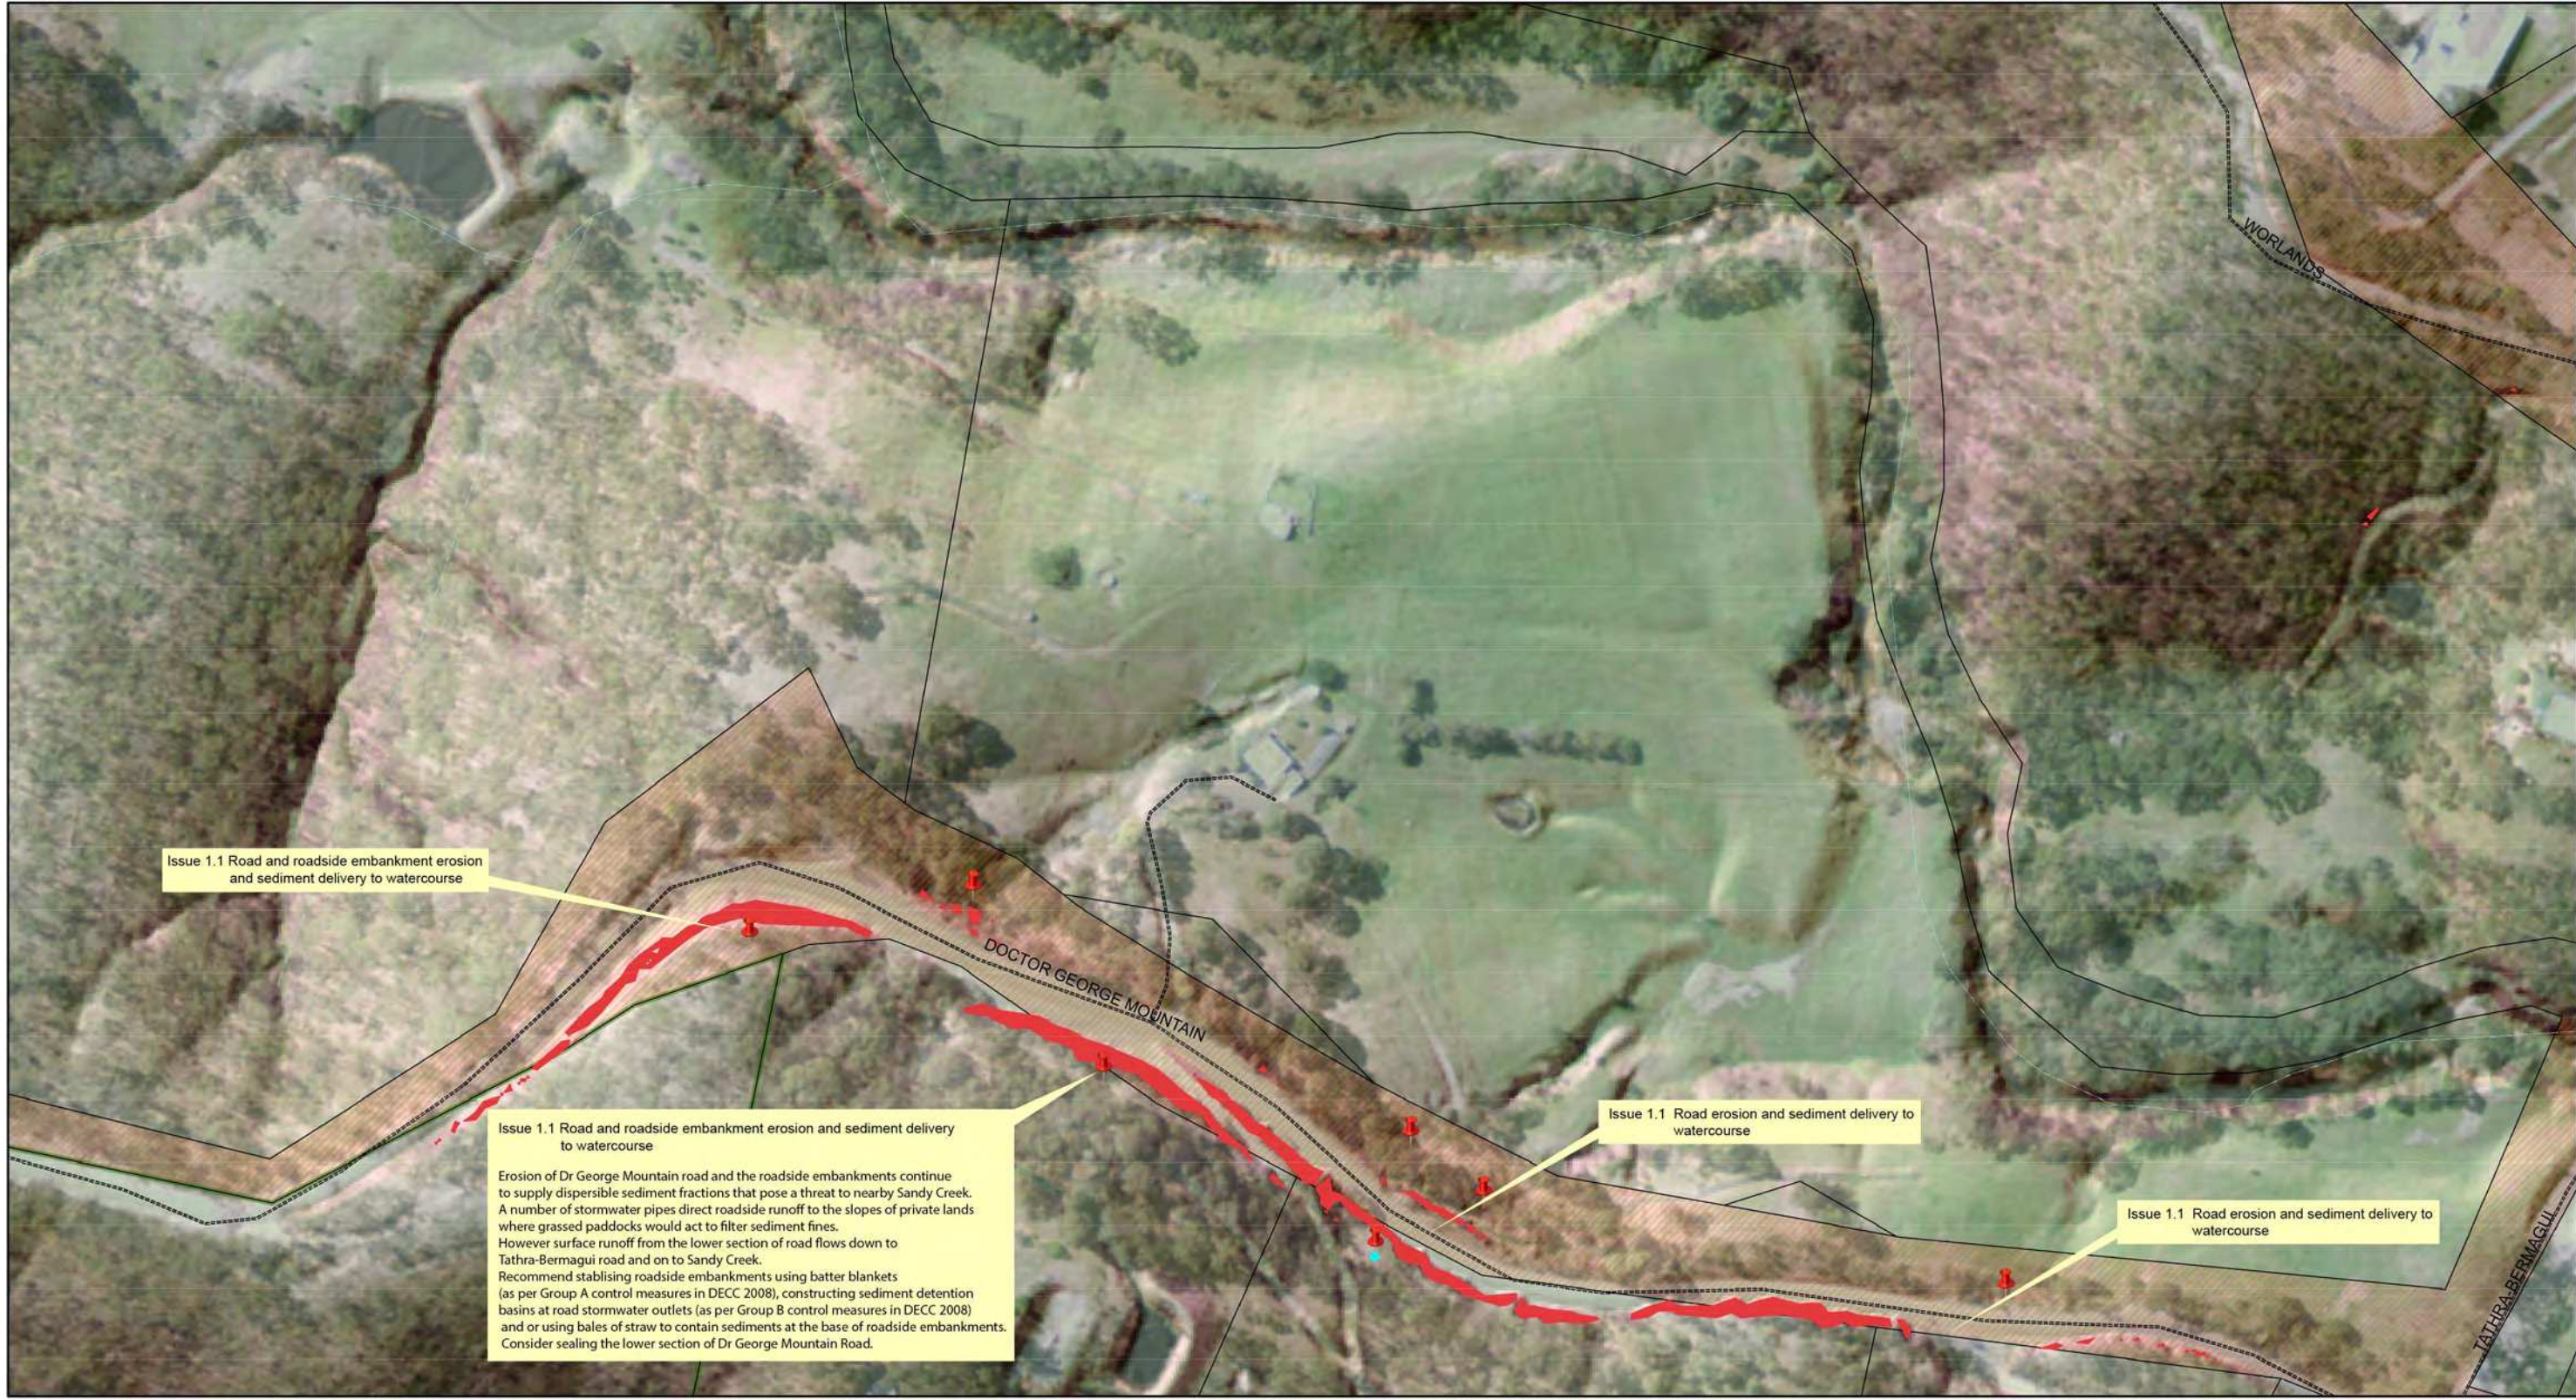
Issue 1.1 Road and roadside embankment erosion and sediment delivery to watercourse

Erosion of Dr George Mountain road and the roadside embankments continue to supply dispersible sediment fractions that pose a threat to nearby Sandy Creek. A number of stormwater pipes direct roadside runoff to the slopes of private lands where grassed paddocks would act to filter sediment fines. However surface runoff from the lower section of road flows down to Tathra-Bermagui road and on to Sandy Creek.

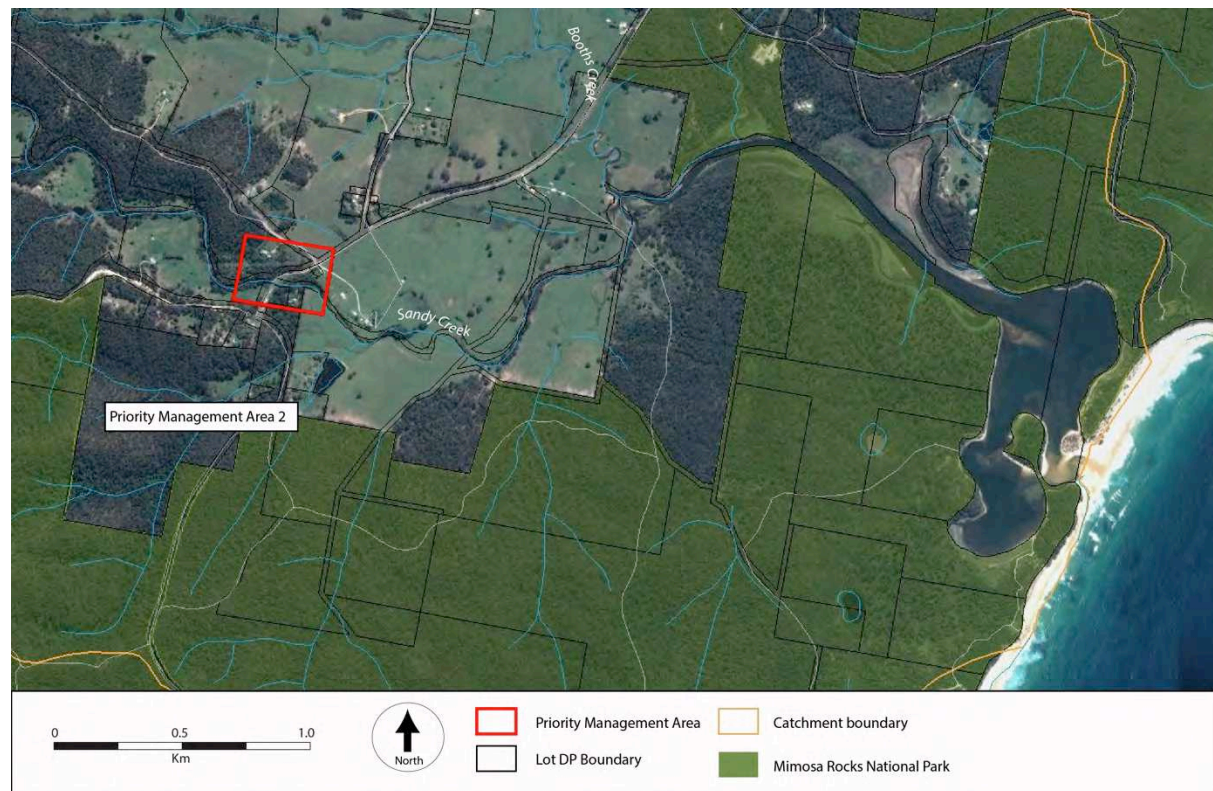
Figure B4 Location of priority management area 2.

The area includes the junction of Dr George Mountain road and Tathra-Bermagui Road and the single lane timber bridge over Sandy Creek. Low priority issues in this area include erosion of roadside embankment and perception that the riparian zone of Sandy Creek upstream and downstream of the bridge is dominated by exotic weed species.

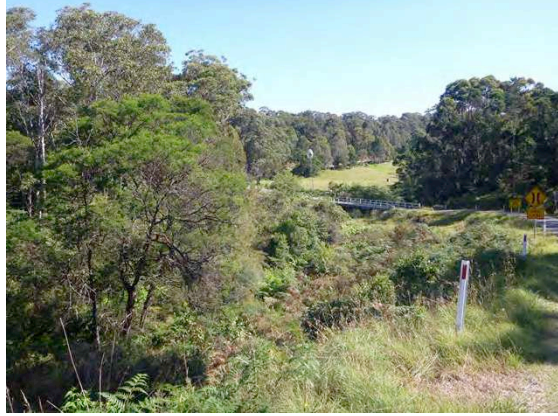
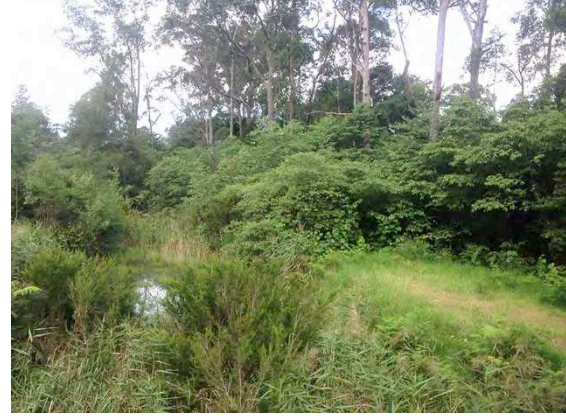
Figure B6 View of the Sandy Creek vegetation community (*left image*). A dense stand of *Commersonia* has naturally regenerated on the right bank of Sandy Creek following flood disturbance in 2010 (*right image*).

- Consider including signage promoting educational awareness of EEC *River-Flat Eucalyptus Forest* and naturally regenerating vegetation of lower Sandy Creek.

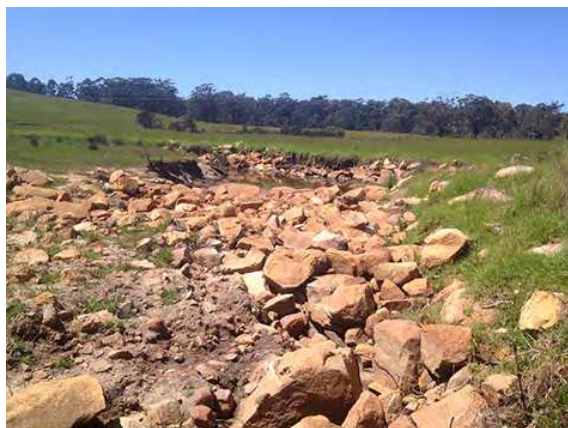
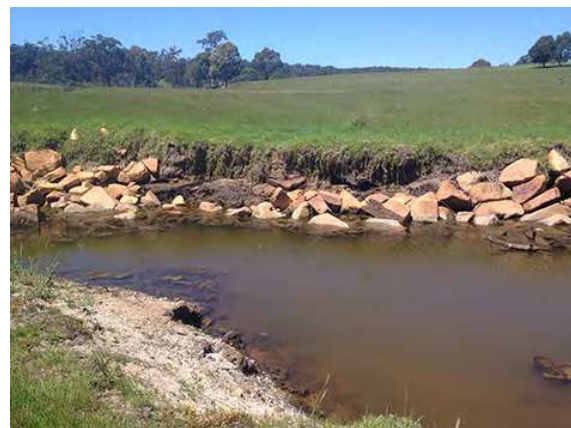
Figure B12 Large granite boulders placed at the culvert outlet for bed protection (*left image*). The

hydraulic jump caused by the culvert has led to development of a scour pool where flows enter Booths Creek and erosion of the opposite bank. Boulders have been placed along the creek banks in an effort to stabilise the banks from the episodic high flows that occur (*right image*).

Issue Description: Episodic high flow events at the box-culvert have caused disturbance to the rock chute with bed sediments now exposed with potential risk of further erosion. The rock chute may need to be re-designed to better disperse stream power. Furthermore, the landholder has expressed desire to move stock between western and eastern sides of property via the box culvert to avoid dangerous practice of walking stock over Tathra-Bermagui Road. However, the rock chute in its current form prevents the movement of stock via the box culvert.

- Repair rock chute, which may include need for redesign and extension of existing rock revetment to disperse high velocity flows.
- Repair and maintenance of the rock chute may consider use of cement stabilised sand for bed protection but also provide even surface for use as stock crossing.

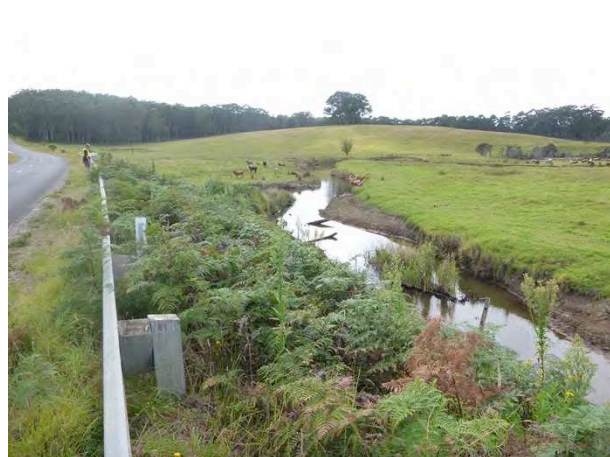
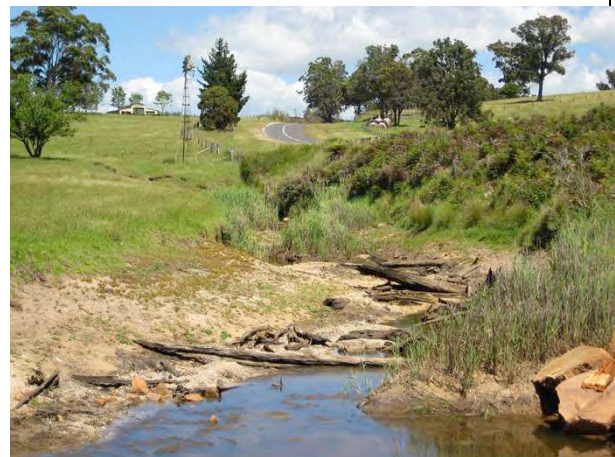
Figure B17 The view of Booths Creek natural alignment above the stormwater pipes (*left image*). The upstream view of Booths Creek natural alignment from the box culvert looking towards the stormwater pipes (*right image*).

- Maintenance of the low-flow stormwater pipes at the natural alignment of Booths Creek.
- Work with landholder to improve the riparian vegetation cover over lower Booths Creek that will provide increased bank protection during high flow events.
- Mitigation of bank erosion problem may also require further engineering investigations and re-design of the rock chute outlet to disperse stream-flow energy.

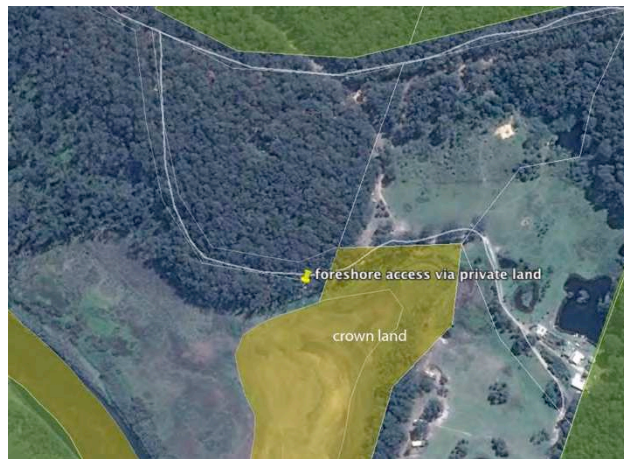
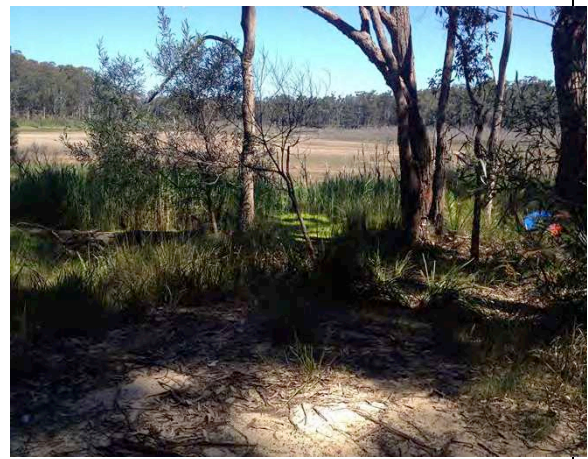
Figure B21 Overview of the issue location with respect to private land and crown land reserve (*left image*). Informal access to lagoon foreshore via private land (*right image*).

- Signage to raise awareness of sensitive saltmarsh community and that access to estuary at this location is not encouraged.

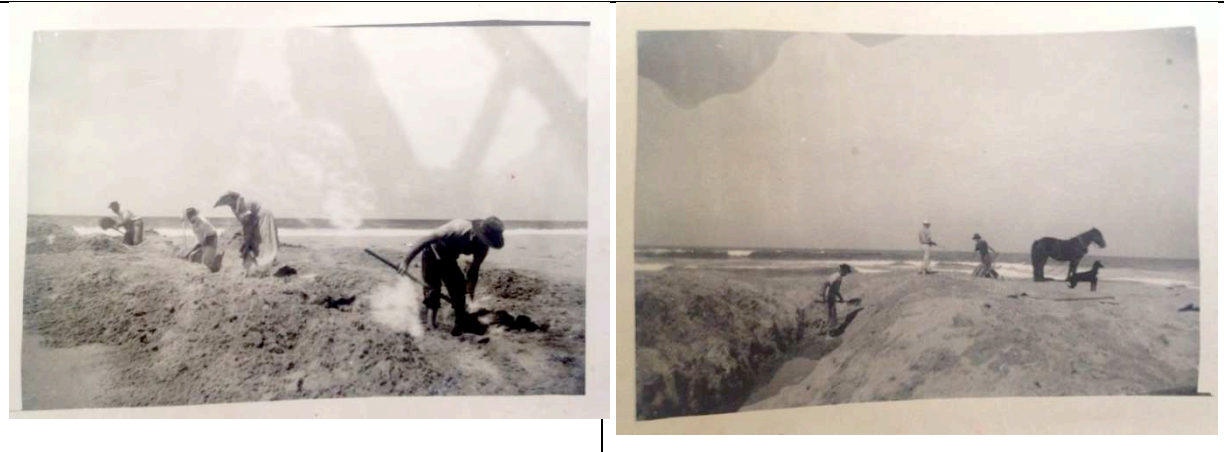
Figure B25. Historical management of the Middle Lagoon ocean entrance – circa 1950s (photos courtesy of N. Dummett).

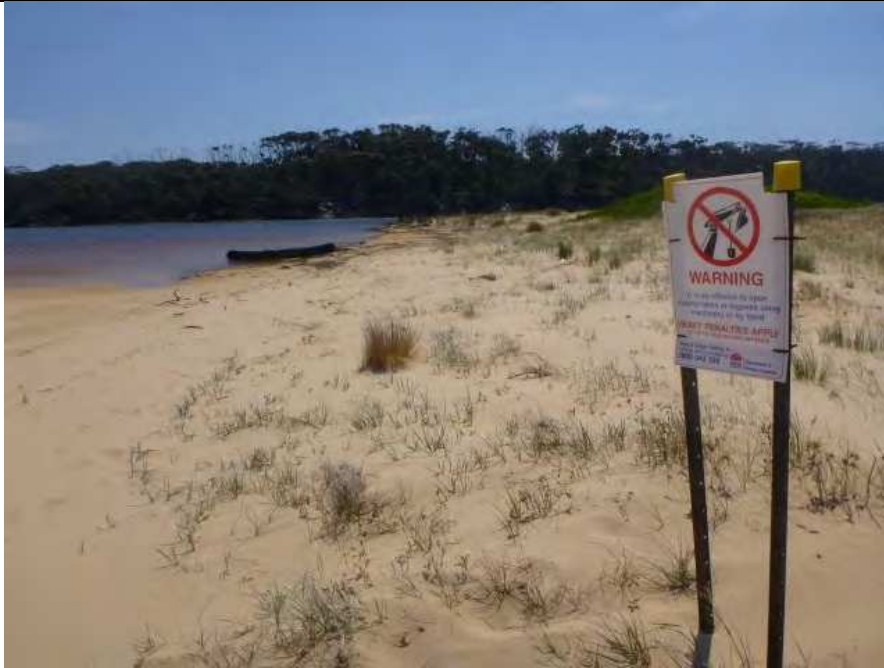
Figure B26 Signage erected near the entrance of Middle Lagoon in 2012 warning persons that opening the estuary is prohibited and prosecutable offence with heavy penalties of up to \$110,000 for individual and \$220,000 for corporations.

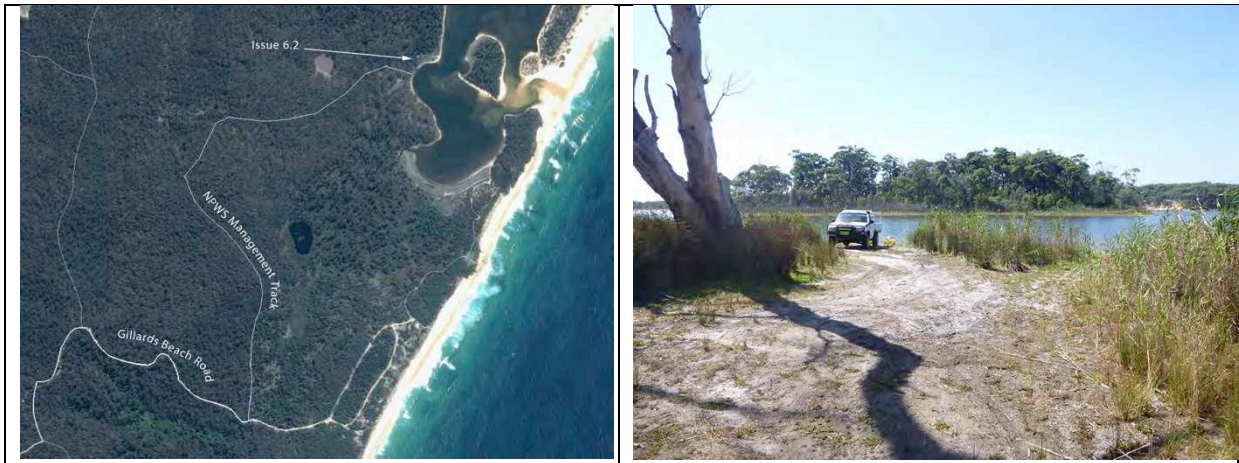
Issue Description: A NPWS management track from Gillards Beach Road provides access to the western foreshore of Middle Lagoon where there is an informal camp. Areas of the foreshore are degrading from uncontrolled use. The track has historically been used by fishermen to launch small vessels and continues to be the primary foreshore access point for commercial fishermen. However the track is currently in very poor condition and not being actively maintained by NPWS. When funding permits, NPWS intend to install a locked gate at the track entrance to further limit use and restrict public use (*pers. comm.* K. Brown, NPWS, Oct 2015). Foreshore access is an important issue to commercial fishermen who are currently permitted to fish the lagoon under Region 7 of the NSW Estuary General Fishery. Consequently, NPWS are obliged to permit alternative and continued access via the Tanja Depot off Haighs Road in lieu of access via other established tracks.

Figure B27. NPWS management track that provides access to the western side of Middle Lagoon (*left image*). Foreshore access at western side of lagoon via NPWS management track used to launch small vessels (*right image*).

- Liaise with NPWS regarding plans to install a locked gate on the management track at Gillards Beach Road to limit track use.
- Work with NPWS to monitor the natural regeneration of vegetation at the degraded foreshore to ensure weeds do not become an issue.

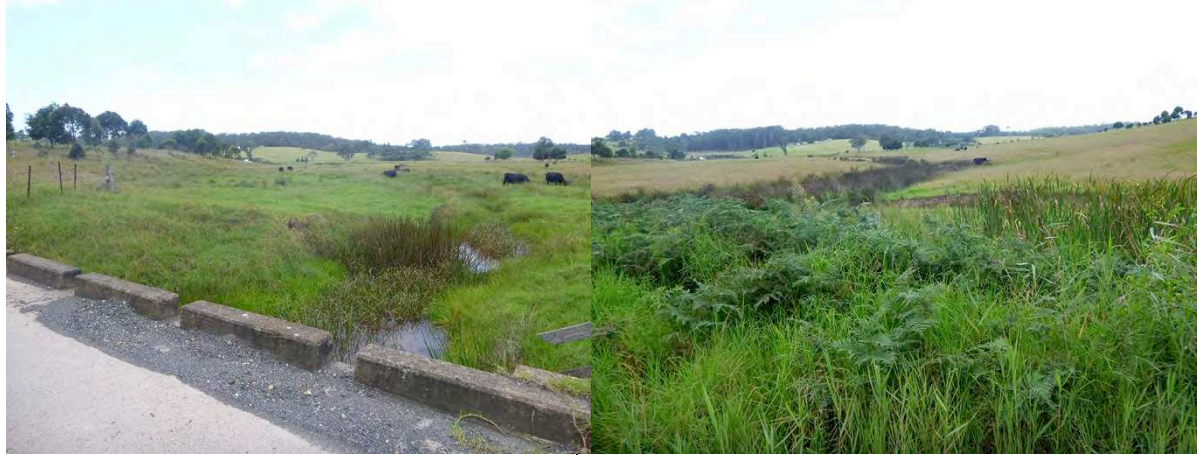
Figure B30 Downstream view of Davis Creek drainage line from Kellys Bridge at Barrabooka Road with cattle grazing in the wetland area (*left image*). A tributary drainage line to Davis Creek defined by the presence of wetland plants including *Juncus* spp. (*right image*).

- Work with landholders along the Davis Creek wetland system to protect natural values of wetland areas from stock impacts and enhance the function of wetland to slow water flows. Fencing may not be practical in all areas due to potential damage during flood events.
- Alternative solutions to improving wetland areas may include discussion with landholders to implement stock management strategy to graze wetland areas only during dry periods to minimise potential damage, and or use of off-stream stock watering troughs.
- Note that South East Local Land Services (SE LLS) will commence work with landholders of Lot 82 DP810431 in 2016 to fence the drainage line to exclude stock access and undertake a replanting program to rehabilitate the riparian zone.

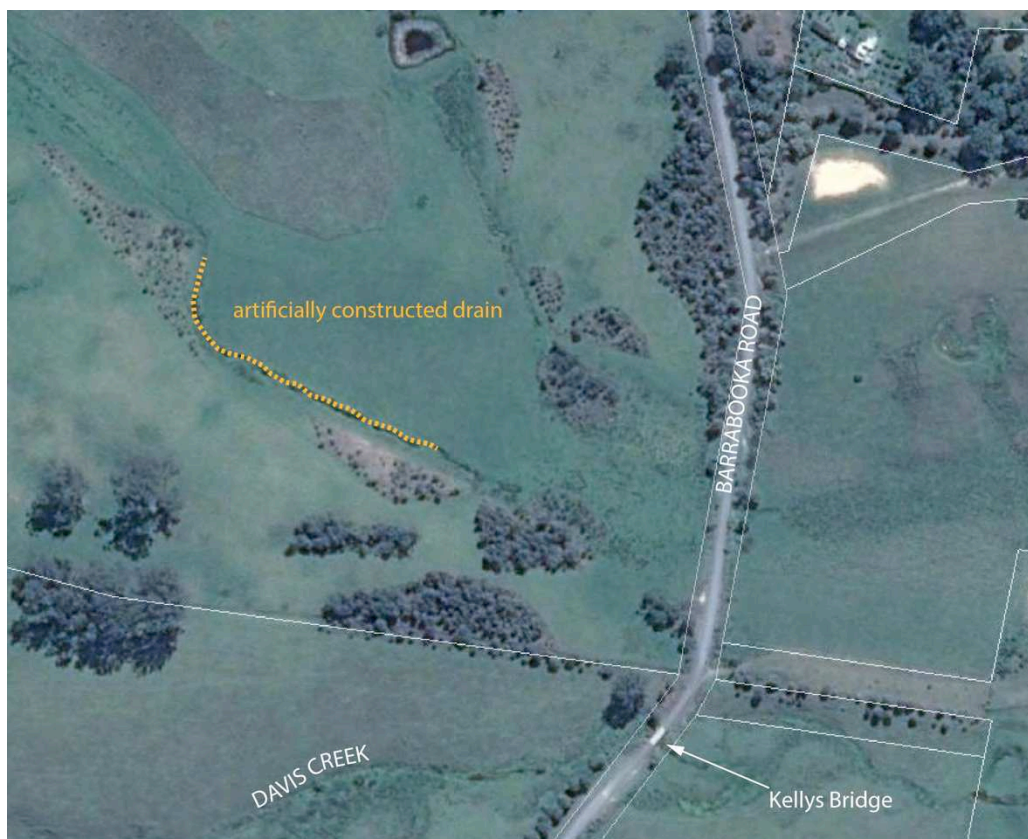
Figure B32 Location of an artificially constructed drain through a floodplain wetland that is now undergoing rehabilitation works.

- No action required. The current landholder is working with SE LLS to improve the condition of the drainage line including re-establishing riparian vegetation and fencing to exclude stock access.
