**DRAFT**  
**Proposed Test Bore Sites Related to a Proposed Dunal Exfiltration Scheme at**  
**Merimbula, NSW**  
**Aboriginal Archaeological Assessment**

A Report to  
nghenvironmental  
PO Box 470  
Bega NSW 2550

June 2009

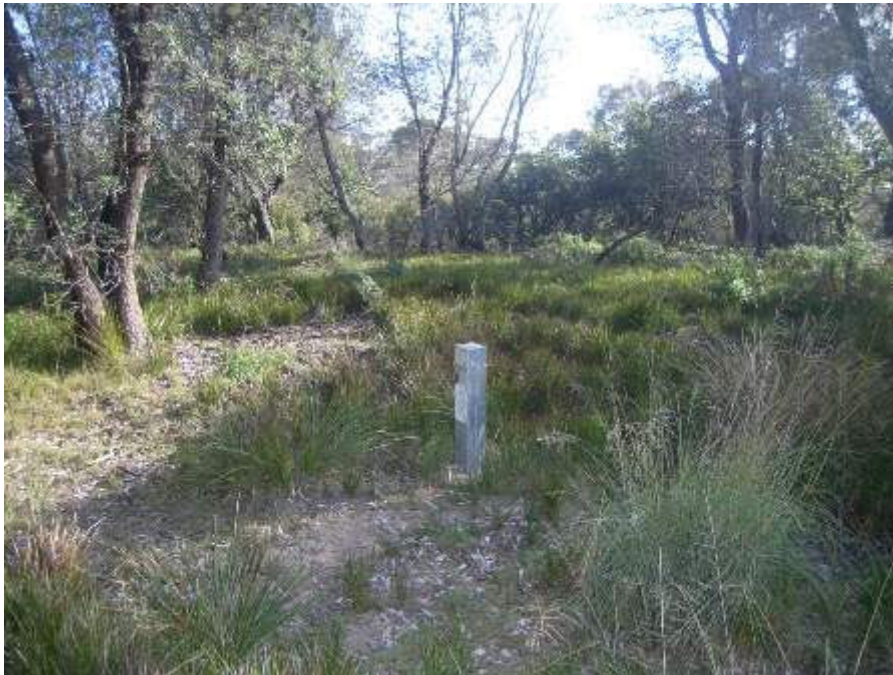
The proposed works entails the drilling of bores, test pumping and water sampling at two locations (Northern and Central Areas) in the dune complex of the Merimbula Bay Barrier. Plans of the approximate locations of the proposed bores (1 test production bore and 6 monitoring bores) and are provided in Figures 2, and 3. An existing monitoring bore (PPK1) is present in the Central Area (Plate 1).

Plate 1. An existing monitoring bore site in the Central Area; note minimal surface disturbance.

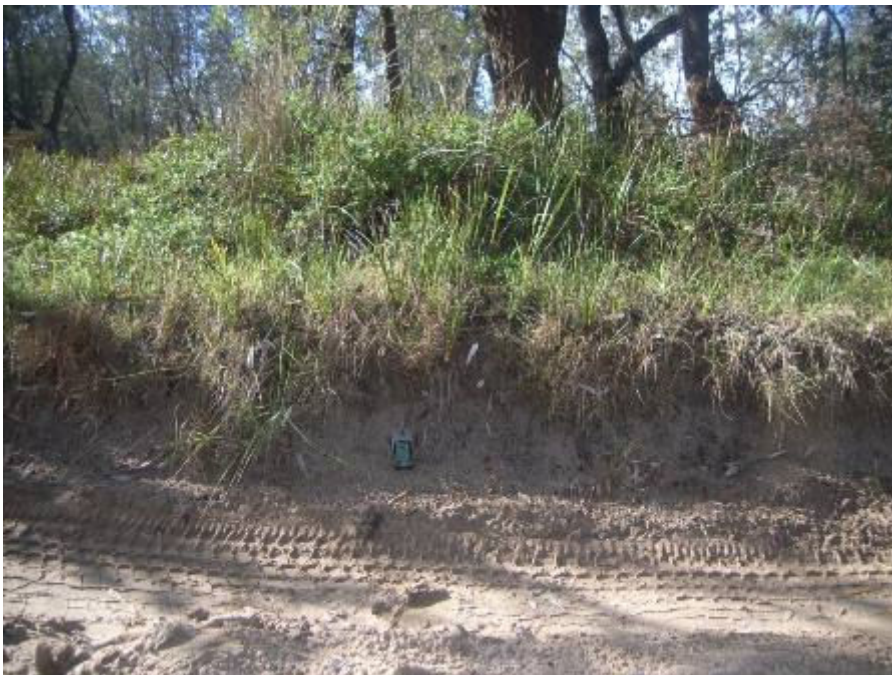
A series of vehicular and pedestrian tracks extend throughout the dune complex and some of these will be utilised for site access during the test bore construction activity. In some instances these tracks are incised through the sand to a depth of c. 0.6 m causing localized impact (Plate 2). Evidence of previous and now abandoned tracks is also present in the immediate vicinity of many of the sites in question.

Plate 2. Track incision in dune at c. 5 m south of the Central Area Test Bore 1

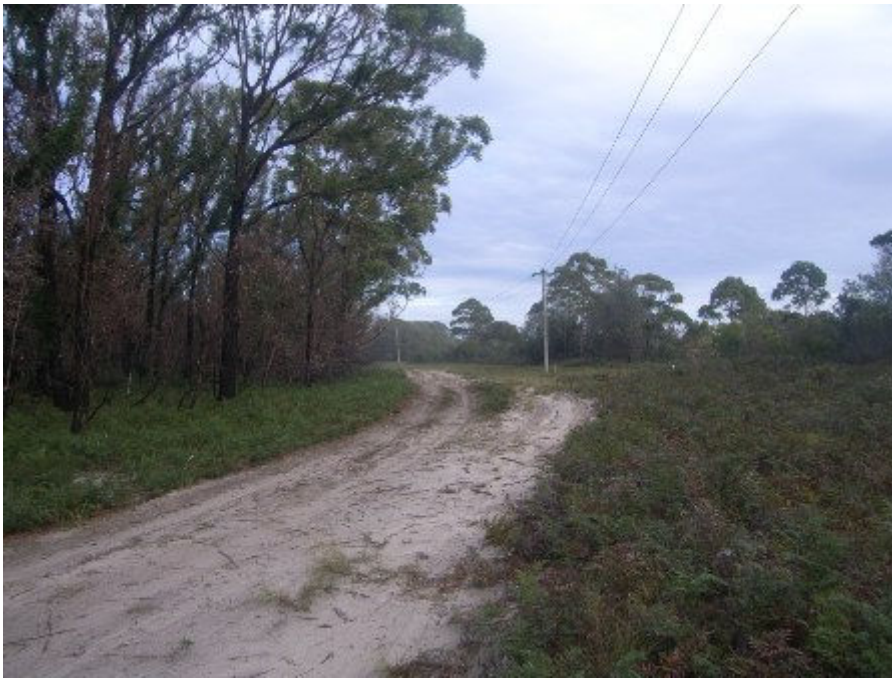
A transmission line extends the length and western side of the landform (Plate 3). The line is located within a c. 50 m wide cleared easement which contains numerous vehicle tracks; disturbance in the area is high. At the Northern Area two test bores are proposed to be located at the margins of this clearing.

Plate 3. Transmission line easement looking south towards the Northern Area Site 1 (to left).

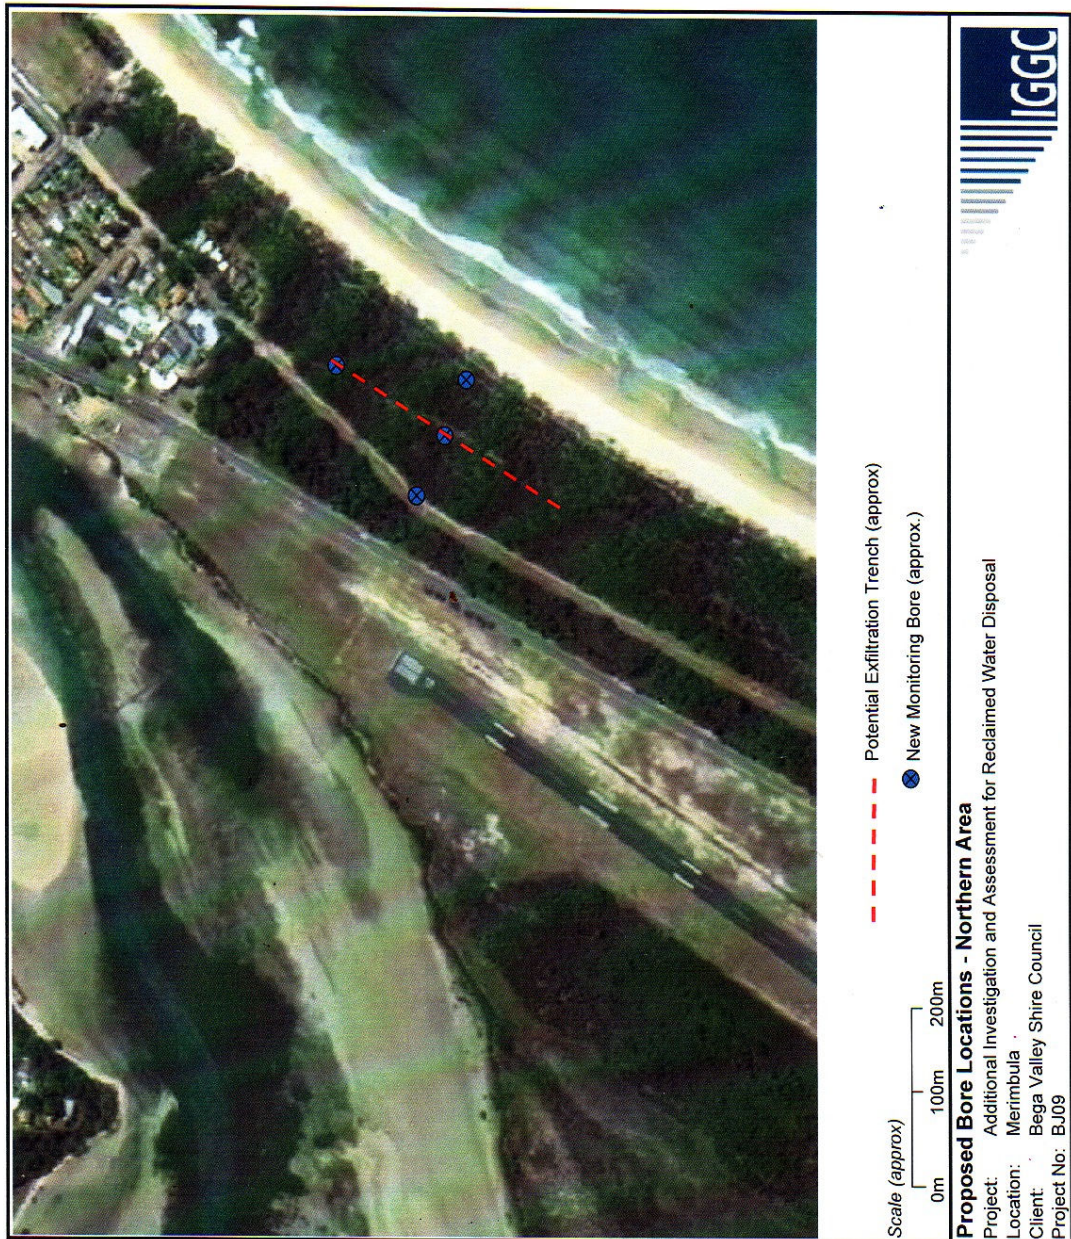
Figure 2. Plans of the approximate location of proposed test bore sites - Northern Area (supplied by client)

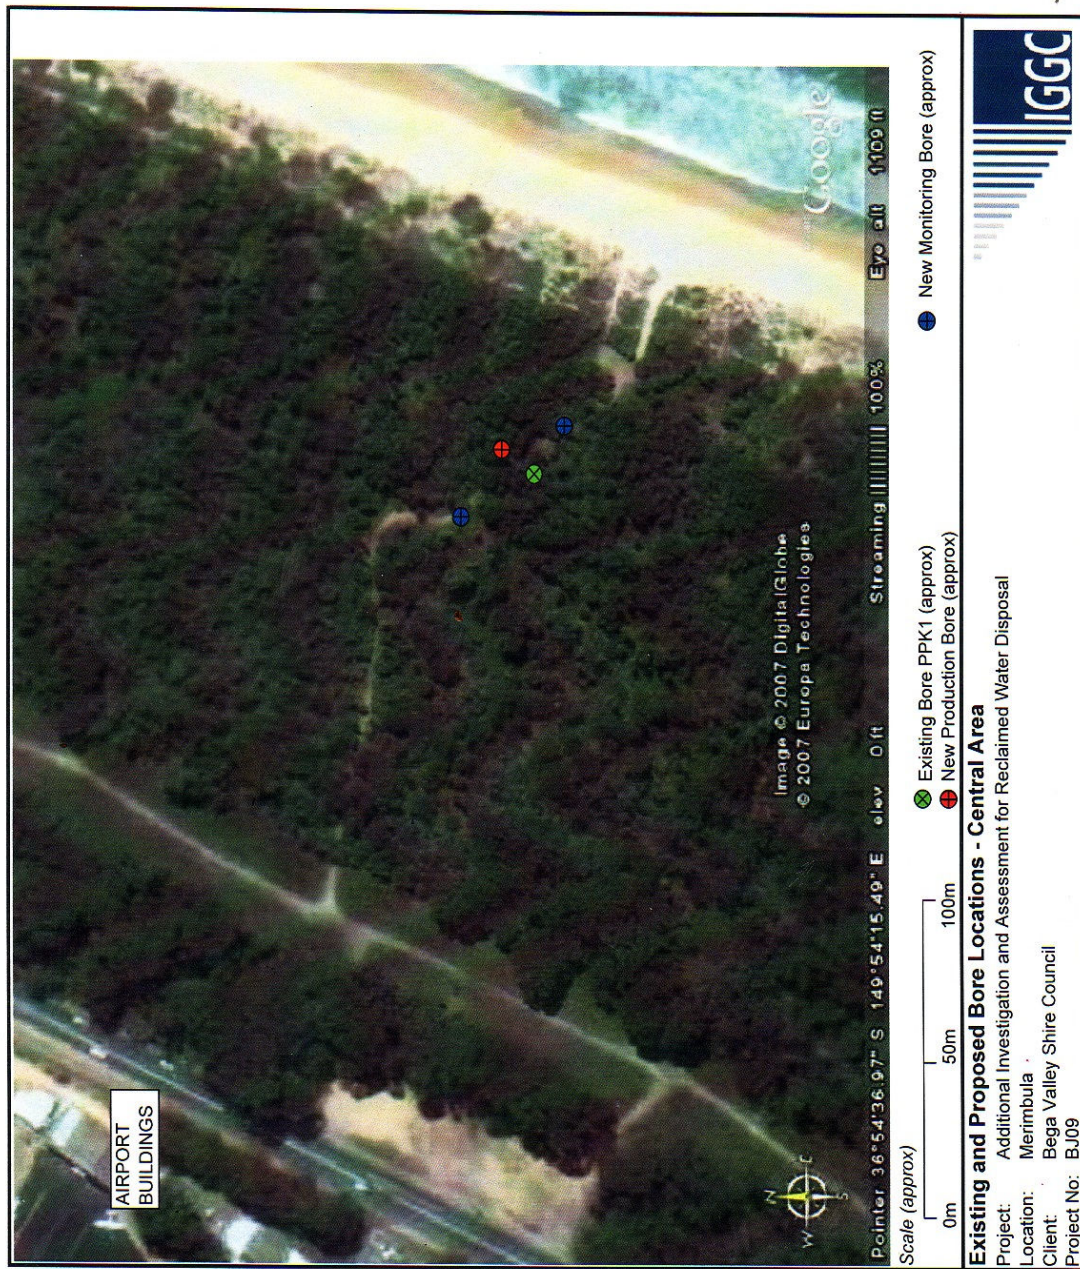
Figure 3. Plans of the existing and approximate location of proposed test bore sites - Central Area (supplied by client)

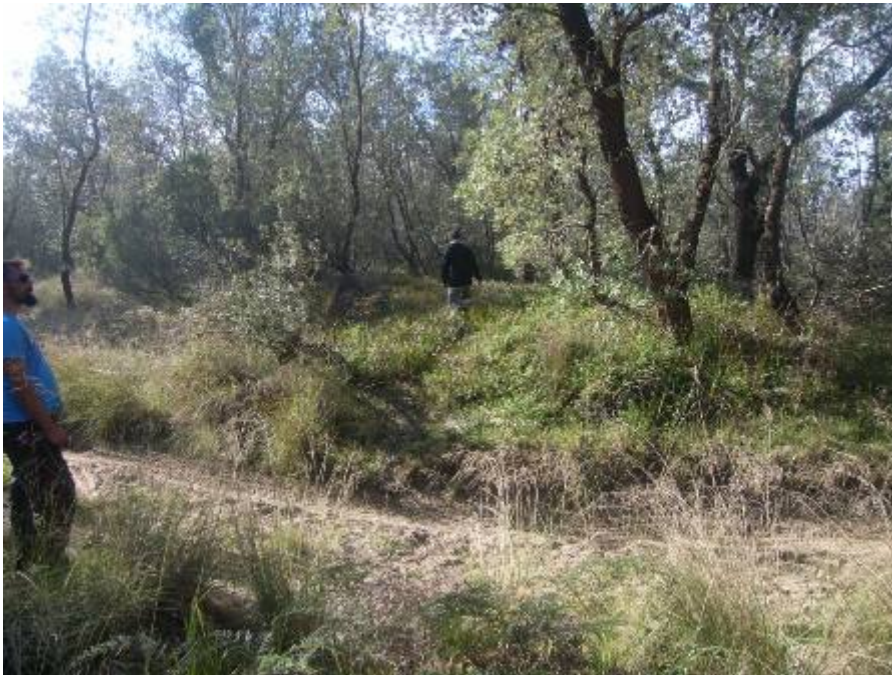
Site 1 (located c. 10 metres north of an existing bore)                      grid ref: 758801e 5911144n (hand GPS- GDA)

This site is the location of the proposed production/injection bore and is located on the crest of a narrow sand ridge (Plate 4). A deeply incised (c. 0.5m deep) beach access track passes in an east/westerly alignment immediately to the south of this site. This track provides an ability to observe the top 50 cm of the soil profile in this area which is a light brown, clean sand with little organic matter. The bore site is situated c. 5 metres north of the existing track in a small area devoid of shrubs. Ground cover is comprehensive at this site and ground exposure was negligible. However good ground exposure and archaeological visibility was present in the adjacent track.

Plate 4. Central Area: Site 1 looking north; note track.

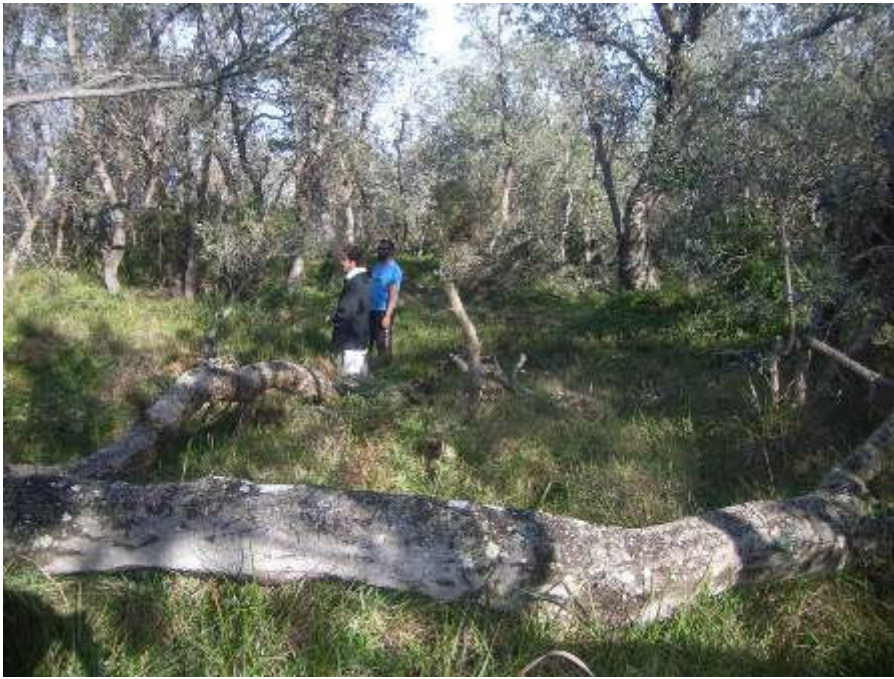
Site 2 (located c. 20 metres east of Site 1)                      grid ref: 758820e 5911125n (hand GPS- GDA)

This site is the location of a proposed monitoring bore and is located in a swale (Plate 5). A beach access track passes in an east/westerly alignment immediately to the south of this site. The bore site is situated c. 5 metres north of the existing track in a small area devoid of shrubs. Ground cover is comprehensive at this site and ground exposure was negligible. However good ground exposure and archaeological visibility was present in the adjacent track.

Plate 5. Central Area: Site 2 looking southeast.

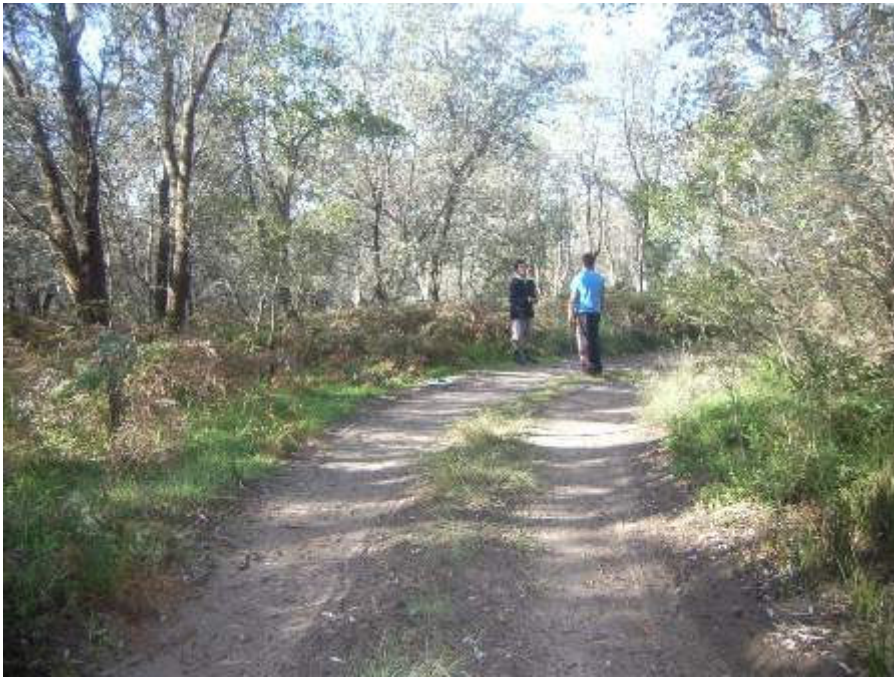
Site 3 (located c. 20 metres northwest of Site 1)

grid ref: 758788e 5911172n (hand GPS- GDA)

This site is the location of a proposed monitoring bore and is located on a broad crest of a sand ridge (Plate 6). A beach access track passes in an east/westerly alignment immediately to the south of this site. The bore site is situated c. 5 metres north of the existing track in a small area devoid of shrubs. Ground cover is comprehensive at this site and ground exposure was negligible. However good ground exposure and archaeological visibility was present in the adjacent track.

Plate 6. Central Area: Site 3 looking east.

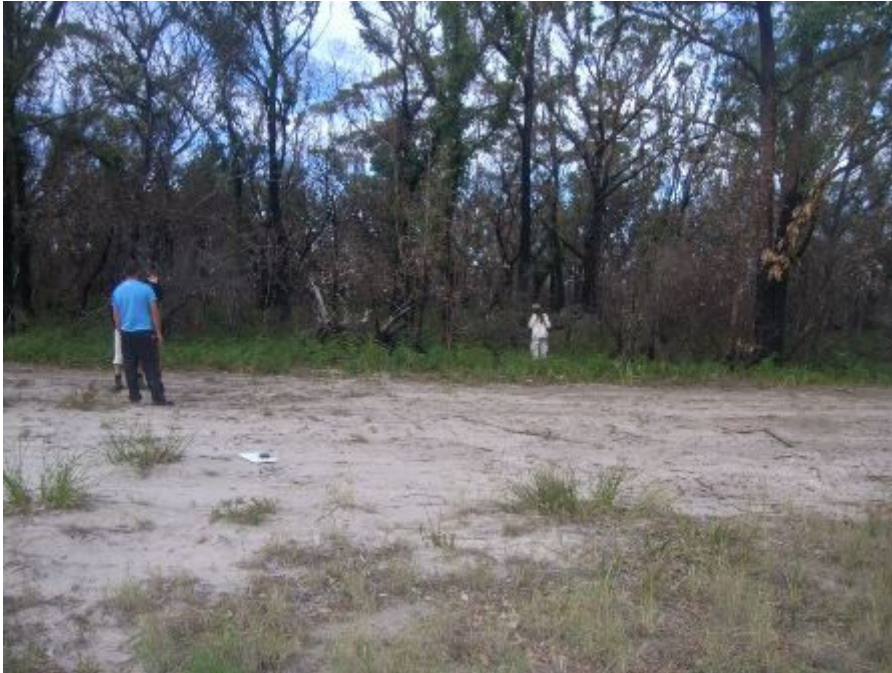
Site 1 (located at the eastern margin of transmission line)      grid ref: 759181e 5912134n (hand GPS- GDA)

This site is the location of a proposed monitoring bore and is located at the margin of the clearing and network of tracks associated the transmission line (Plate 7). This area has been subject to recent fire activity and accordingly ground exposure is relatively high (c. 50%) with archaeological visibility estimated to be c. 30%. High ground exposure and archaeological visibility was present in the adjacent track network west of the site. The site has been subject to relatively high levels of previous disturbance.

Plate 7. Northern Area: Site 1 looking east.

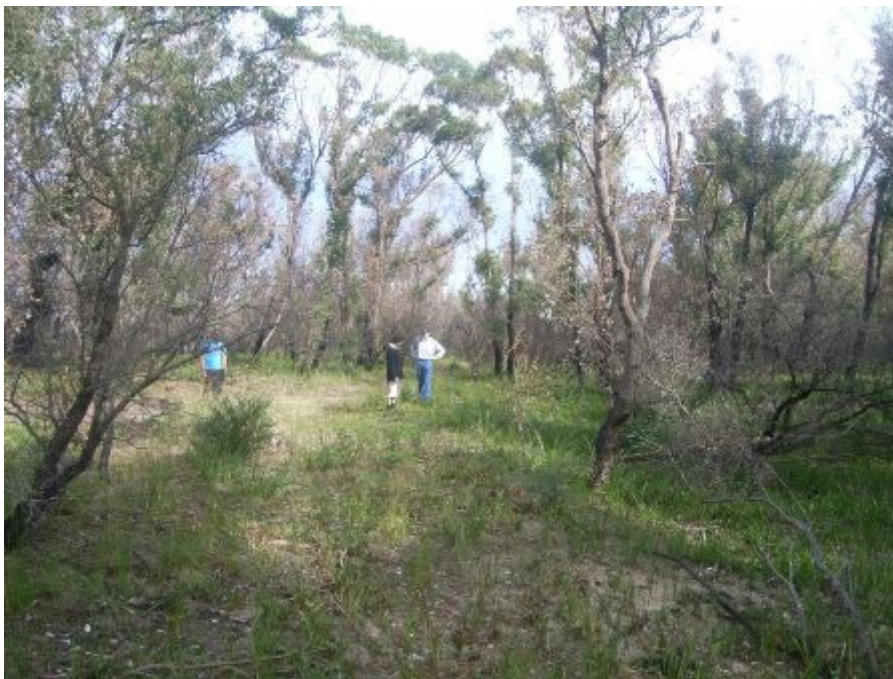
Site 2 (located c. 70 m east of Site 1)      grid ref: 759253e 5912067n (hand GPS- GDA)

This site is the location of a proposed monitoring bore and is located immediately adjacent to a beach access track (Plate 8). This area has been subject to recent fire activity and accordingly ground exposure is relatively high (c. 50%) with archaeological visibility estimated to be c. 30%. The site has been subject to relatively high levels of previous disturbance.

Plate 8. Northern Area: Site 2 looking south.

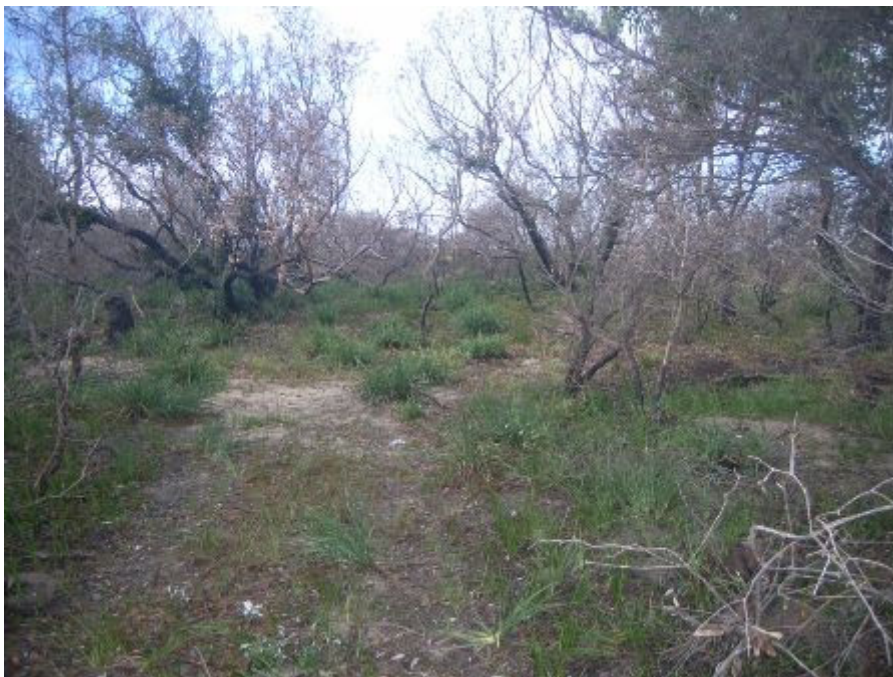
Site 3 (located c. 50 m east of Site 2 closest to beach)

grid ref: 759300e 5912058n (hand GPS- GDA)

This site is the location of a proposed monitoring bore and is located immediately adjacent to an old beach access track (Plate 9). This area has been subject to recent fire activity and accordingly ground exposure is relatively high (c. 50%) with archaeological visibility estimated to be c. 30%. The site has been subject to relatively high levels of previous disturbance.

Plate 9. Northern Area: Site 3 looking east.

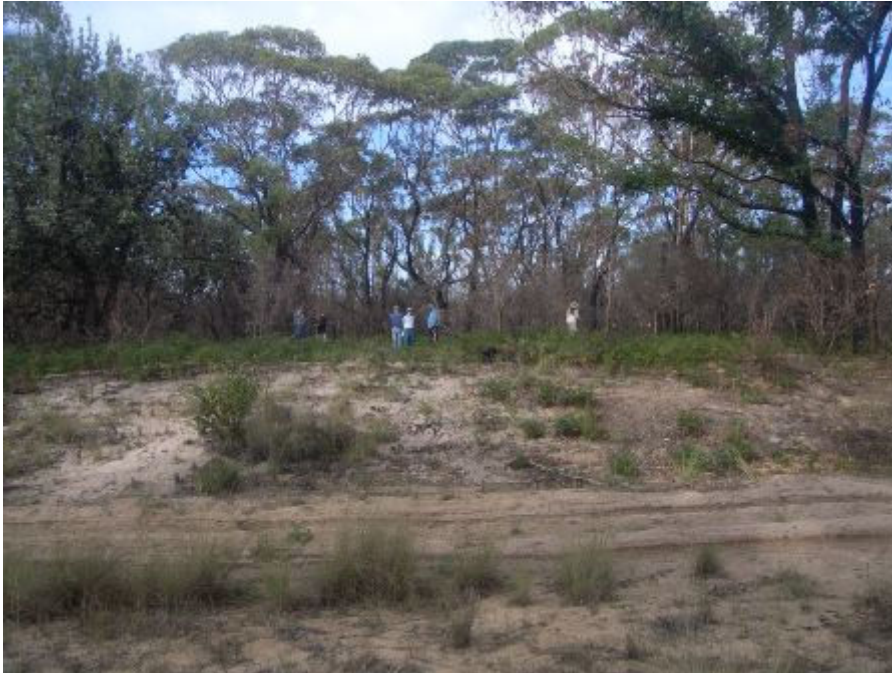
Site 4 (located c. 250 m north of sites 1-3)

grid ref: 759368e 5912291n (hand GPS- GDA)

This site is the location of a proposed monitoring bore and is located immediately adjacent to the clearing and network of tracks associated the transmission line (Plate 10). This area has been subject to recent fire activity and accordingly ground exposure is relatively high (c. 70%) with archaeological visibility estimated to be c. 30%. The site has been subject to relatively high levels of previous disturbance.

Plate 10. Northern Area: Site 4 (where figures are standing) looking east; note track to west of site which traverses the transmission line easement.
