Eden, Twofold Bay, Towamba River Flood Study

Flood Study

Prepared For: Bega Valley Shire Council
Project Name: Eden, Twofold Bay and Towamba River Flood Study
Rhelt Reference: J1053_R04_Stage_5_Rev0
Document Location: J1053 - Eden Flood Study\4. Reports\Stage 5 Report\J1053_R05_Stage_5_Rev0.docx
Client Reference: Stage 5 Report

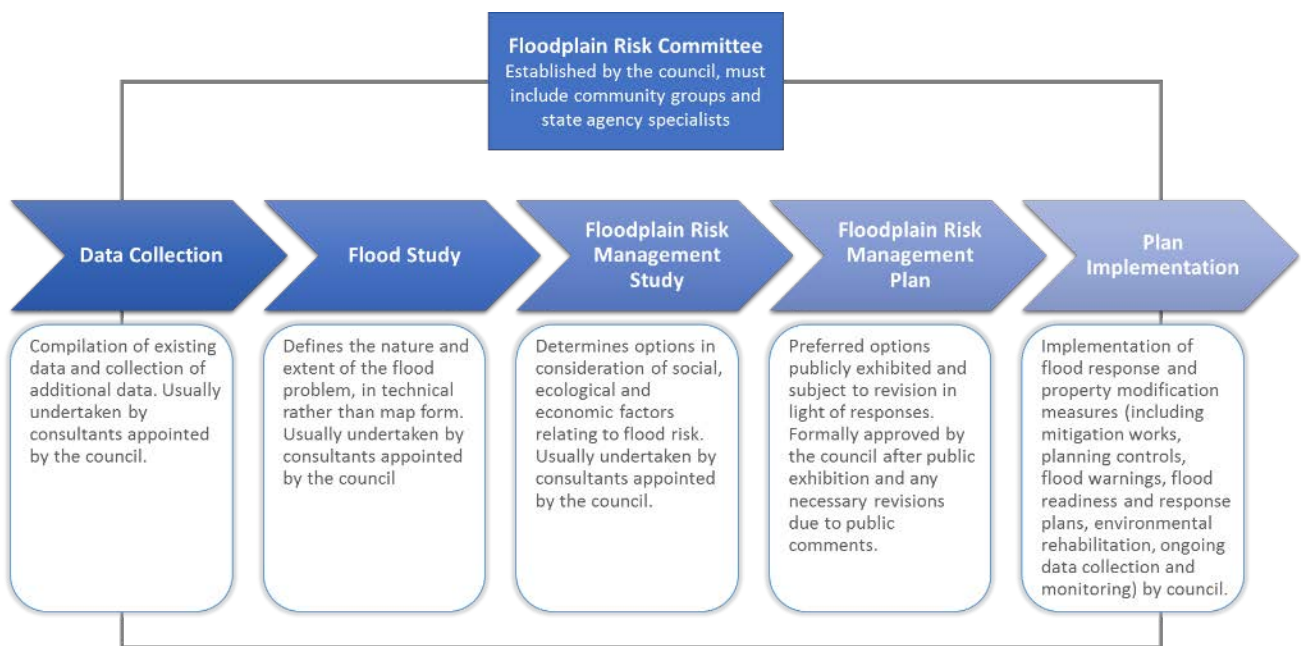
Figure F1 The Floodplain Risk Management Process (source: NSW Government, 2005)

The *Floodplain Development Manual* (NSW Government 2005) is provided to assist councils to meet their obligations through the preparation and implementation of floodplain risk management plans, through a staged process. **Figure F1**, taken from this manual, documents the process for plan preparation, implementation and review.

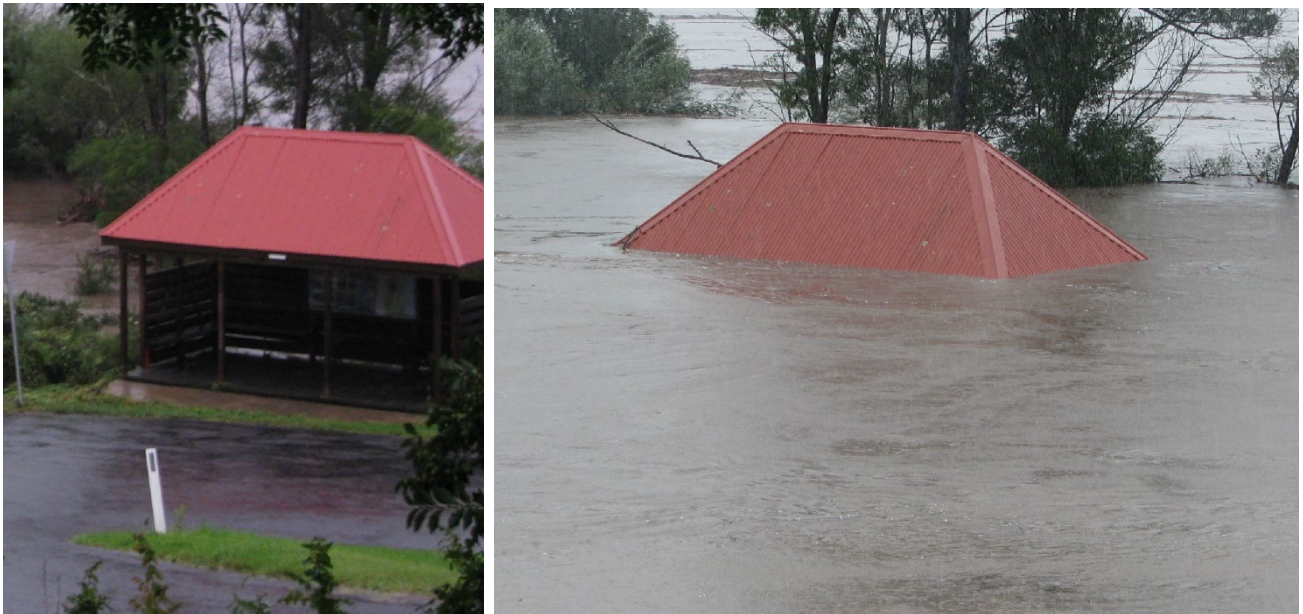
Figure 5-3 Towamba Bus Shelter Flooding in 2011

The flood level surveyed for the 1978 event was marked by a hacksaw on a post near the intersection of Yambulla Road and Towamba Street. The point was surveyed as being at 36.52m AHD. The model at this location has a level of 36.39m AHD, 0.13m lower than the survey mark.

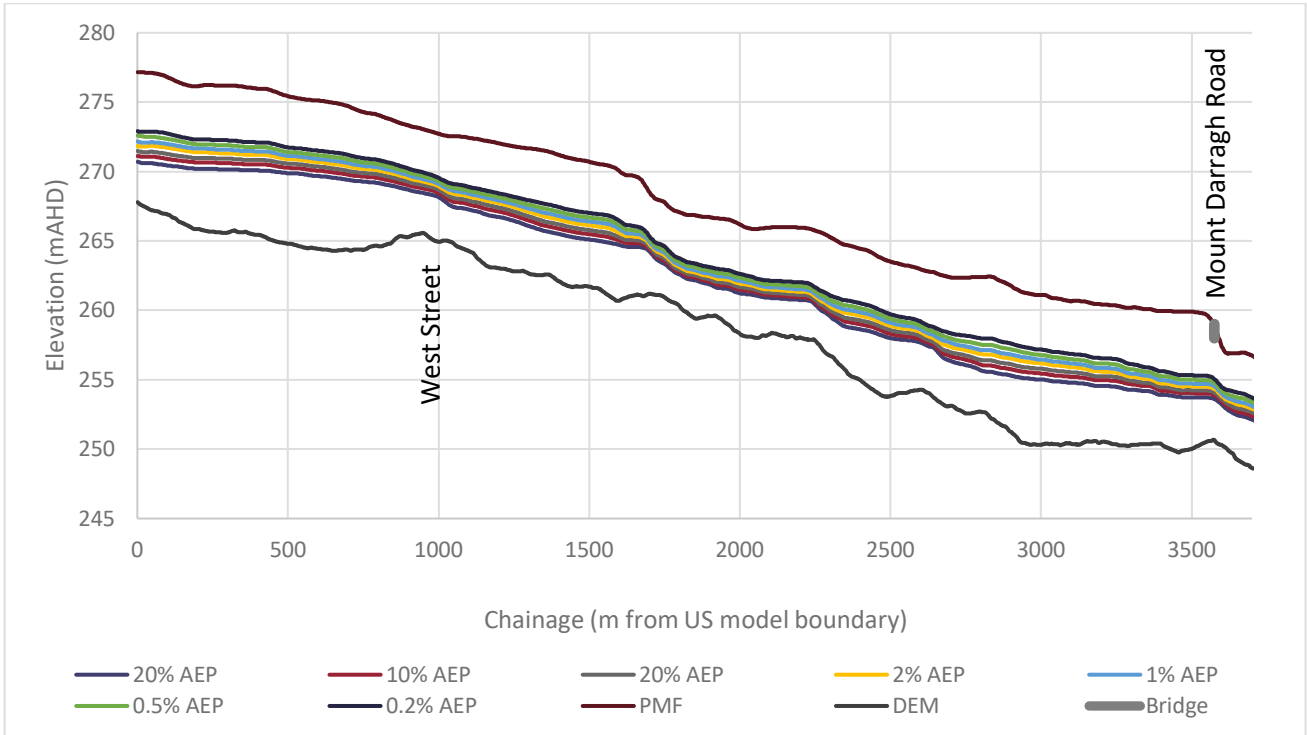
Figure 6-1 Wyndham Long Section

A long section through the study area is provided in **Figure 6-1**, with chainages shown in **Figure 6-2**. The long section shows that the AEP events have depths in the order of 2 to 5 metres, the PMF event has depths of up to 10 metres, which explains the significant increase in flood extent from the 1% AEP event to the PMF event.

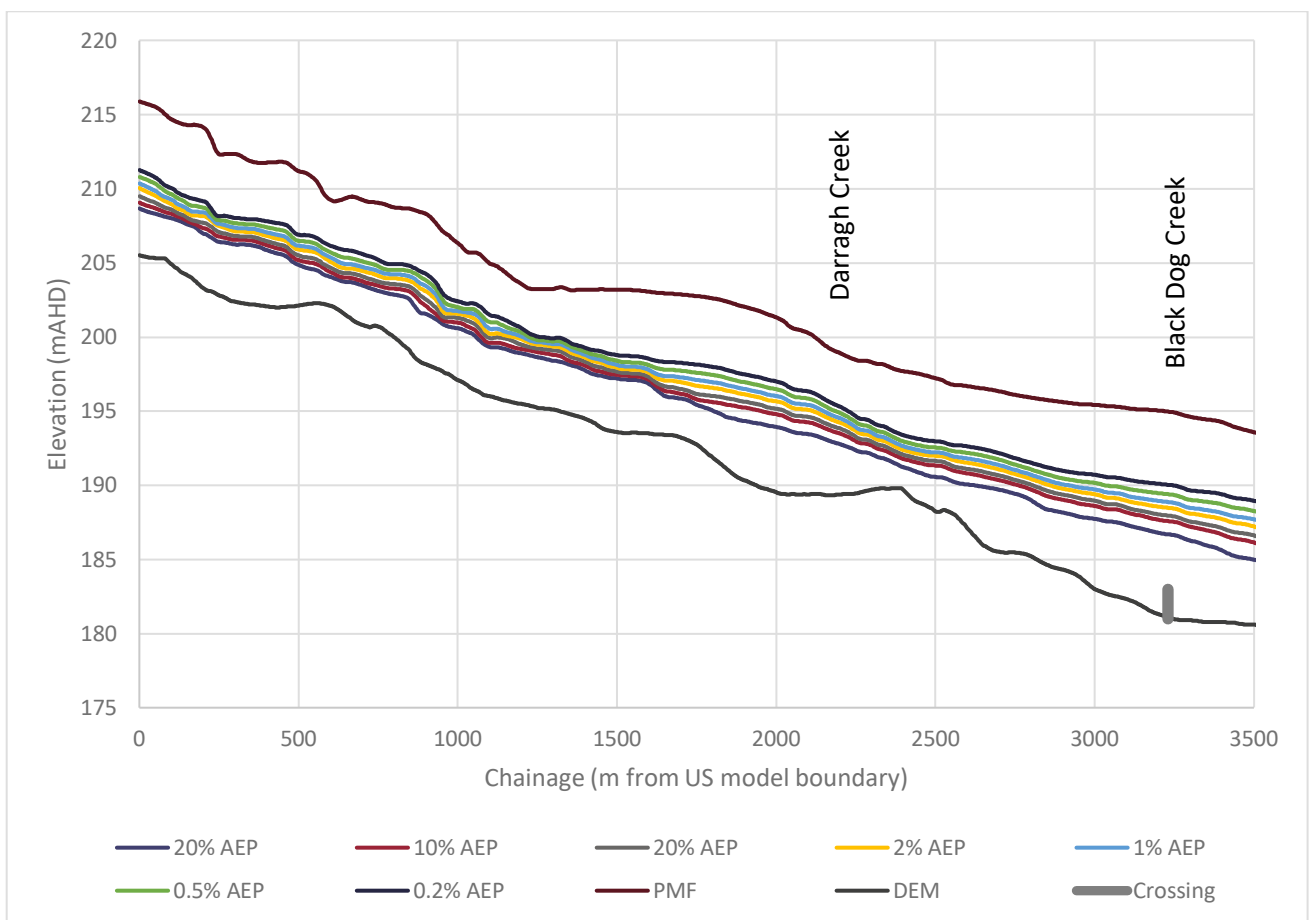
Figure 6-3 Rocky Hall Long Section

A long section through the study area is provided in **Figure 6-3** and the chainages in **Figure 6-4**. The long section shows that, similar to Wyndham, the PMF is typically twice as high as the 0.2% AEP event.

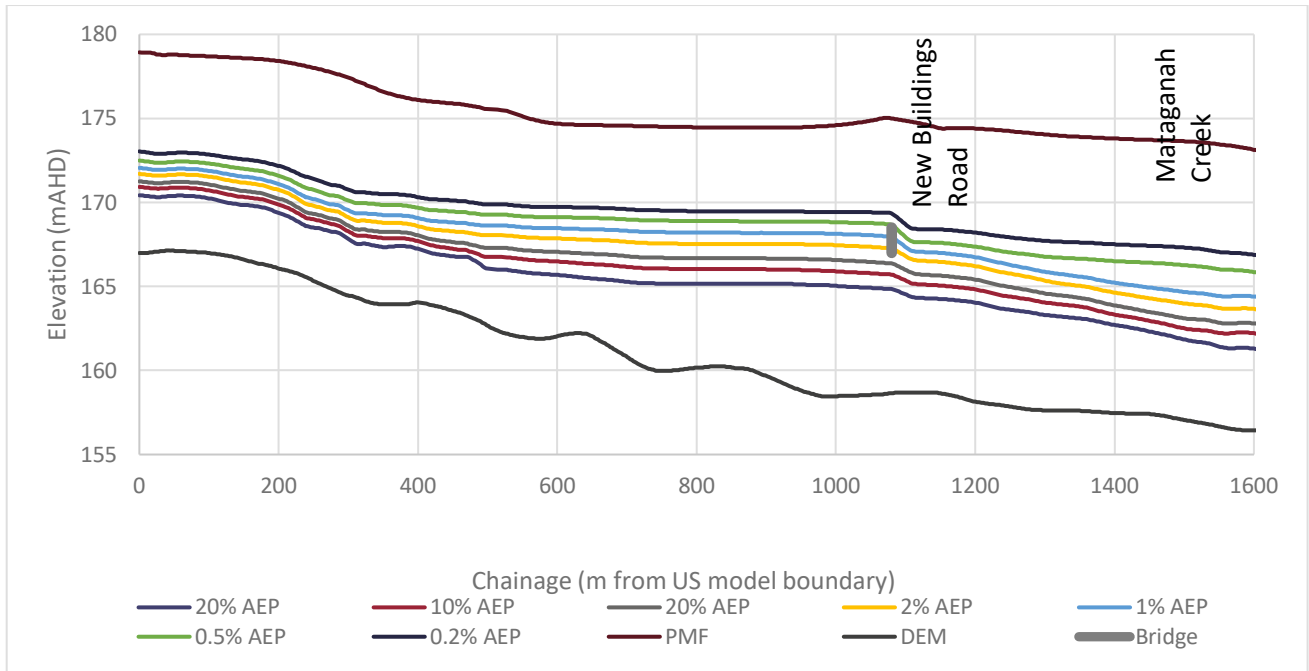
Figure 6-5 New Buildings Long Section

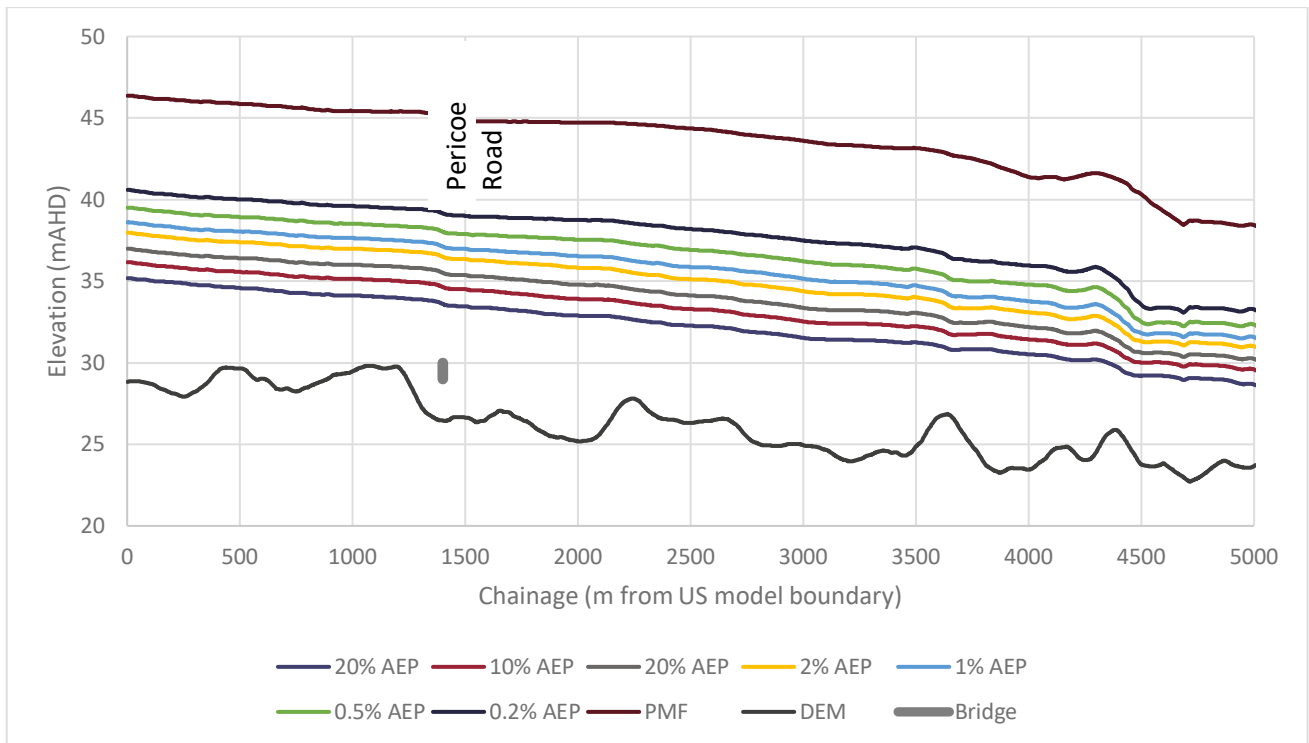
Figure 6-9 Towamba Long Section

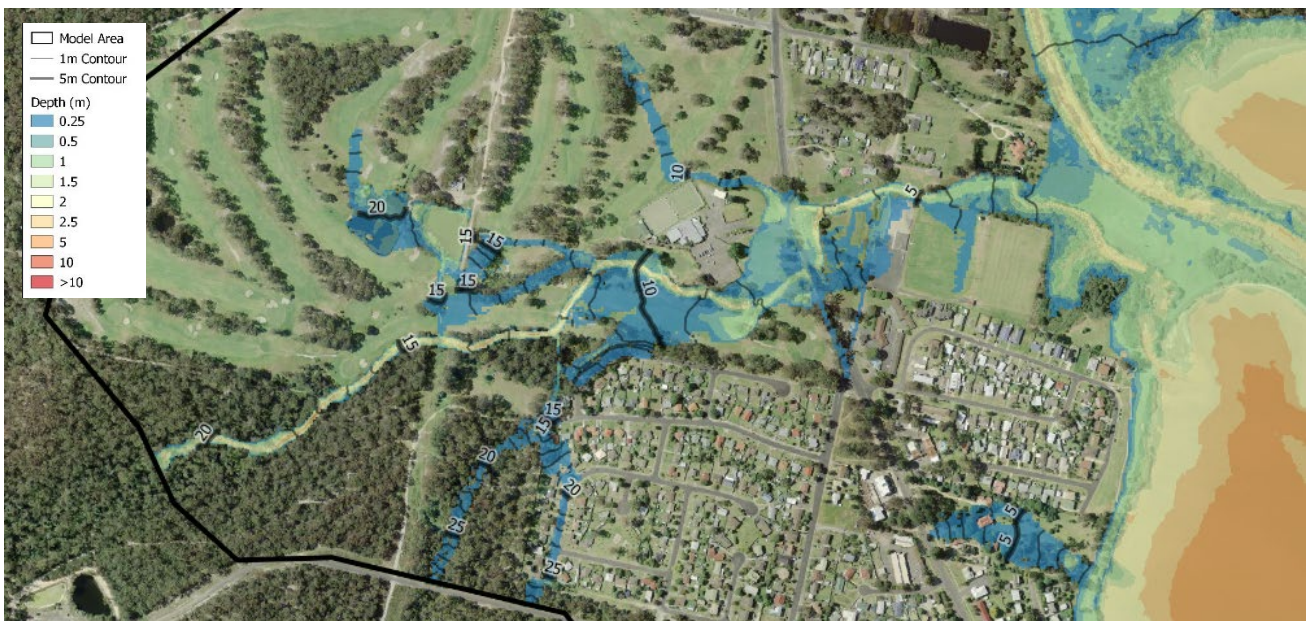
Figure 6-12 Lake Curalo Western Tributaries (with 1% AEP flooding)

In the PMF event however, there is substantial overbank flow, largely driven by the increased lake levels (refer **Figure 6-15**) that results in inundation of the sports fields, and property flooding along Clare Crescent and Cook Drive. Lakeside Drive properties are also flooded in the PMF, but this is driven by lake levels, rather than catchment flow.

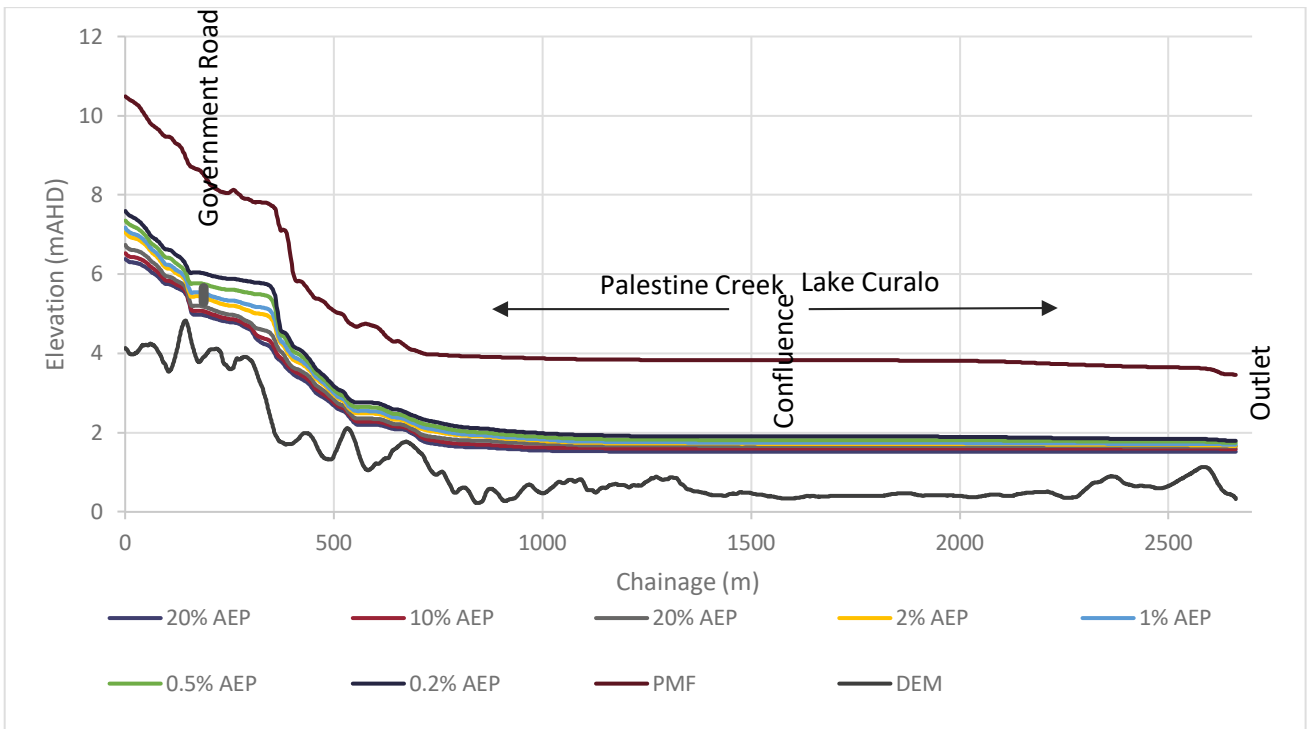
Figure 6-15 Lake Curalo Long Section

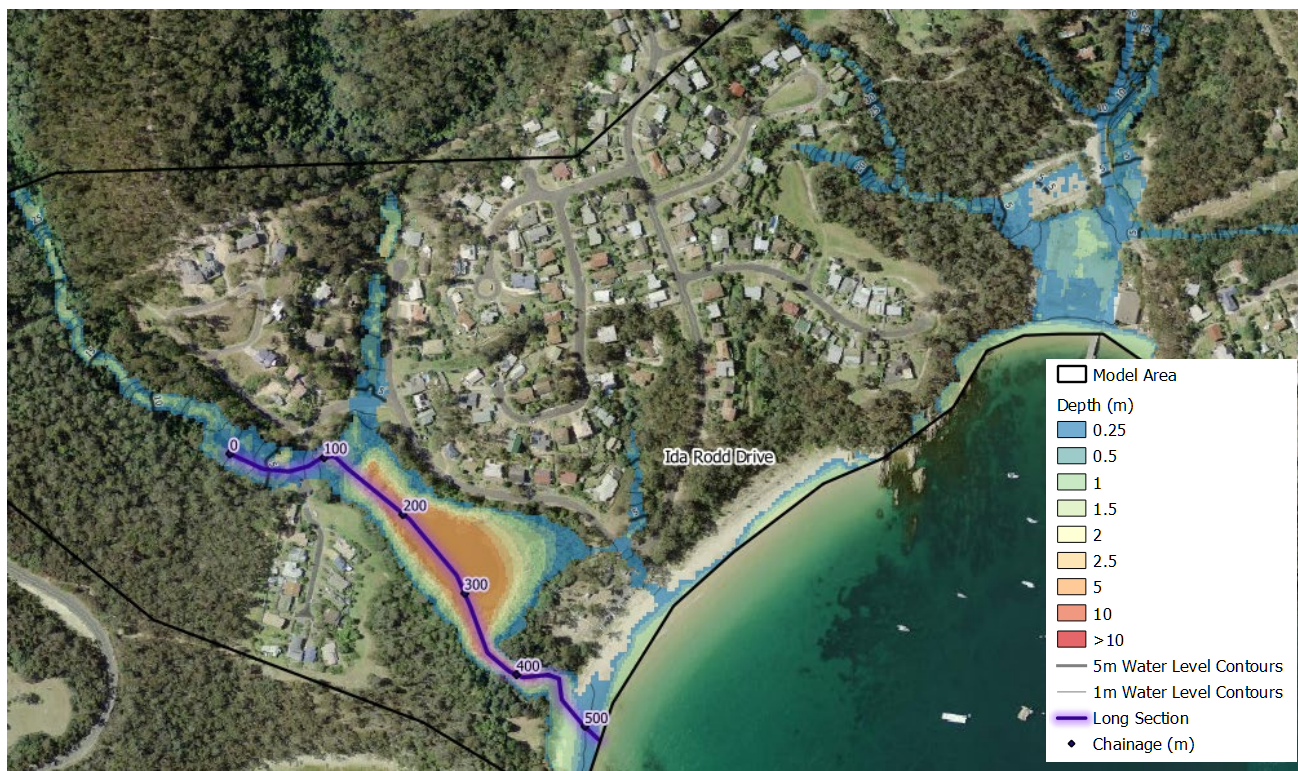
Figure 6-16 Lake Cocora 1% AEP Flooding & Long Section Chainage

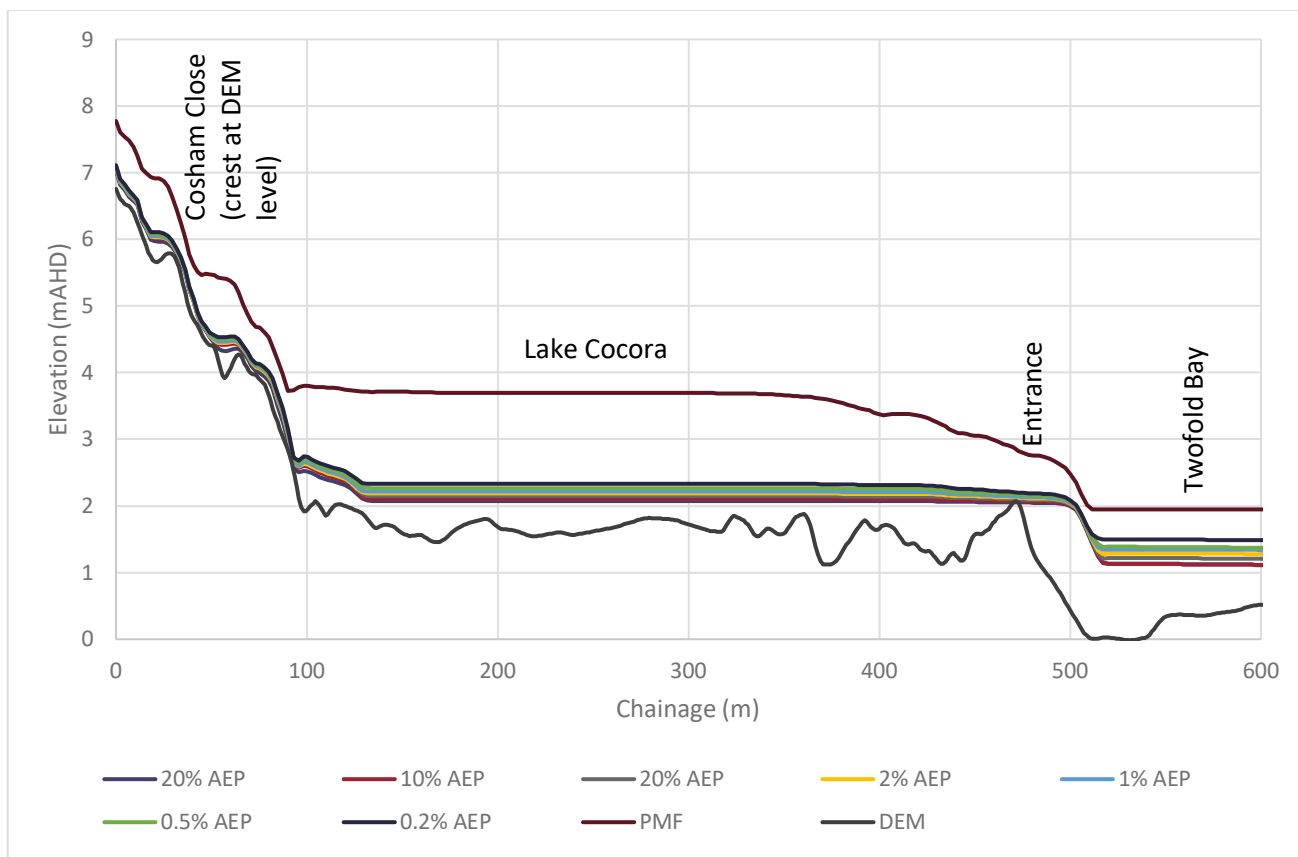
Figure 6-17 Lake Cocora Long Section

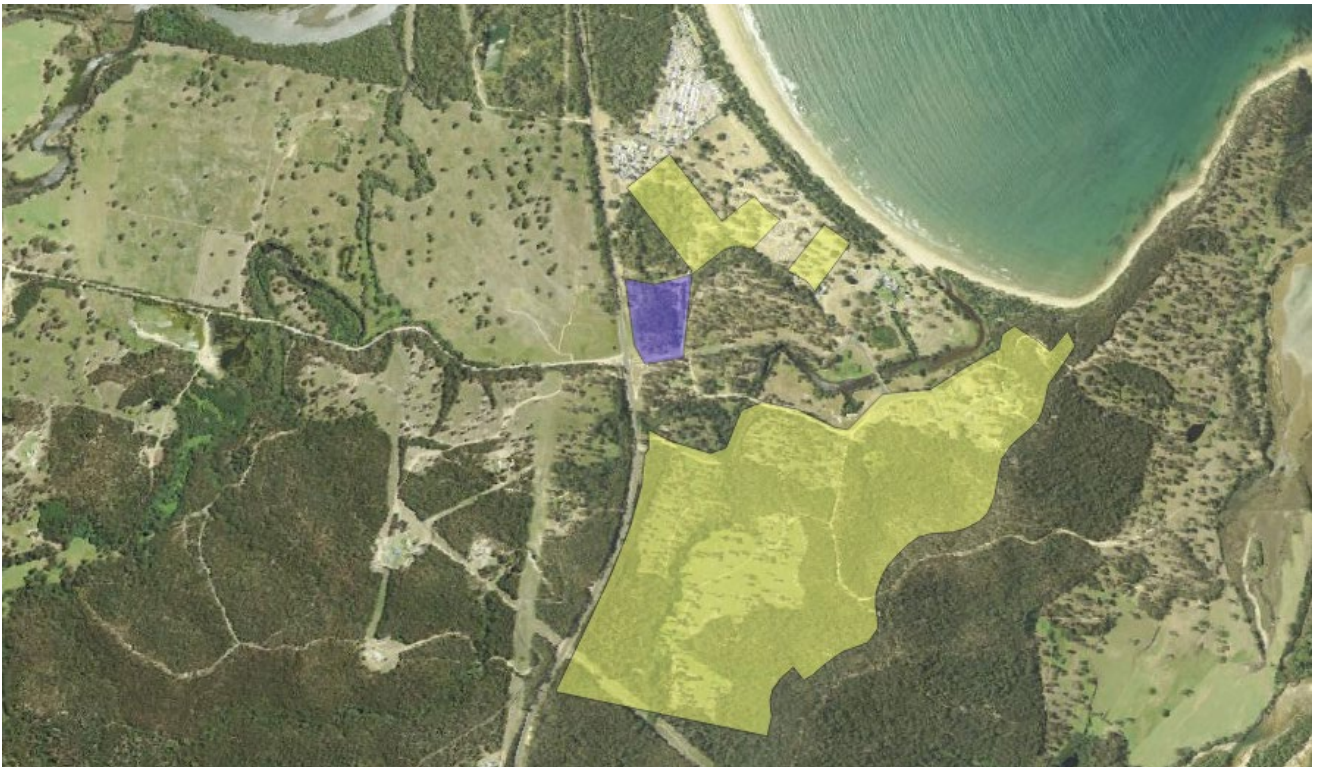
Figure 7-1 Regions of Permissible Future Development (Residential shaded yellow, Business shaded purple)

There are some regions of the catchment zoned low density residential and business that are currently undeveloped. These zones are at the downstream end of the catchment, between the Princes Highway and Twofold Bay (refer **Figure 7-1**). The hydrological model was updated to include this development. As it is located at the far downstream end, it had no impact on peak flows through the study areas, and consequently, no impact on peak flood levels. However, development within this region would have implications for the local drainage network, which would need to be assessed as part of the development of this region.

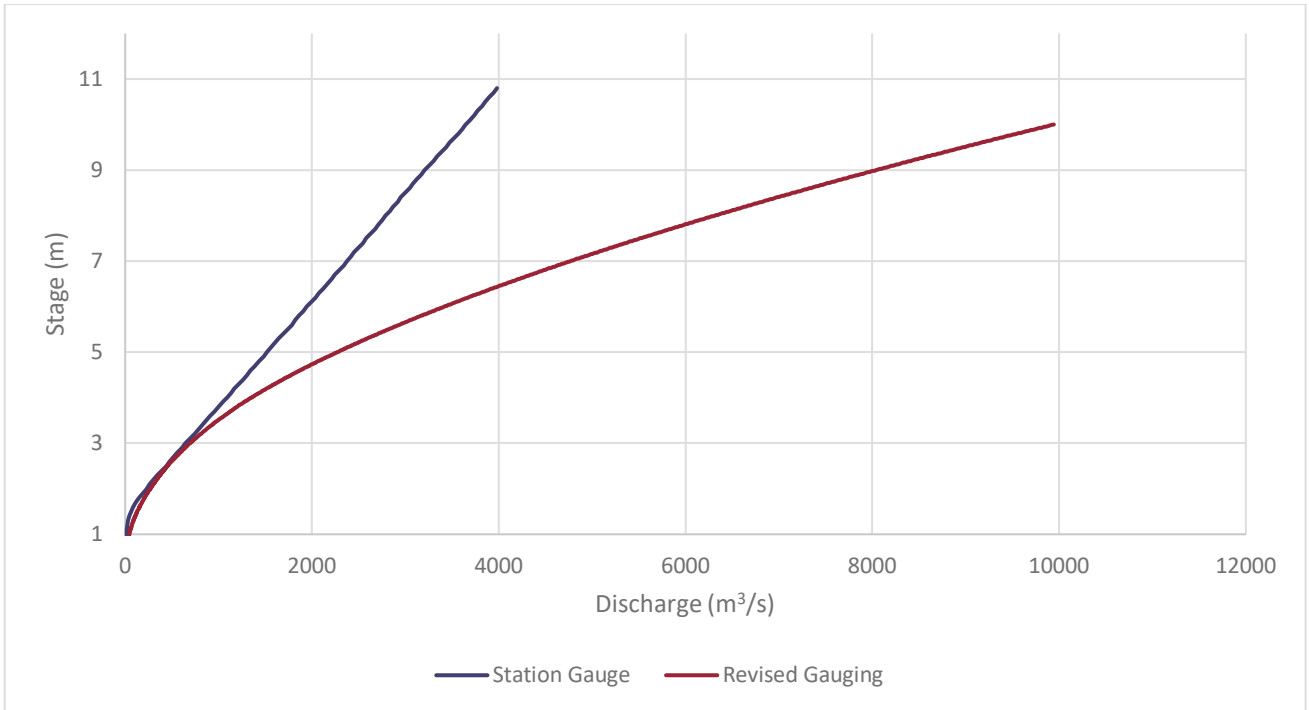
Figure B2 Towamba Rating Curves

Once the roughness values had been calibrated for lower flows, a revised rating curve was established for the higher flows estimating the roughness for the banks and sides of the channel. These new rating curves, as well as the previous, original curves, are shown in **Figures B2 to B4**.

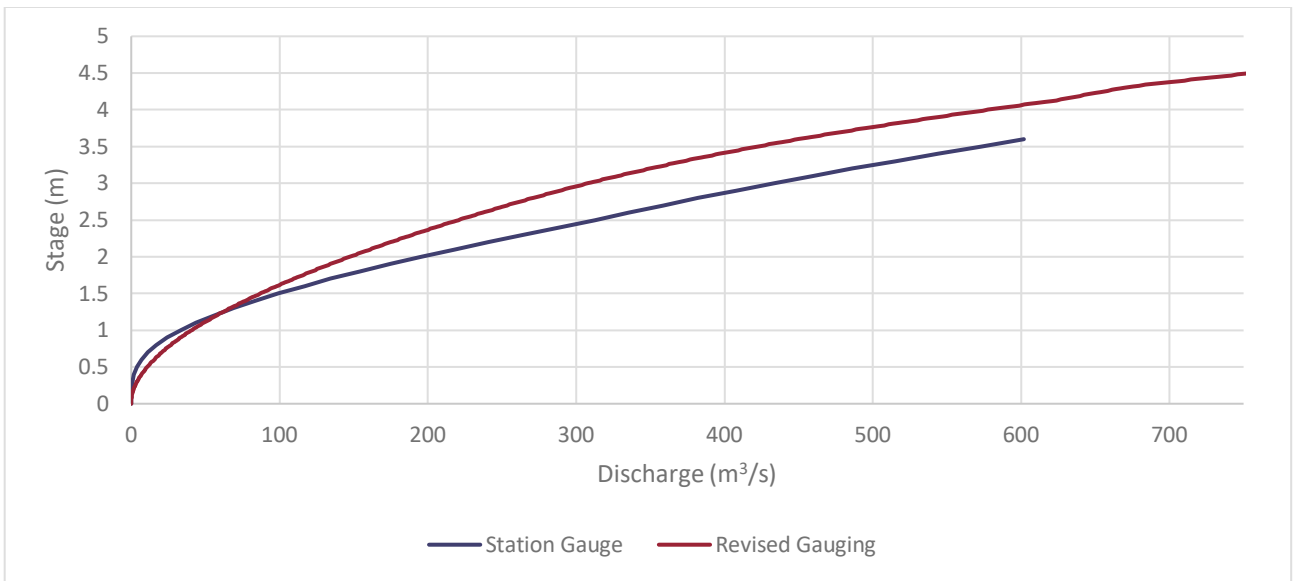
Figure B3 New Buildings Rating Curves

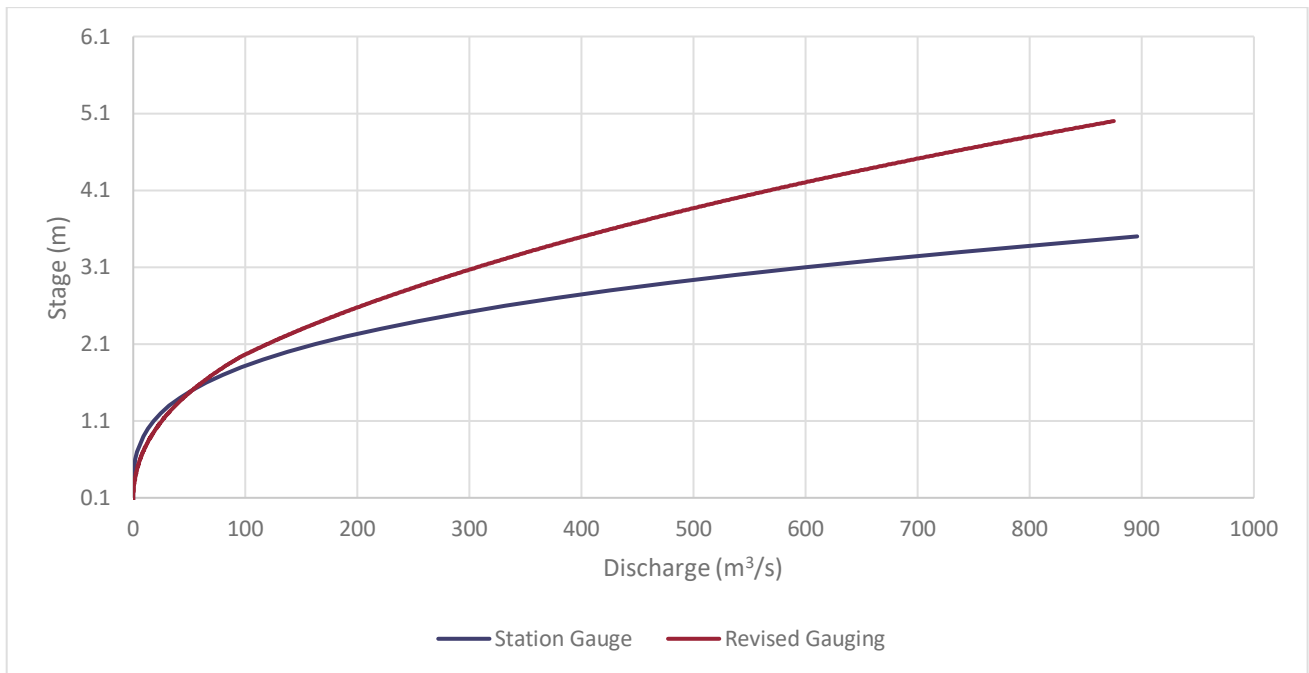
Figure B4 Rocky Hall Rating Curves

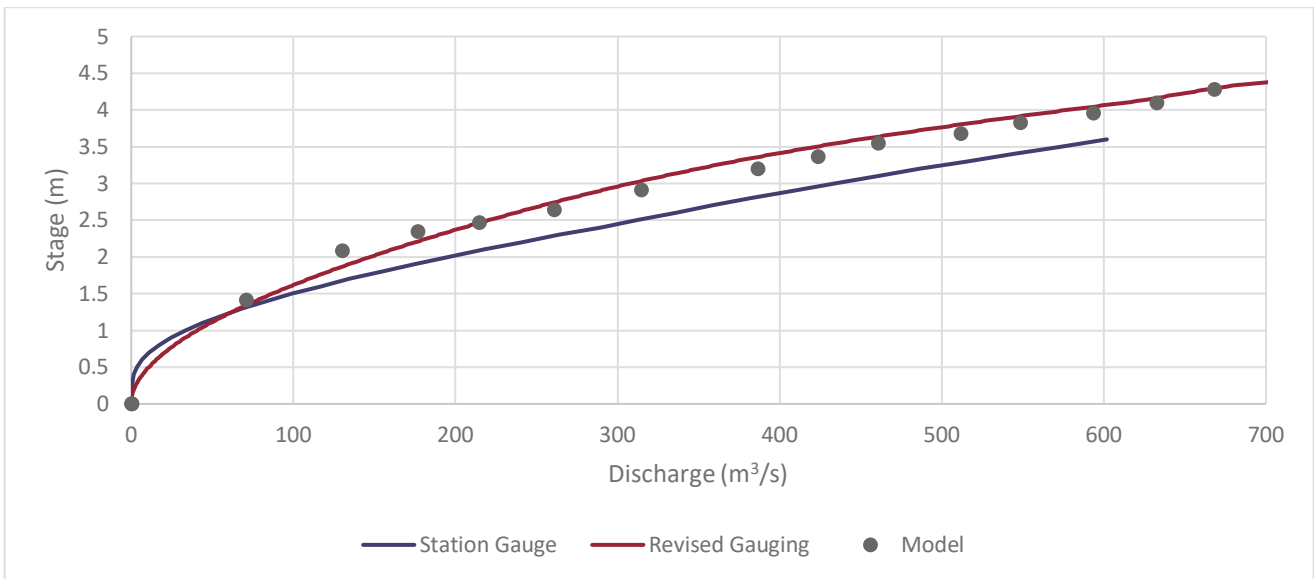
Figure B5 Comparison of Calculated and Modelled Rating Curves at New Buildings

The rating curve extracted from the hydraulic model is shown against the revised and original rating curves in **Figure B5**.

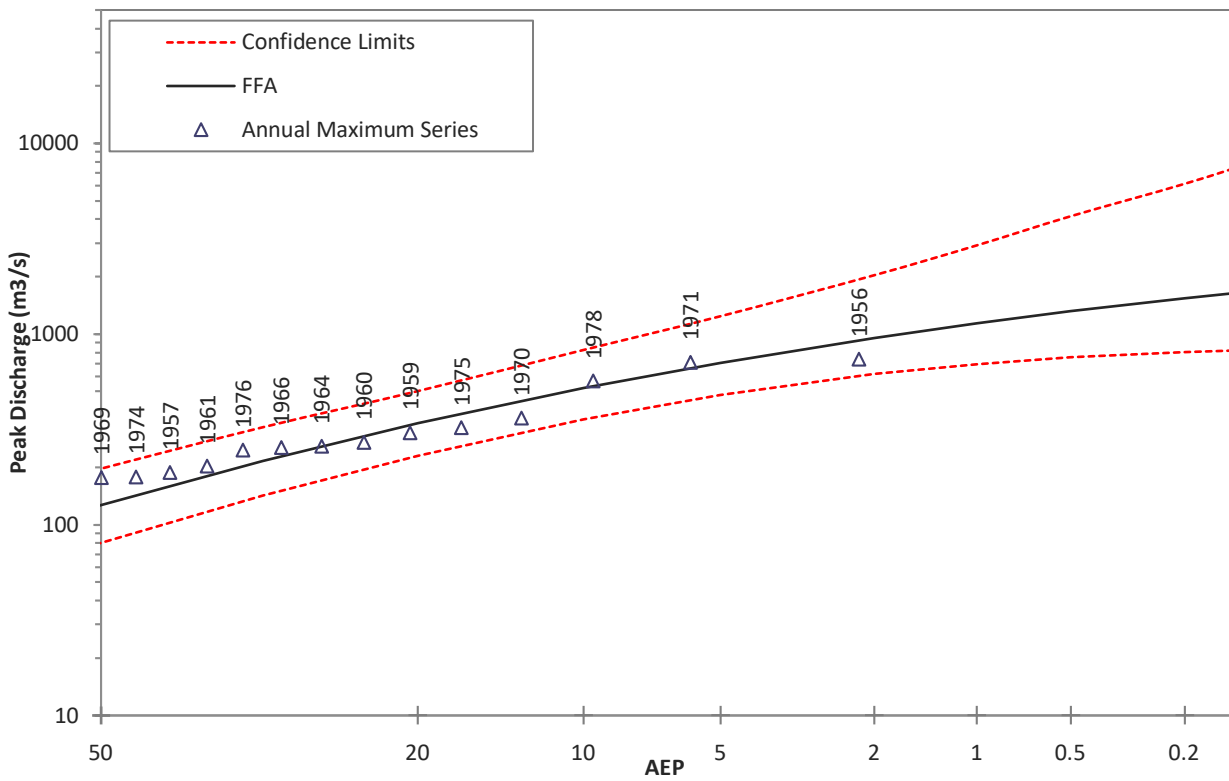
Figure B7 New Buildings FFA Comparison

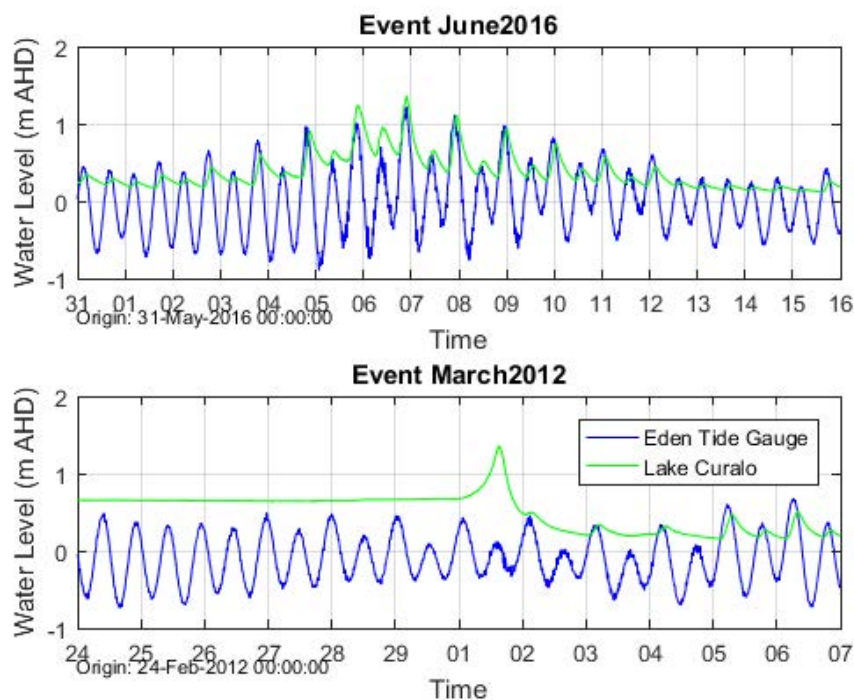
Figure D-1 Water levels at Eden Tide gauge used as coastal boundary conditions in the Lake Curalo model

Measured water levels at the Eden tide gauge were used as the coastal boundary conditions for the two periods, see **Figure D-1**. Similarly, the inflow data from the catchment model (XP-RAFTS) applied to the Delft3D model were also derived from measured rainfall during the two events.

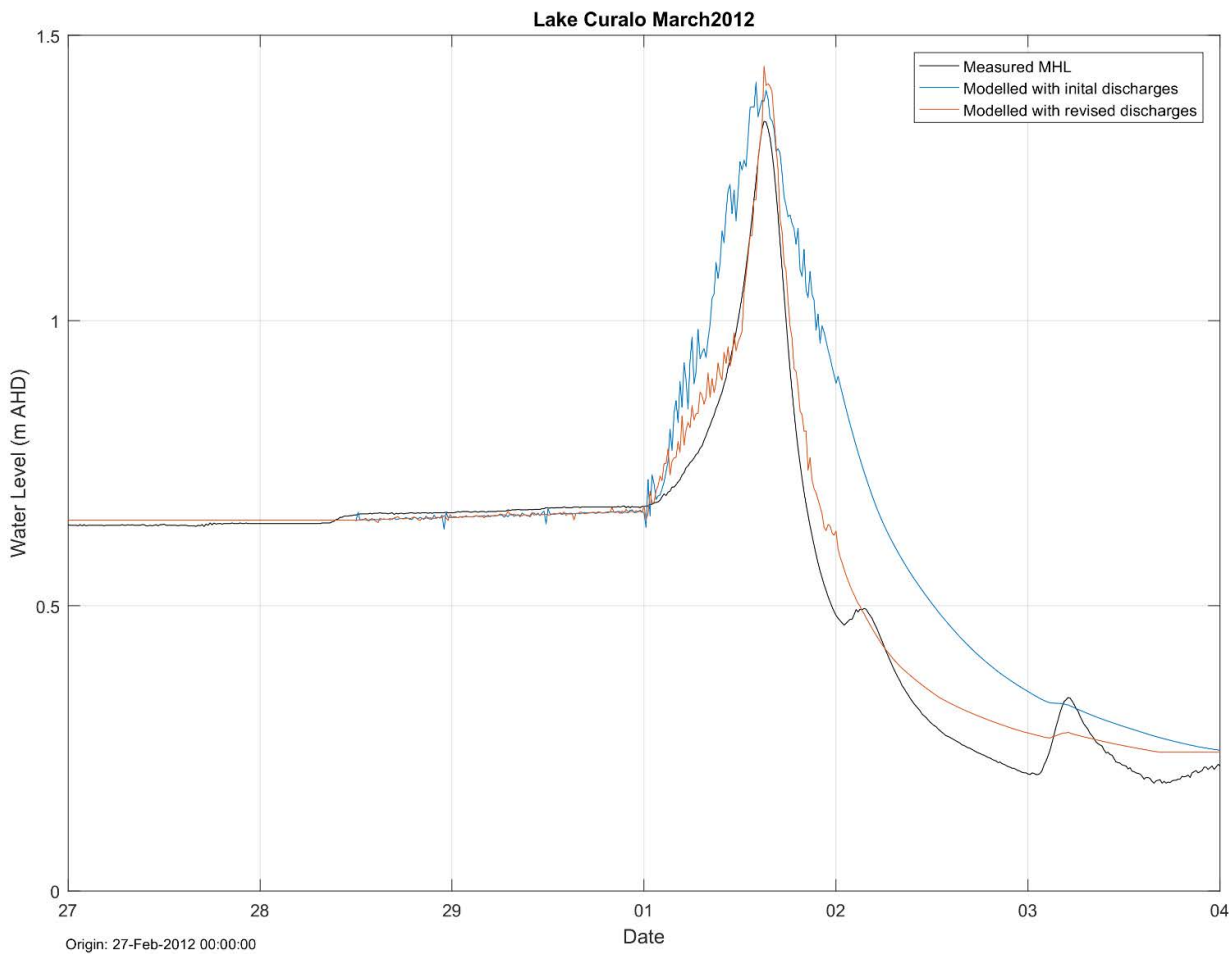
Figure D-3 Comparison of modelled lake water levels with the measured water levels from the MHL gauge within Lake Curralo for the March 2012 breakout event.

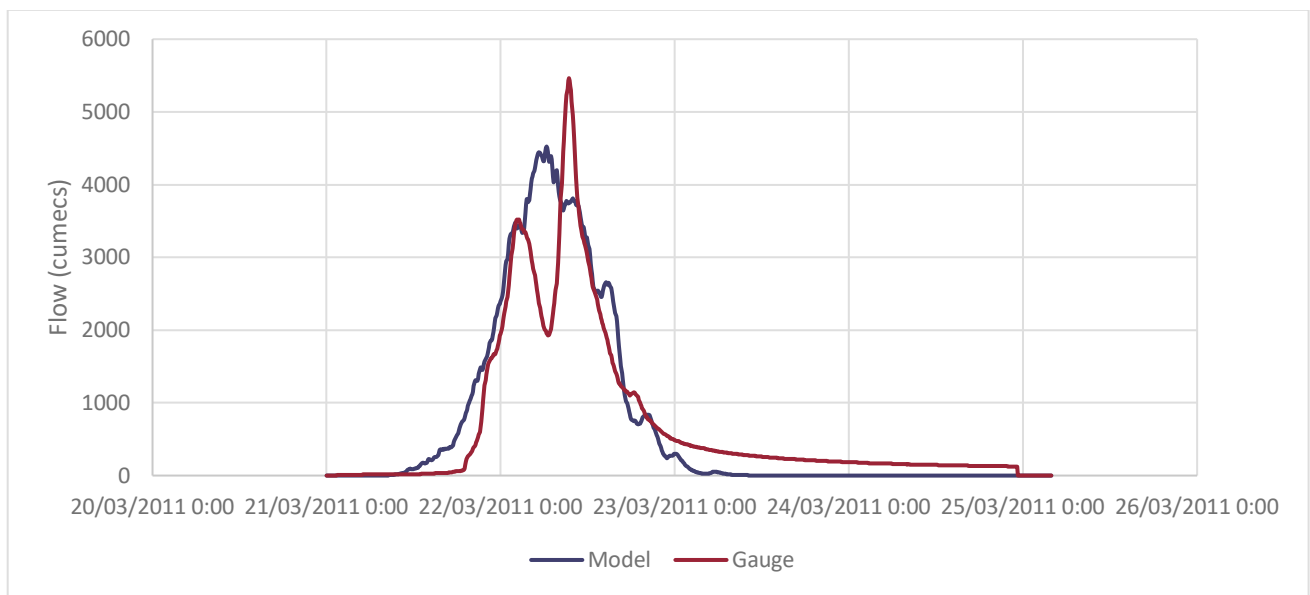
Figure D-4 Comparison of modelled and gauge flows at Towamba, 2011

Given the uncertainties with the peak flow estimates for the historical events, the XP-RAFTS model was validated against the FFA using ARR2016 design rainfall intensities and temporal patterns. This provides greater confidence on the peak flow estimates. The 2011 event, by comparison, then provides confidence on the flow routing in the model to ensure that the timing between the rainfall and flow at Towamba is similar.

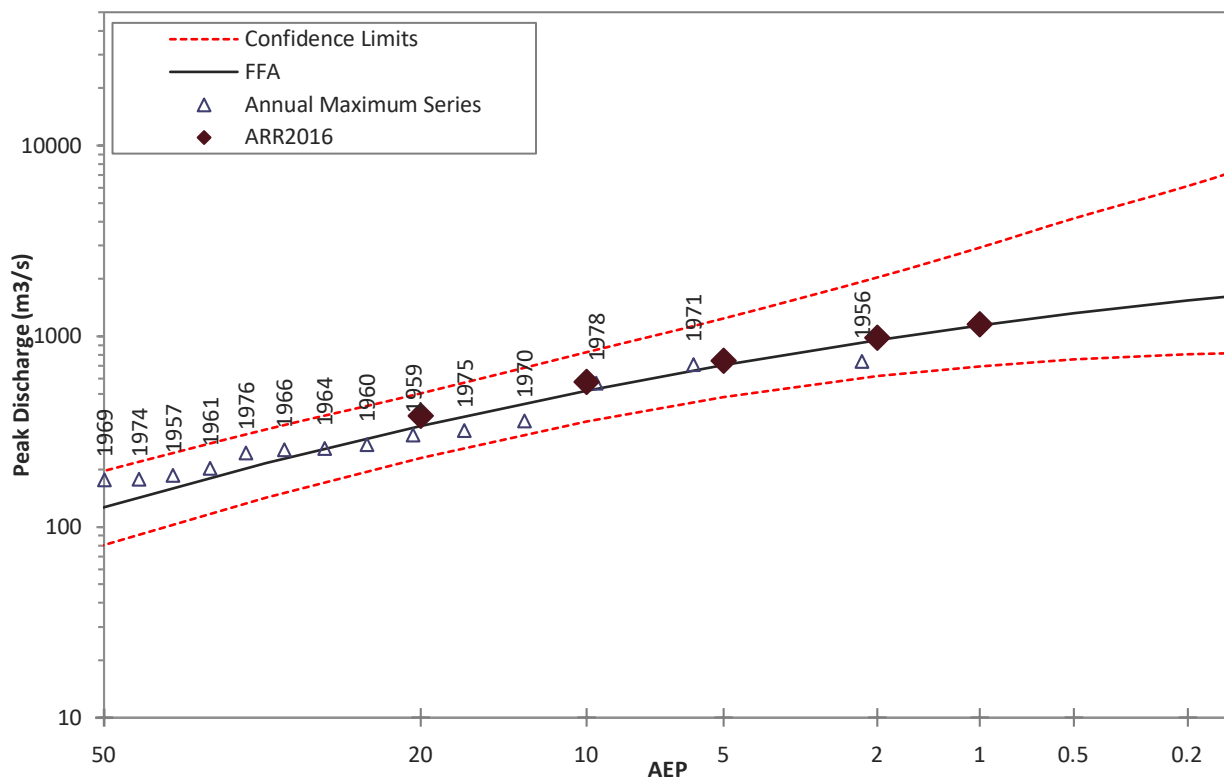
Figure D-6 New Buildings FFA Comparison

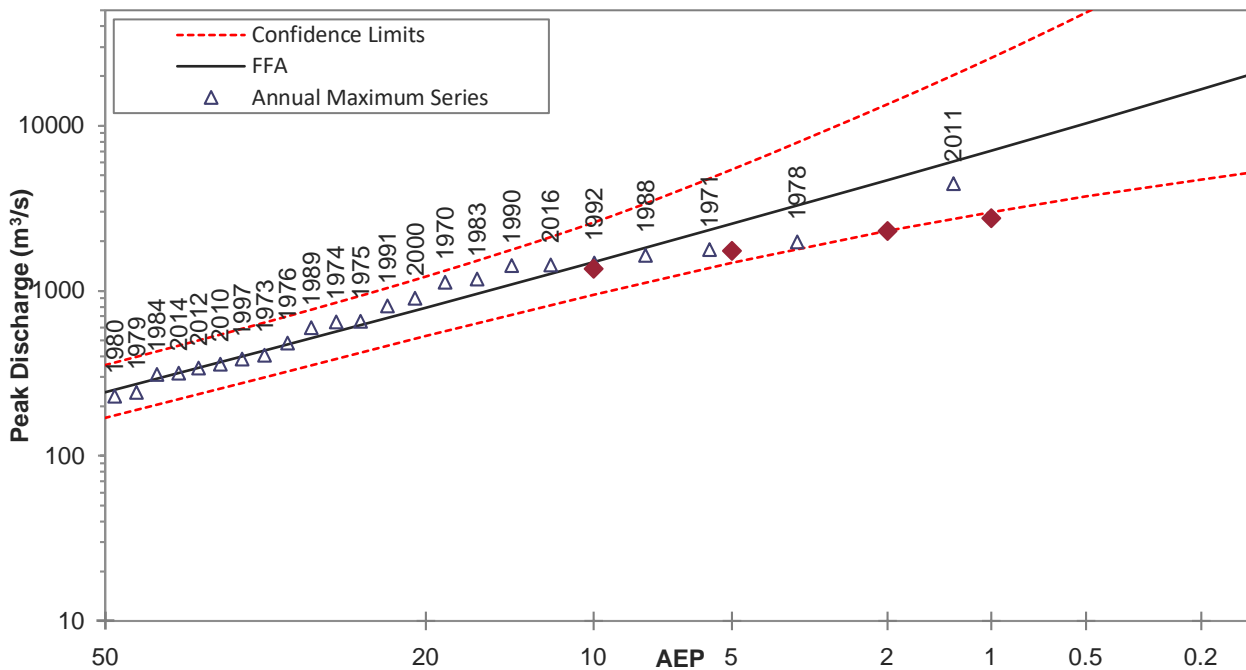
Figure D-7 Towamba FFA Comparison

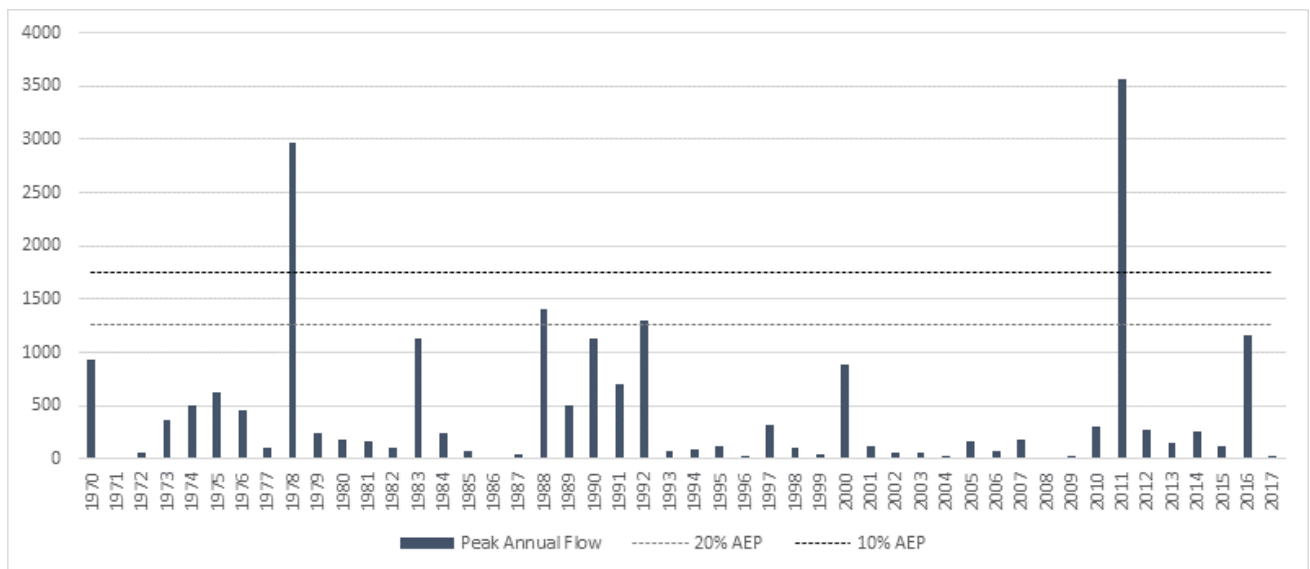
Figure D-8 Towamba Annual Peak Flow

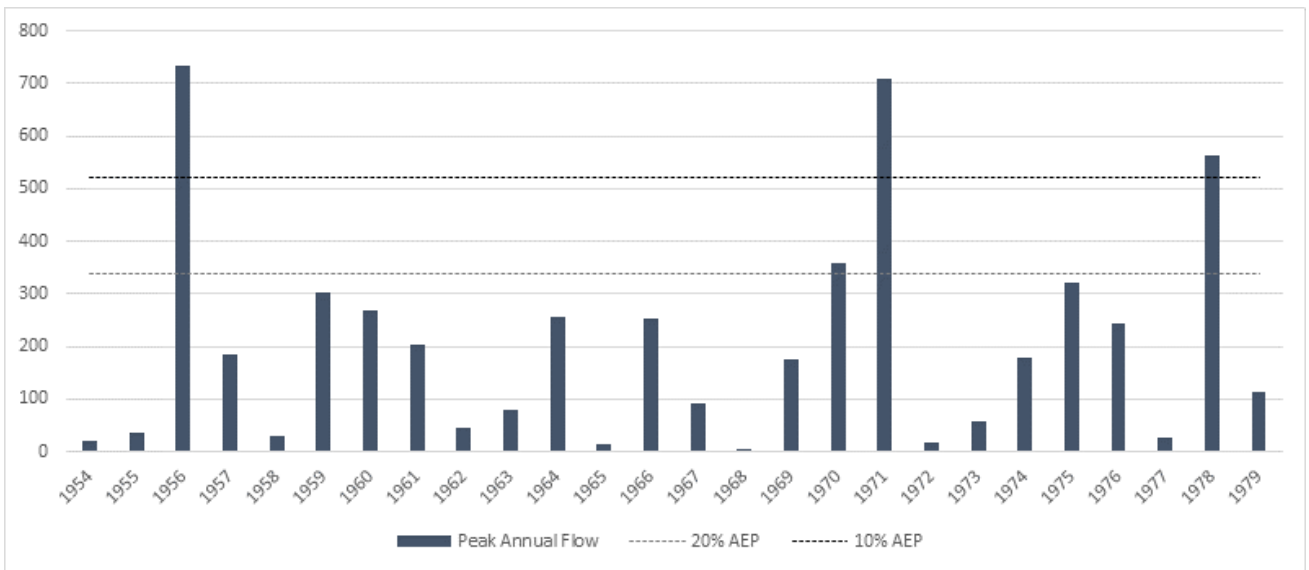
Figure D-9 New Buildings Annual Peak Flow
